LEVEE SYSTEM EVALUATION REPORT

VINCENNES, INDIANA

LOUISVILLE DISTRICT CORPS OF ENGINEERS

May 2014

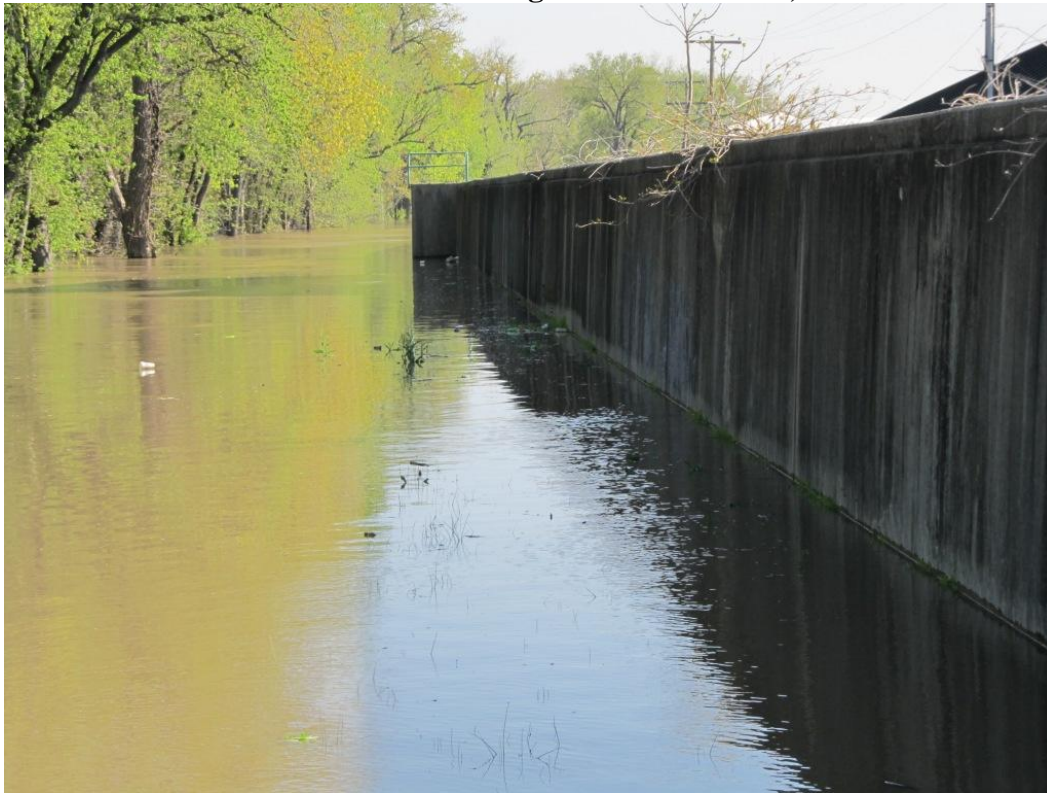
Photo 7.3-1. Levee I-wall during 2013 Flood Event, sta. 260+00

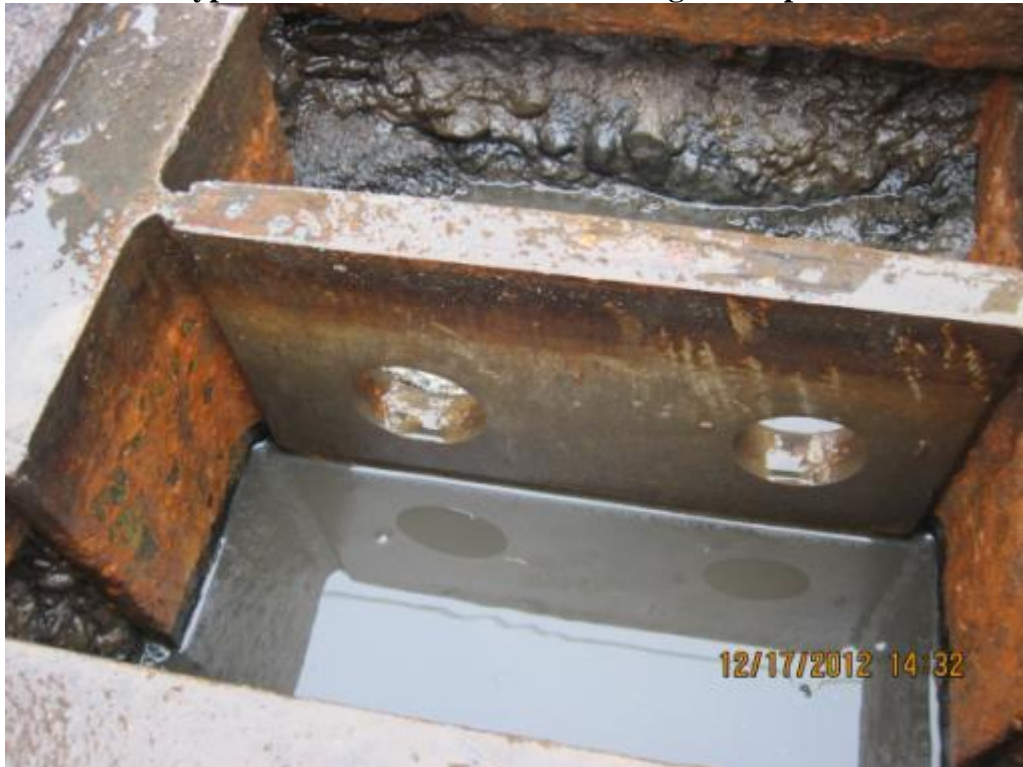
Photo 8.3-4 Standing Water at B&O Railroad Closure Sill

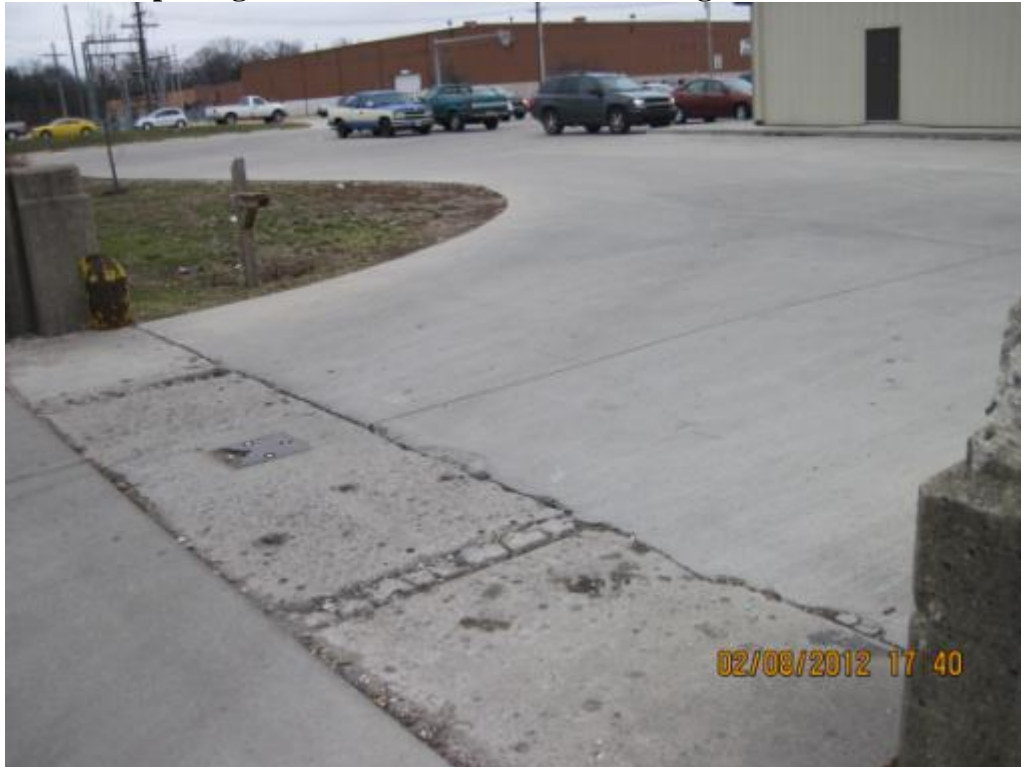
Photo 8.3-7 Sill Condition at Second and Niblack Closure

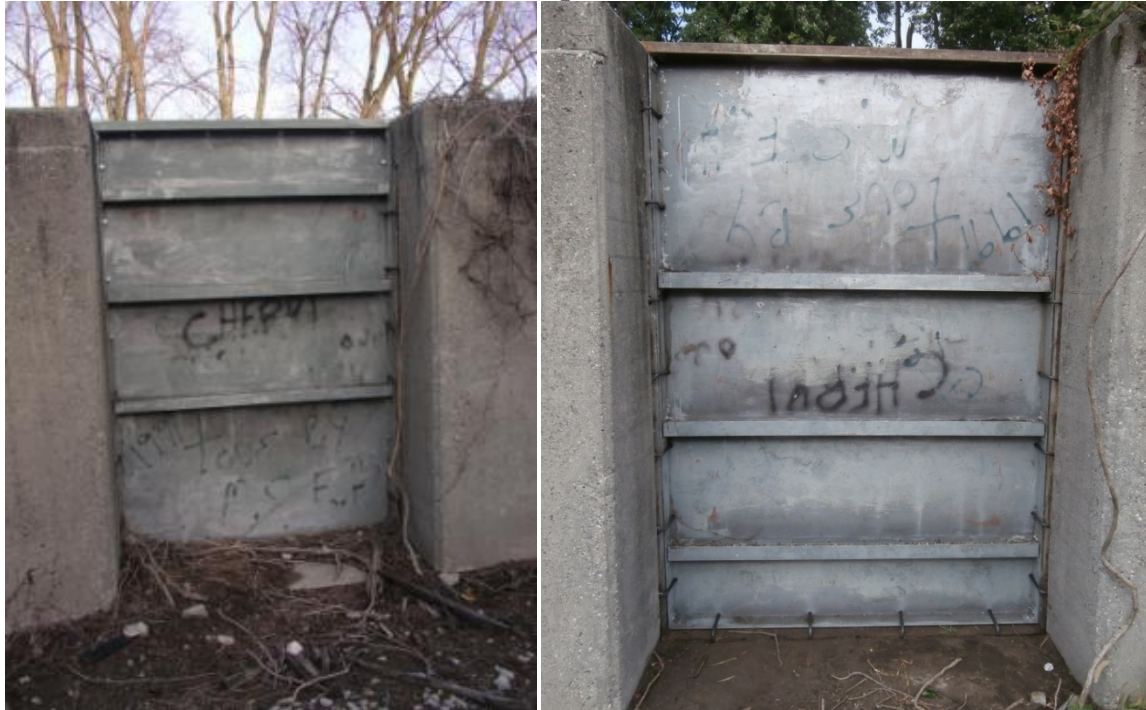
Photo 8.3-8 Service Opening bulkhead at Station 263+15 installed upside down (left), corrected in September of 2013 (right)

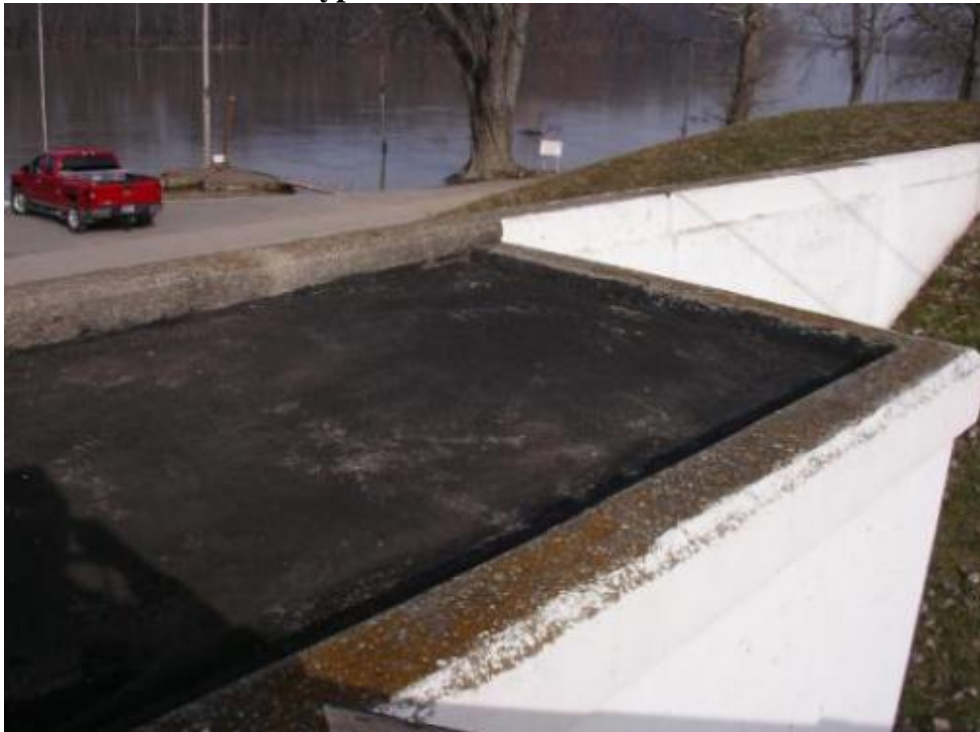
Photo 8.3-11 Ponding Water on B&O Closure Vault Roof

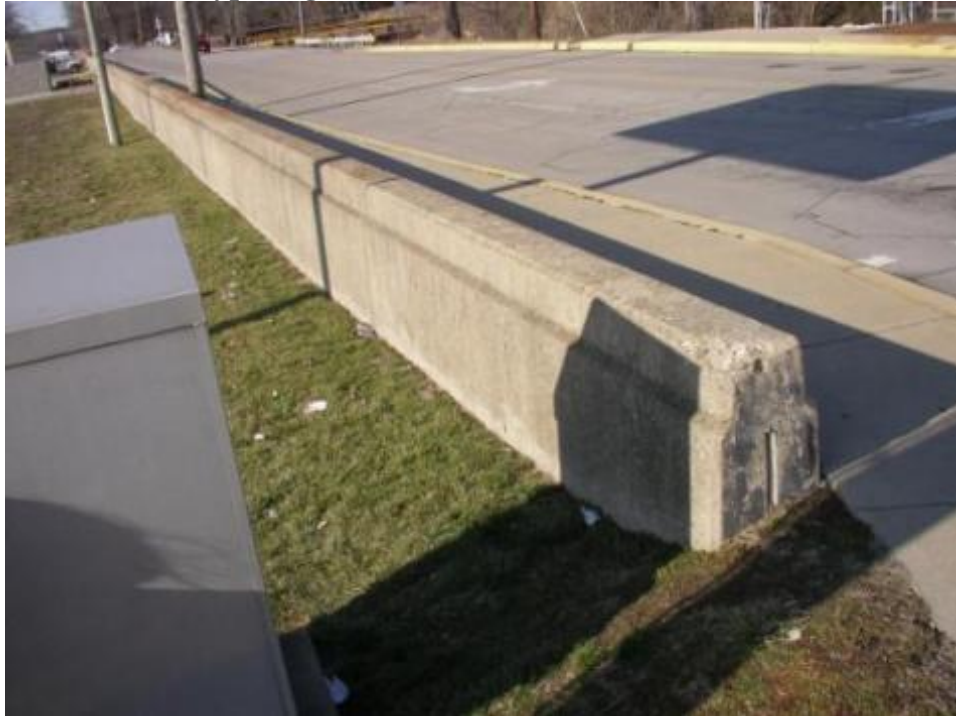
Photo 8.3-16 Minor surface damage on floodwall in Section A, Part 1

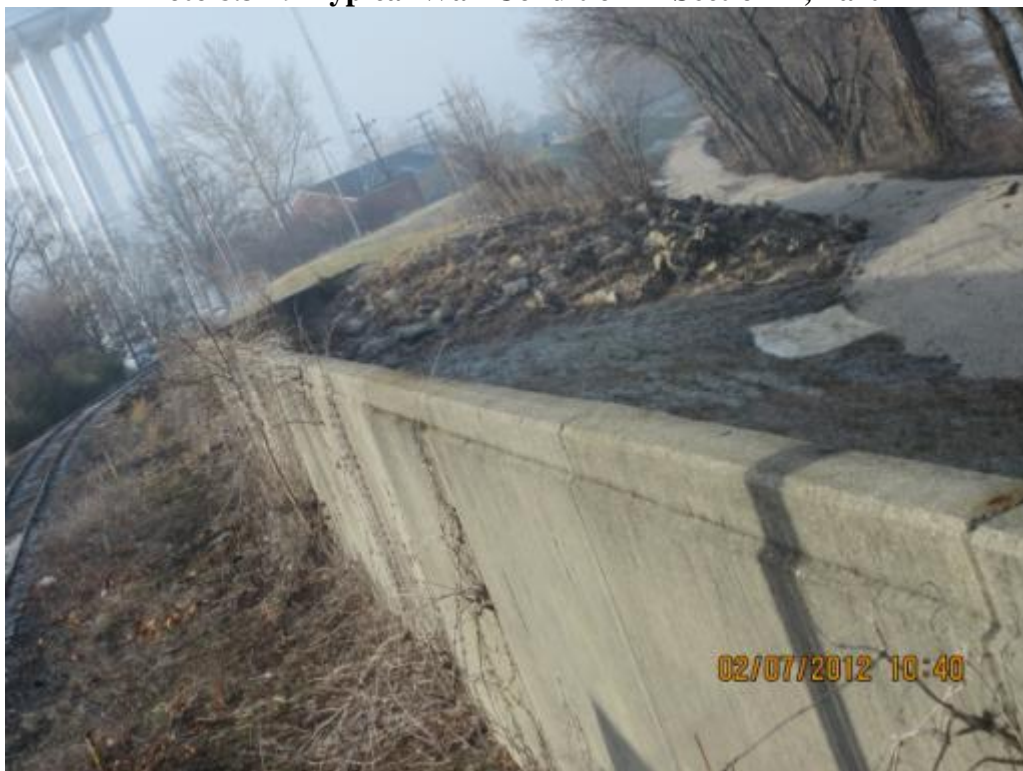
Photo 8.3-20 Localized crack in top of wall in Section A, Part 2

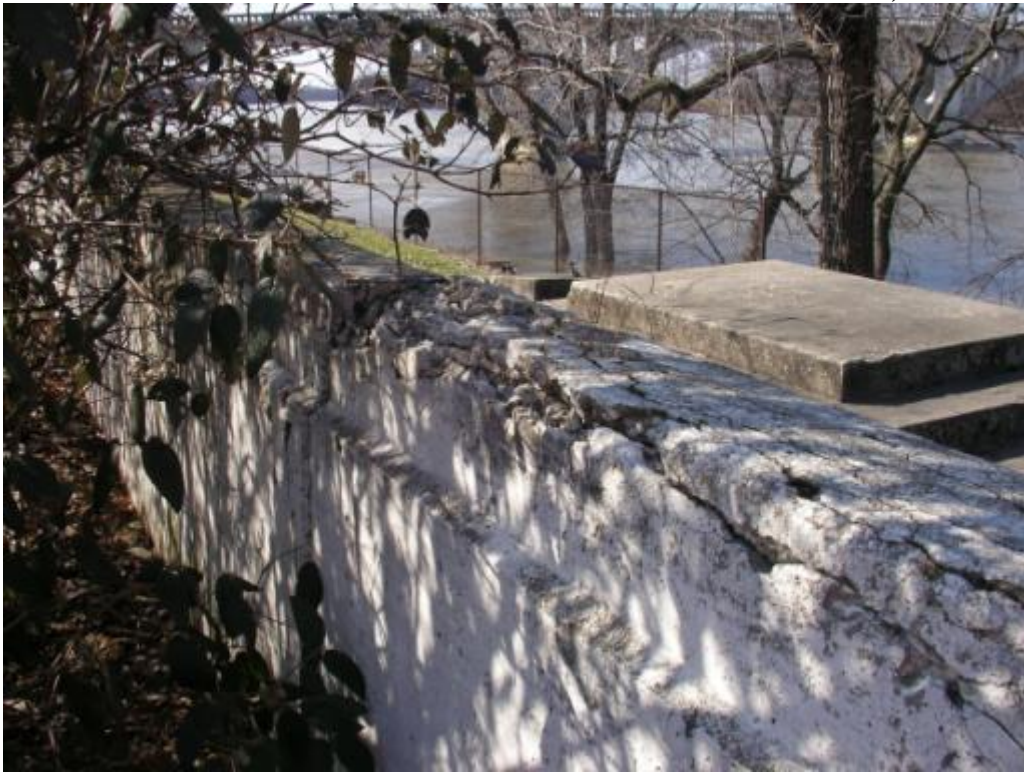
Photo 8.3-27 Poor condition of floodwall monolith in Section B, Part 1

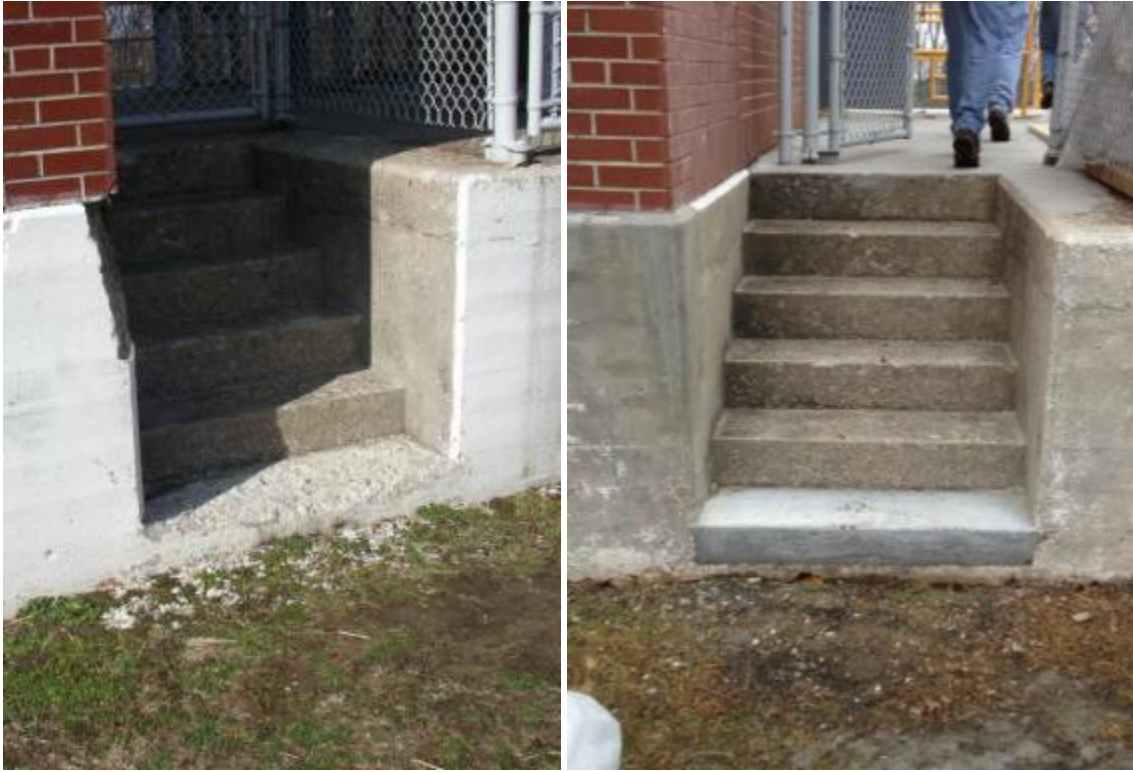
Photo 8.3-38 Concrete around Perry Street foundation and stairs, before and after

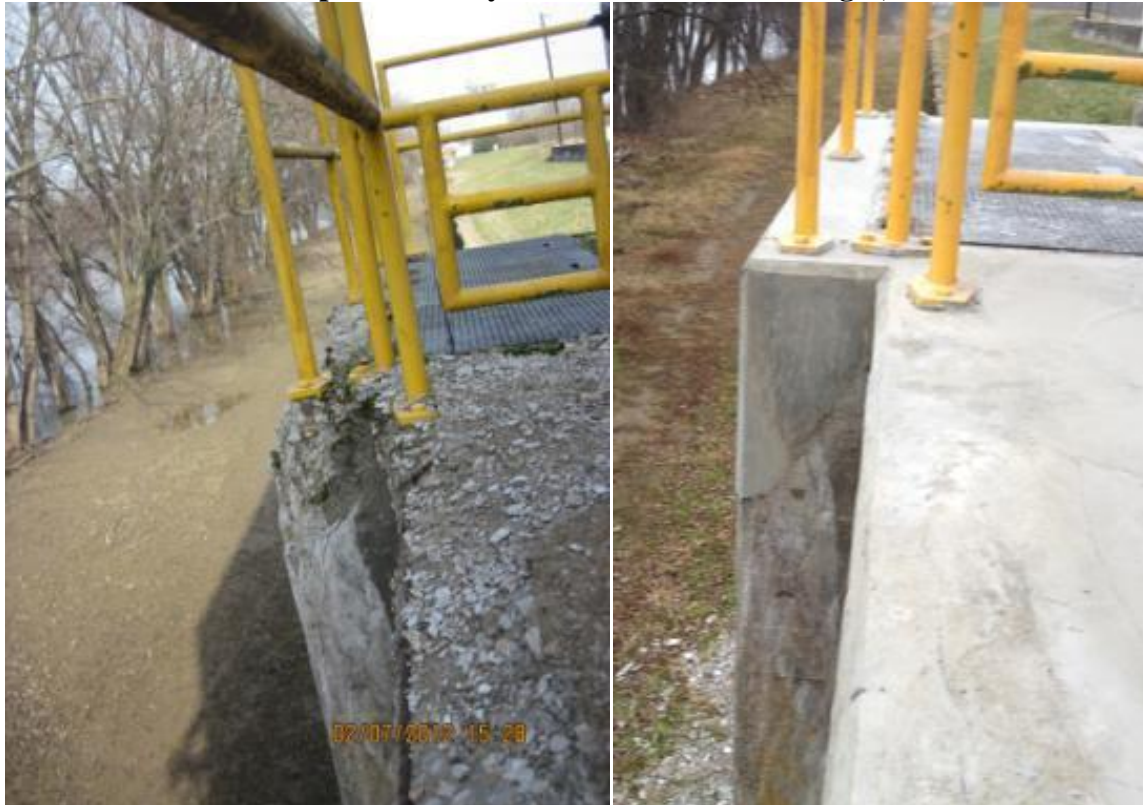
Photo 8.3-39 Severe spalls at Perry Street handrail anchorages, before and after

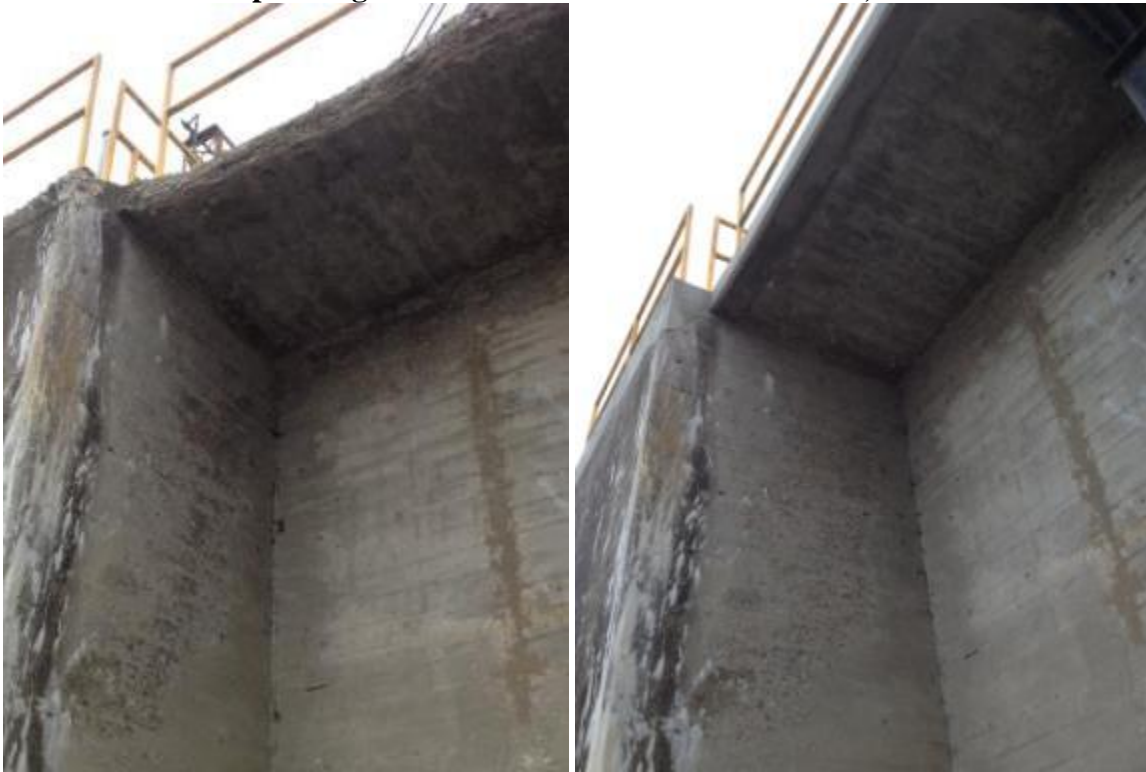
Photo 8.3-40 Operating floor concrete condition from below, before and after

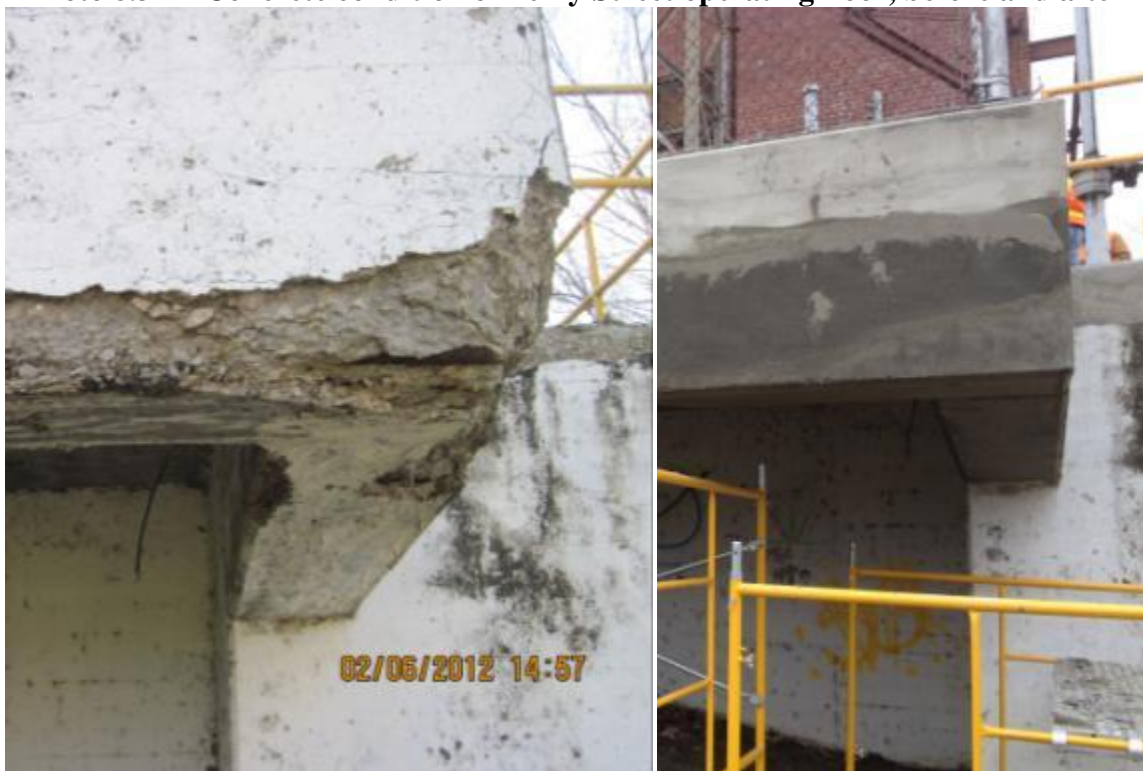
Photo 8.3-41 Concrete condition of Perry Street operating floor, before and after

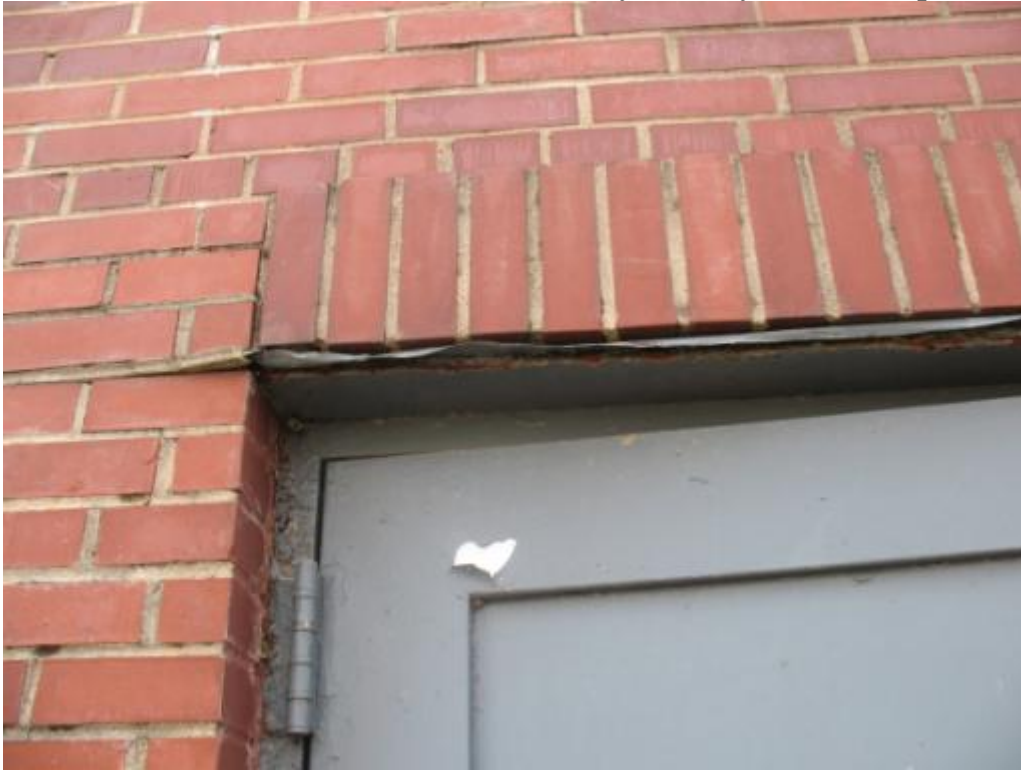
Photo 8.3-42 Corrosion of lintel over doorway at Perry Street Pump Plant

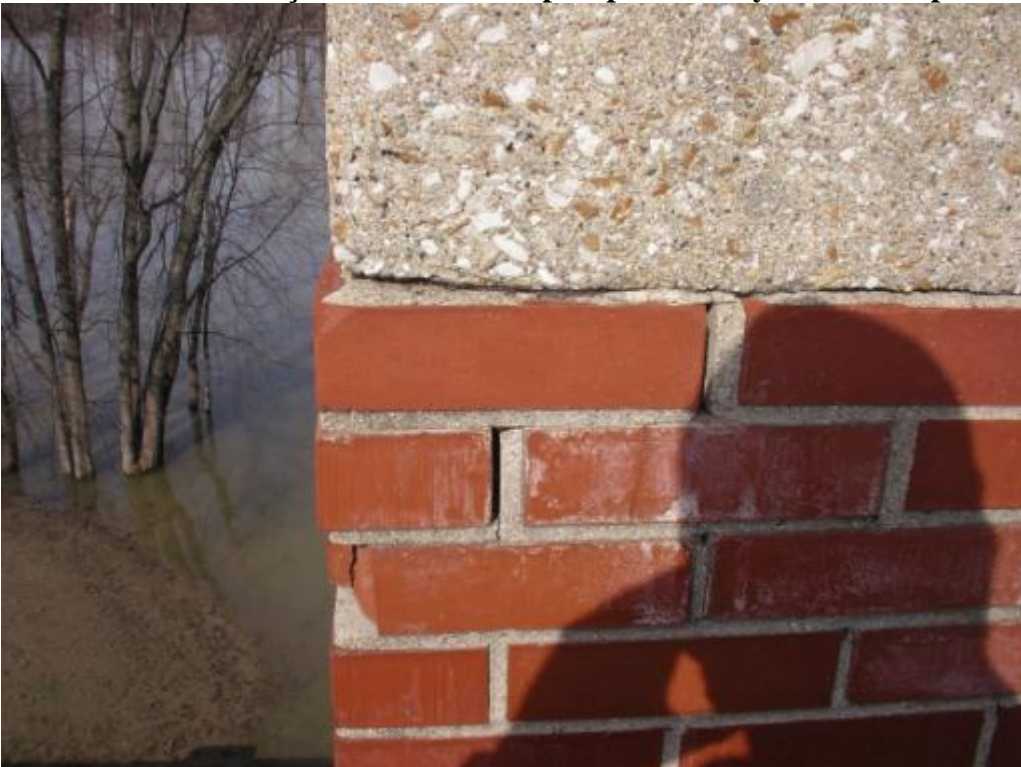
Photo 8.3-43 Brick façade failure below parapet of Perry Street Pump Plant

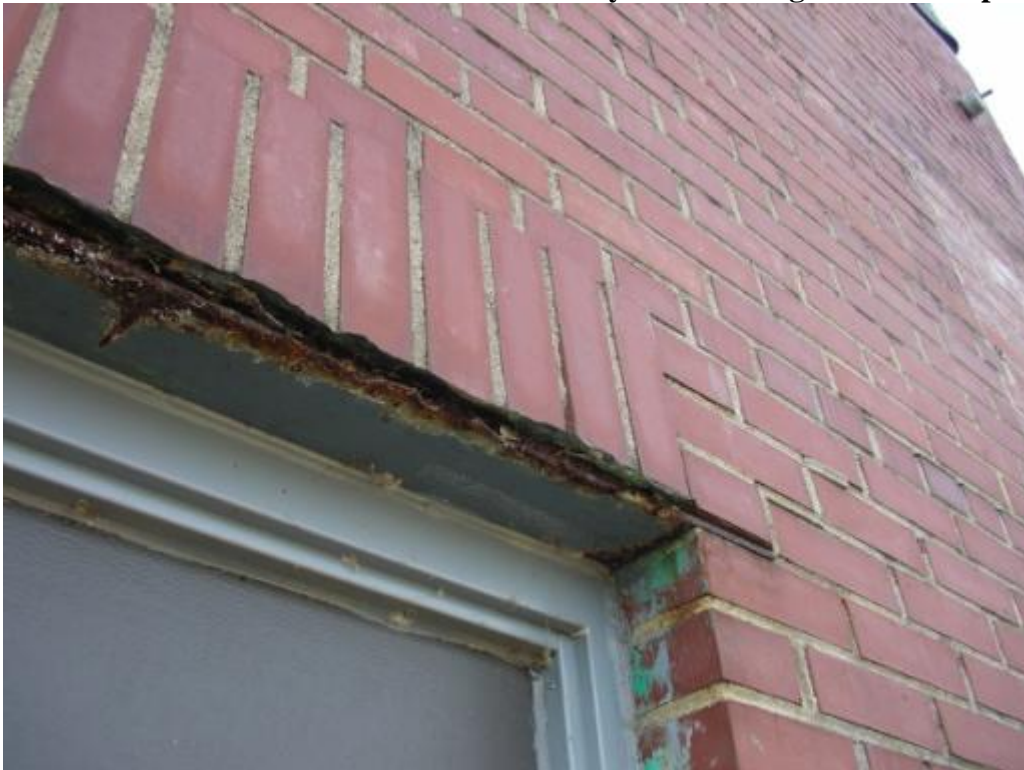
Photo 8.3-44 Corrosion of lintel over the doorway at the College Street Pump Plant

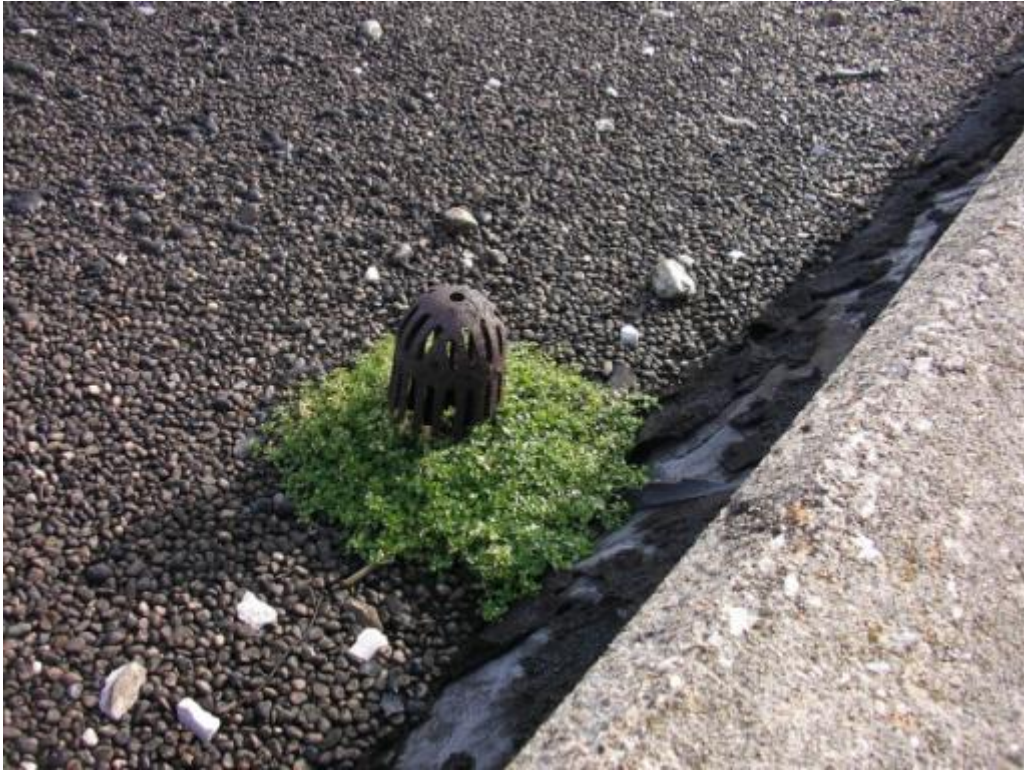
Photo 8.3-46 St. Clair Avenue roof drain and membrane in early stages of failure

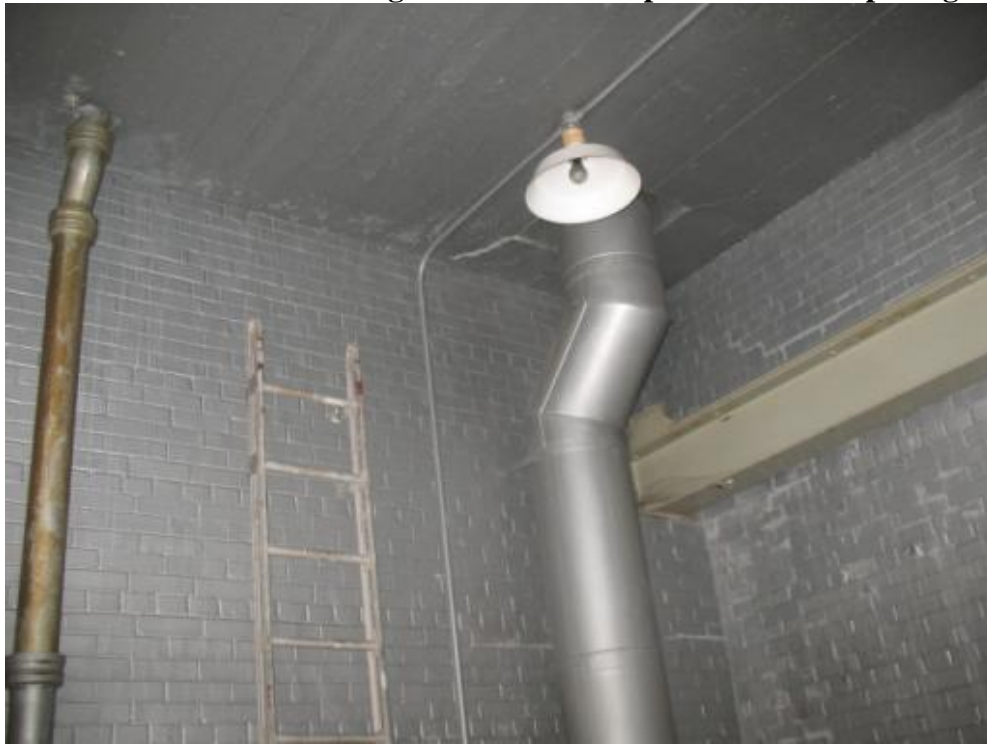
Photo 8.3-47 Cracks in Highland Street Pump Plant roof at opening

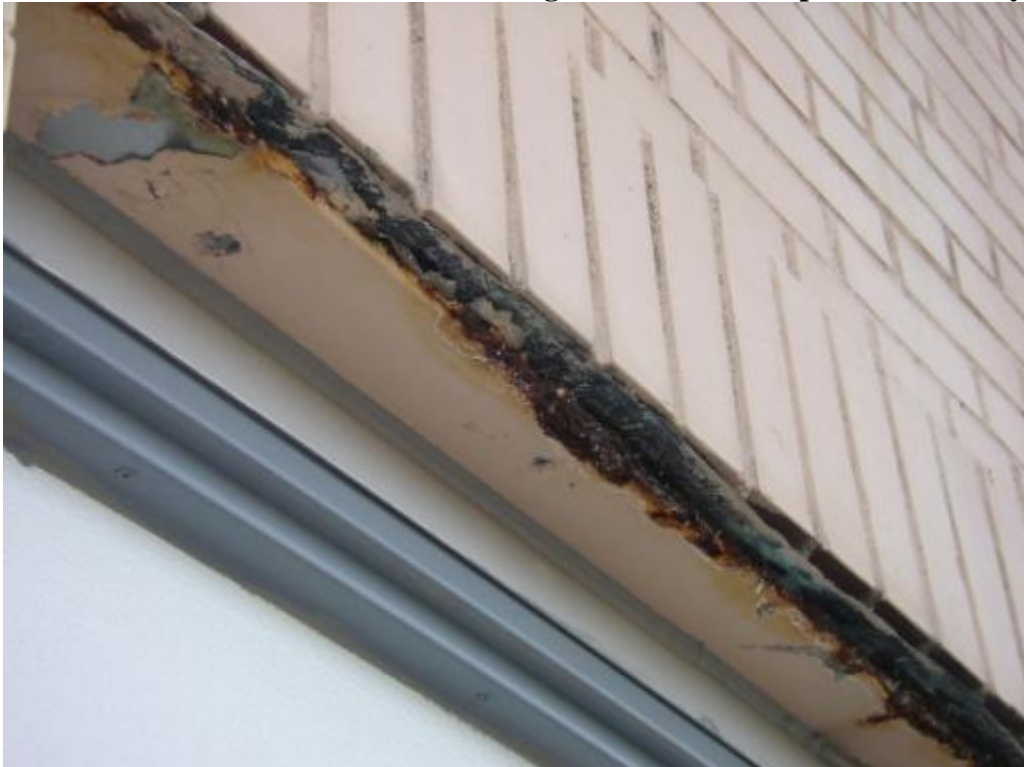
Photo 8.3-48 Corrosion of lintel over Highland Street Pump Plant doorway

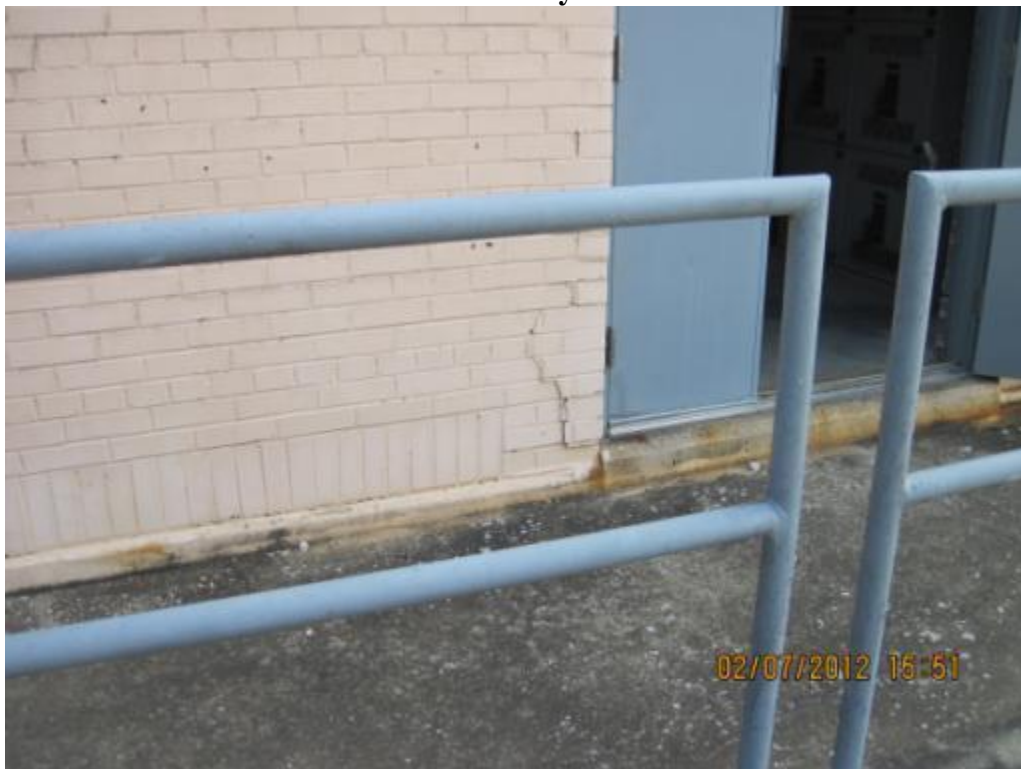
Photo 8.3-49 Loose brick section near bottom of Highland Street Pump Plant doorway

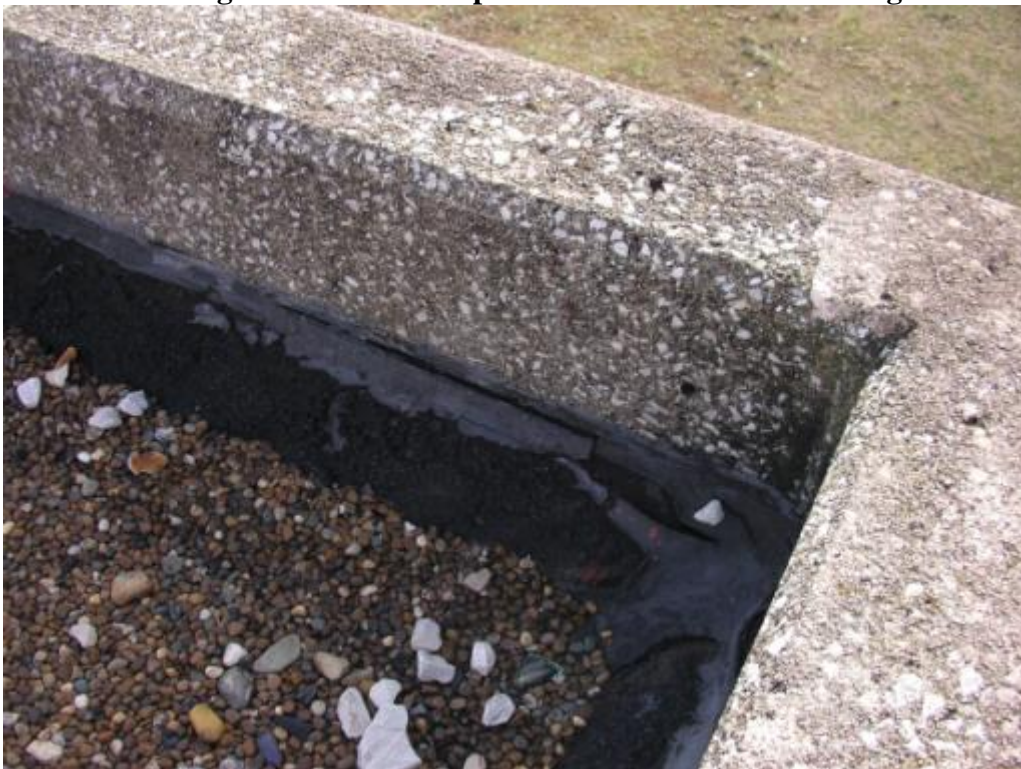
Photo 8.3-50 Highland Street Pump Plant roof membrane has begun to fail

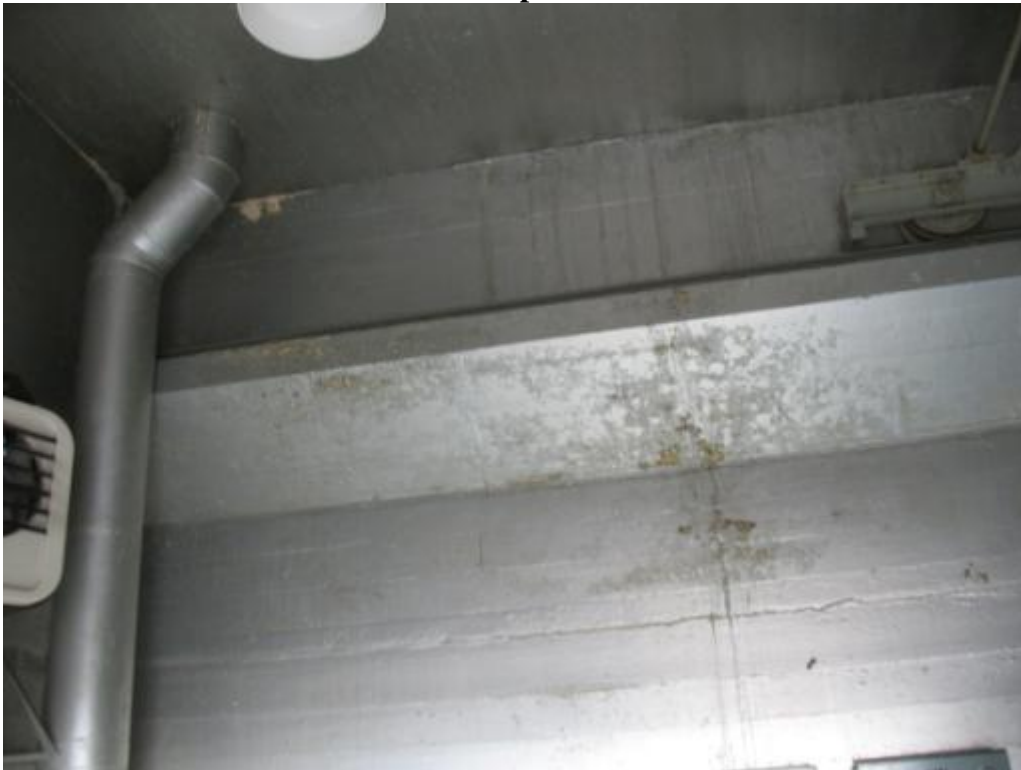
Photo 8.3-51 The interior corbel for the overhanging crane has a crack at the midspan

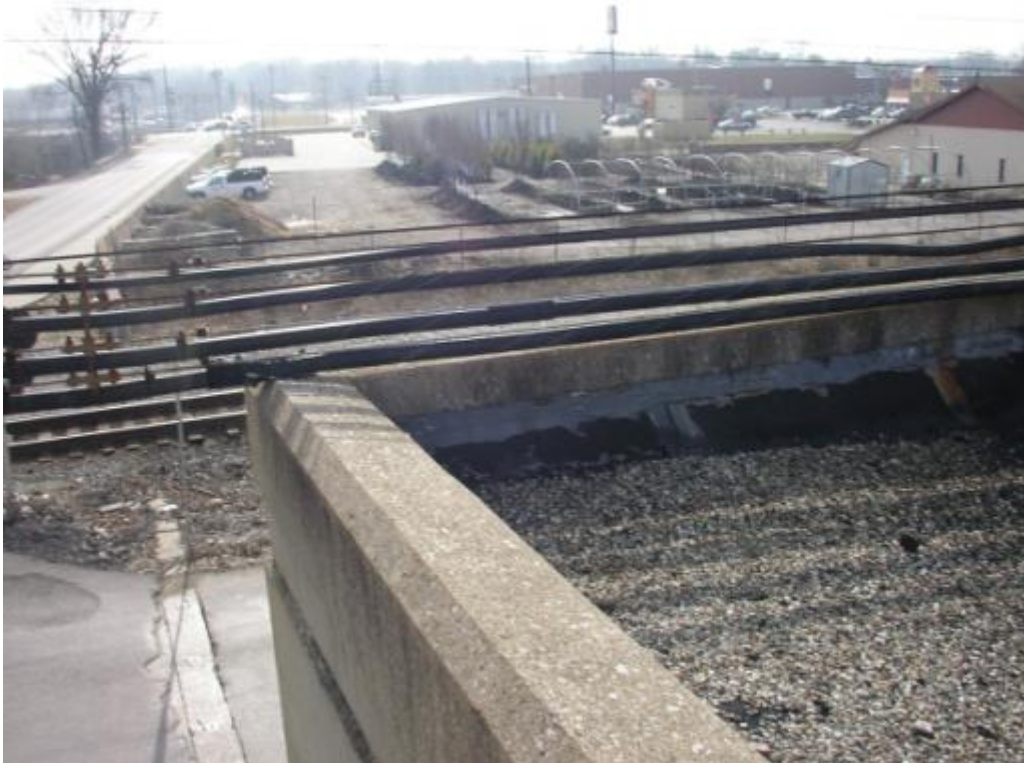
Photo 8.3-52 Overhanging lines in contact with the Second Street Pump Plant parapet

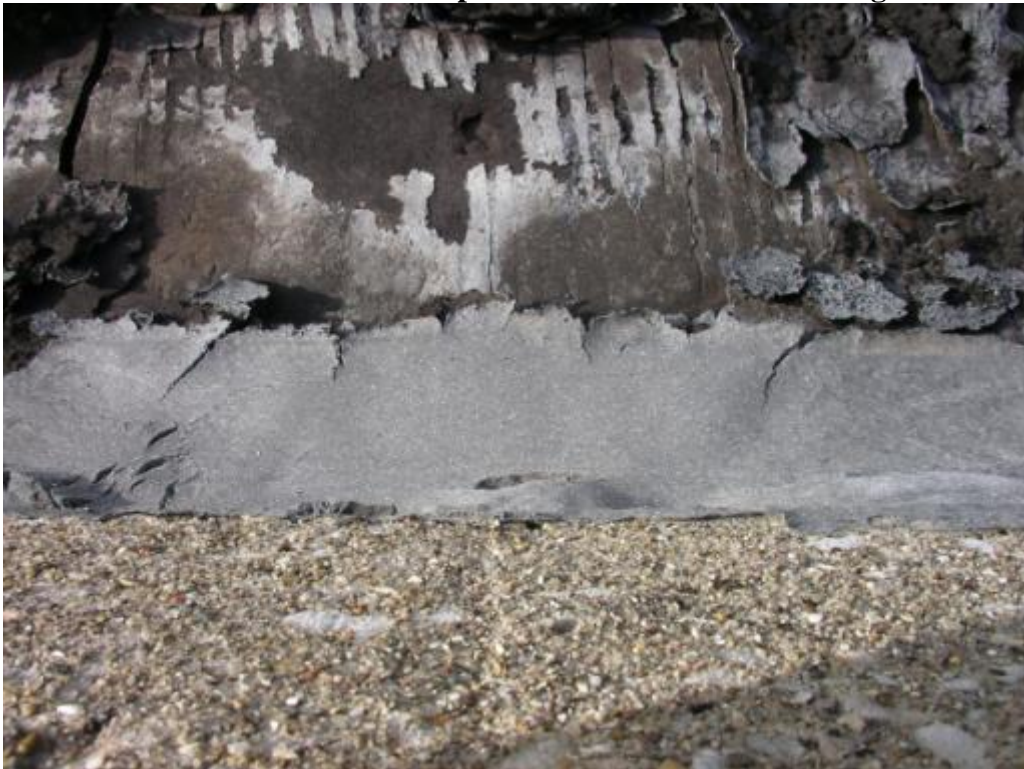
Photo 8.3-53 Second Street Pump Plant roof membrane has begun to fail

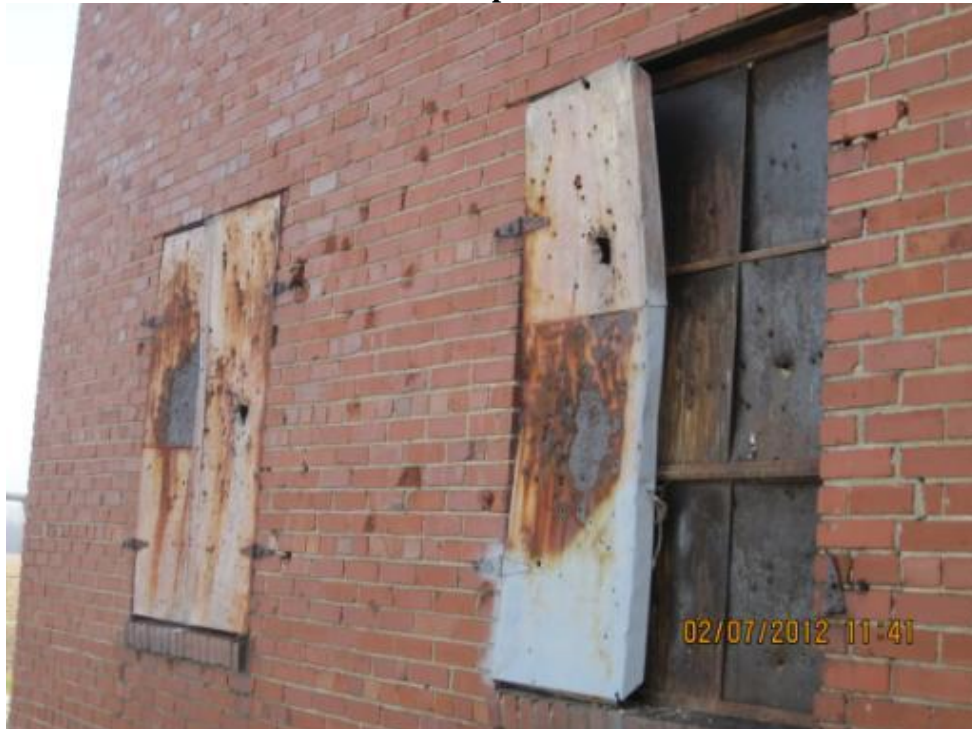
Photo 8.3-54 Damage on City Ditch Pump Plant exterior wall caused by trespassers

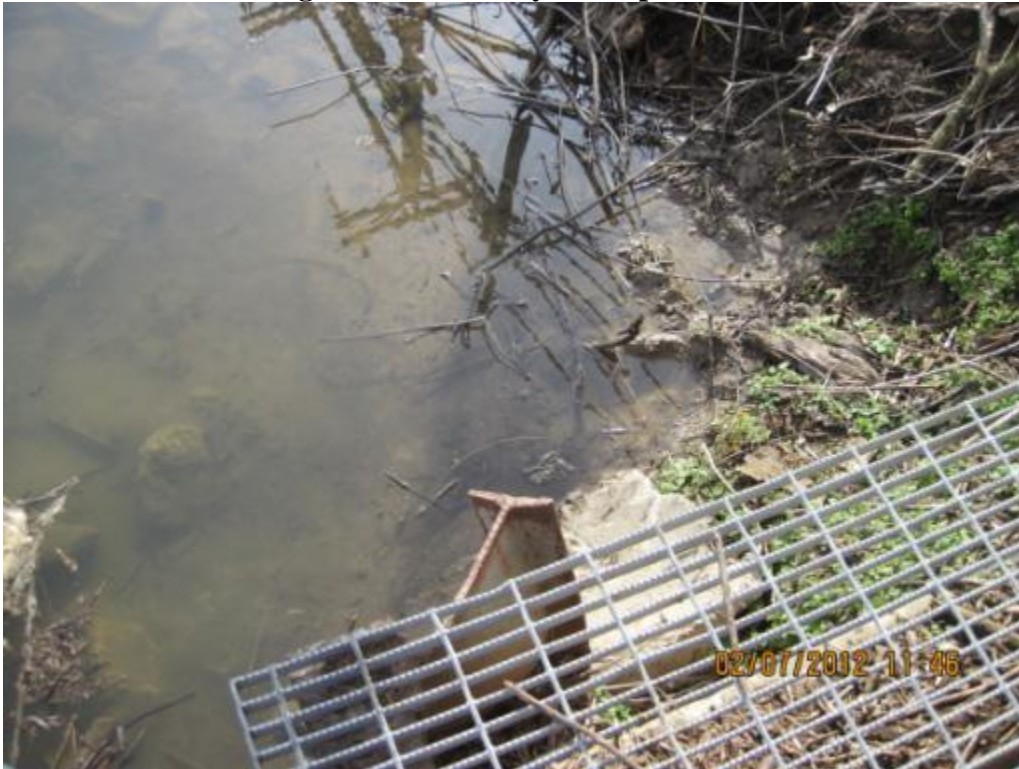
Photo 8.3-55 Missing handrail on City Ditch platform above trash rack

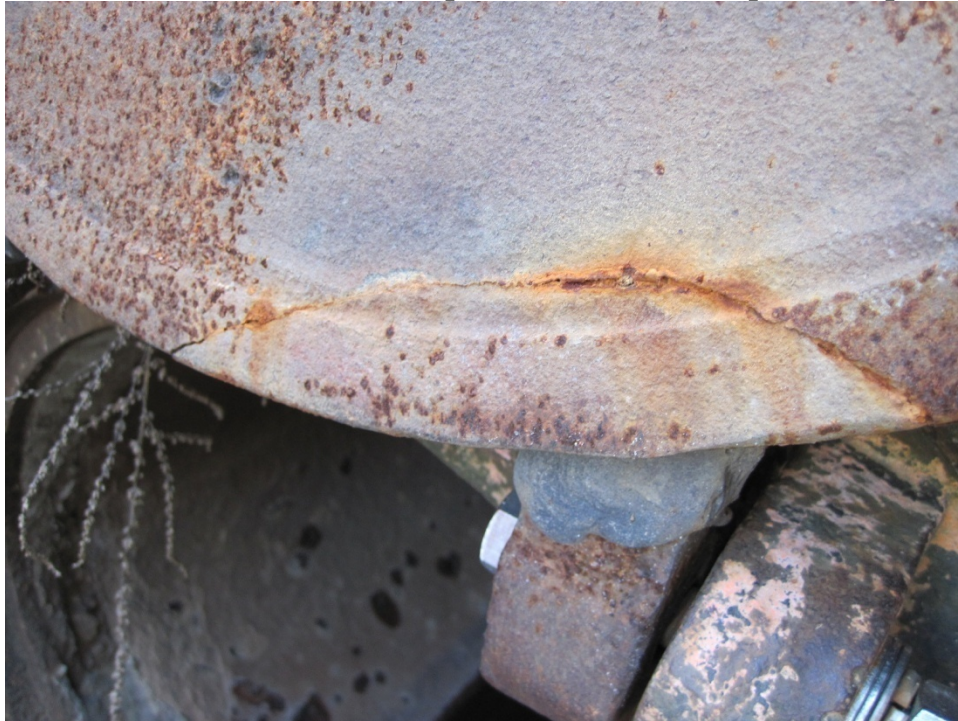
Photo 8.5-3 Second Street Pump Station Previous Flap Gate Repair

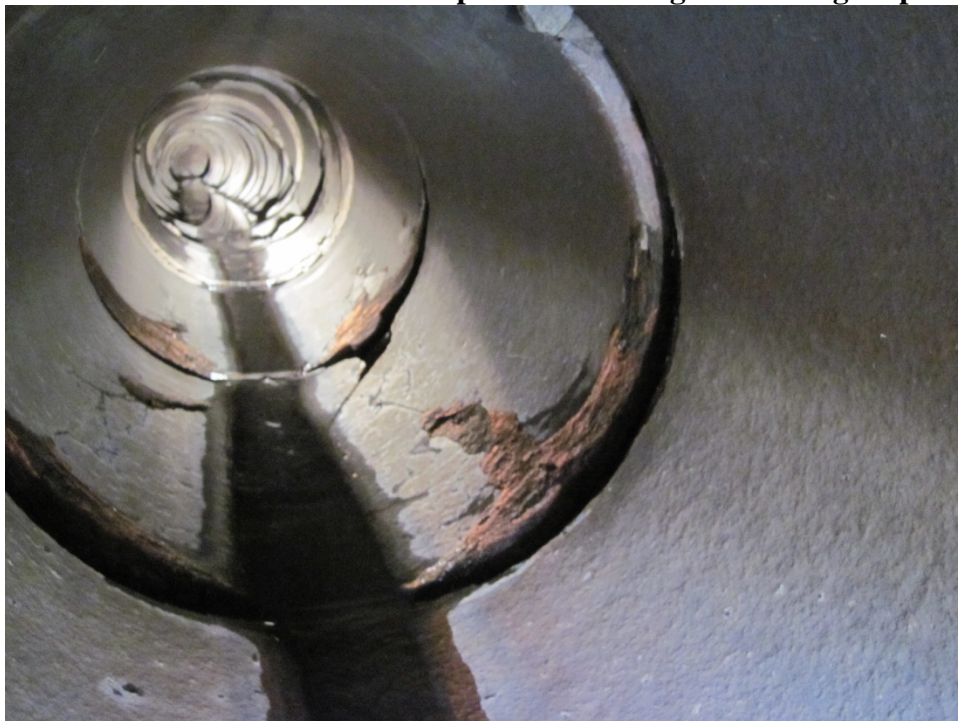
Photo 8.5-4 Second Street Pump Station Damaged Discharge Pipe

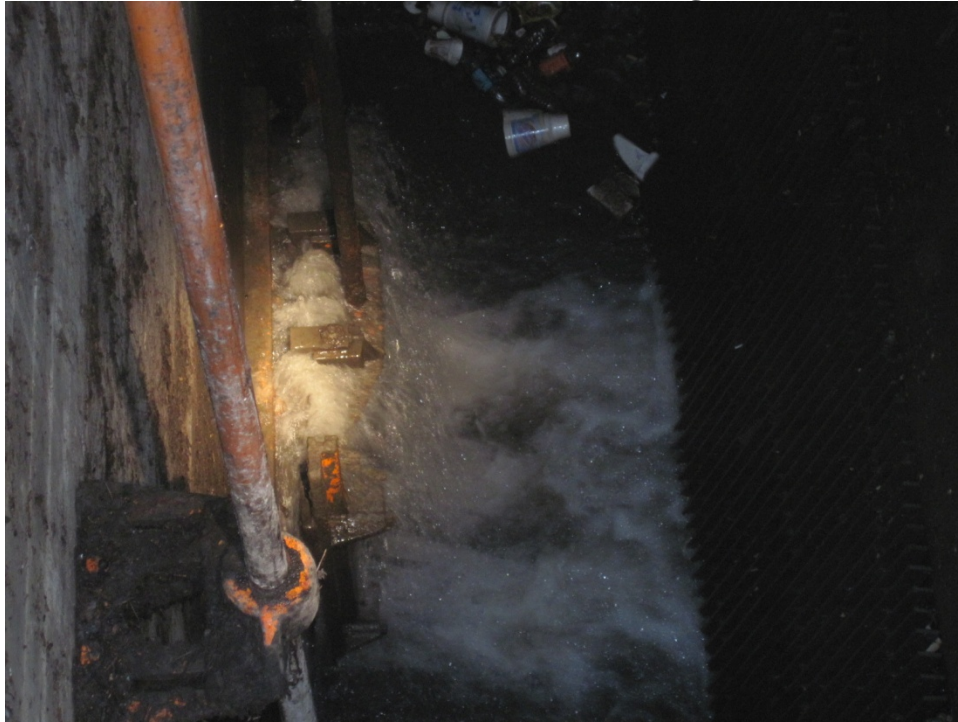
Photo 8.5-5 College Avenue Sluice Gate Leakage When Closed

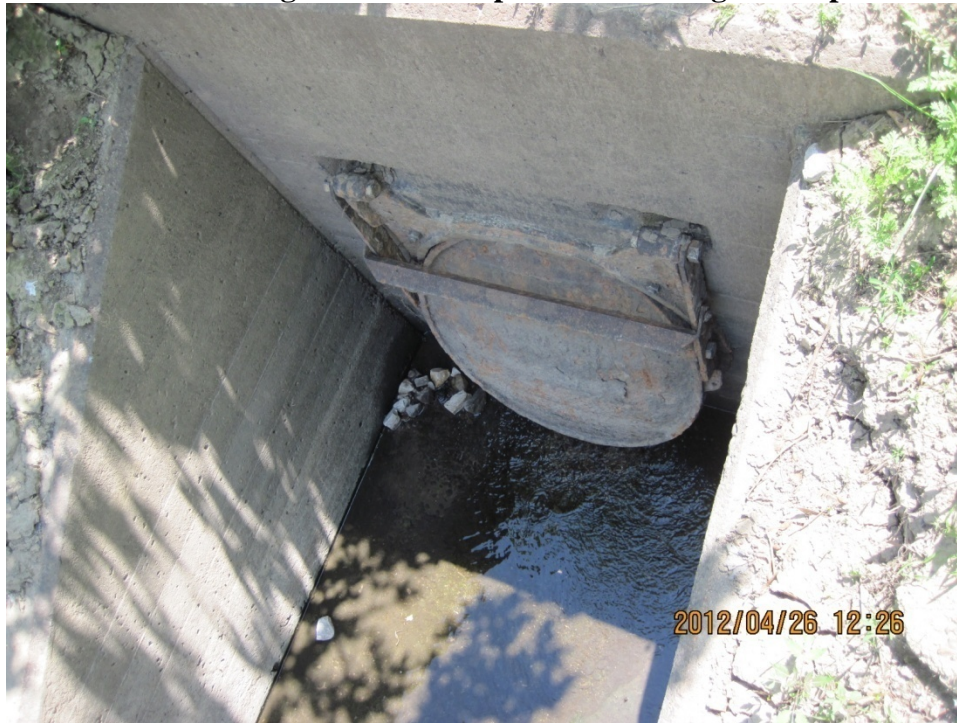
Photo 8.5-8 College Avenue Pump Station Misaligned Flap Gate
