LEVEE SYSTEM EVALUATION REPORT

VINCENNES, INDIANA

LOUISVILLE DISTRICT CORPS OF ENGINEERS

May 2014

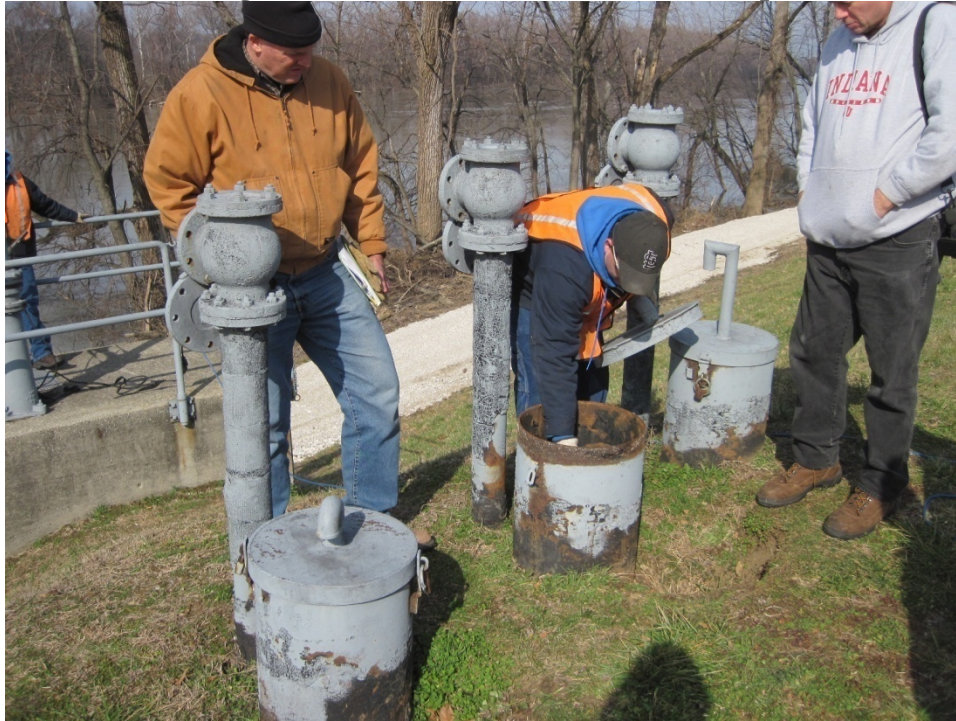
Air vents and siphon breakers operated acceptably. There was minor air leakage from the siphon breakers during operation, but this is only noted for record. Ground settlement near the siphon breakers (Photo 8.5-9) was noted for record to see if the condition worsens. Levee personnel indicated that the settlement has been present for many years and has not changed.

Photo 8.5-9 College Avenue Ground Settlement Near Siphon Breakers

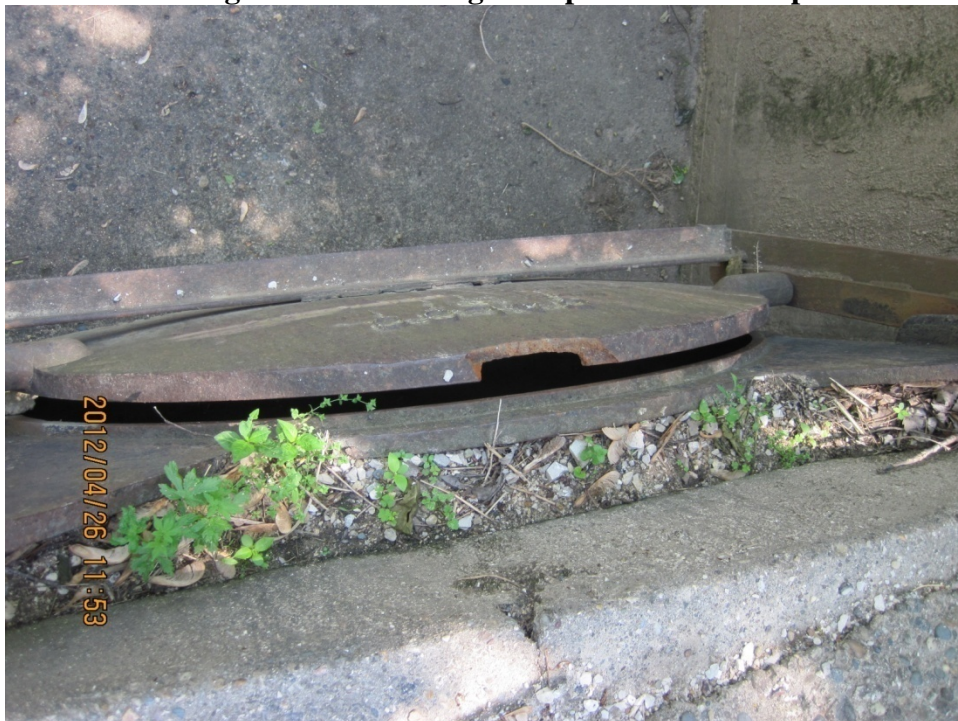
Photo 8.5-15 Highland Street Larger Flap Gate Follow-Up Condition

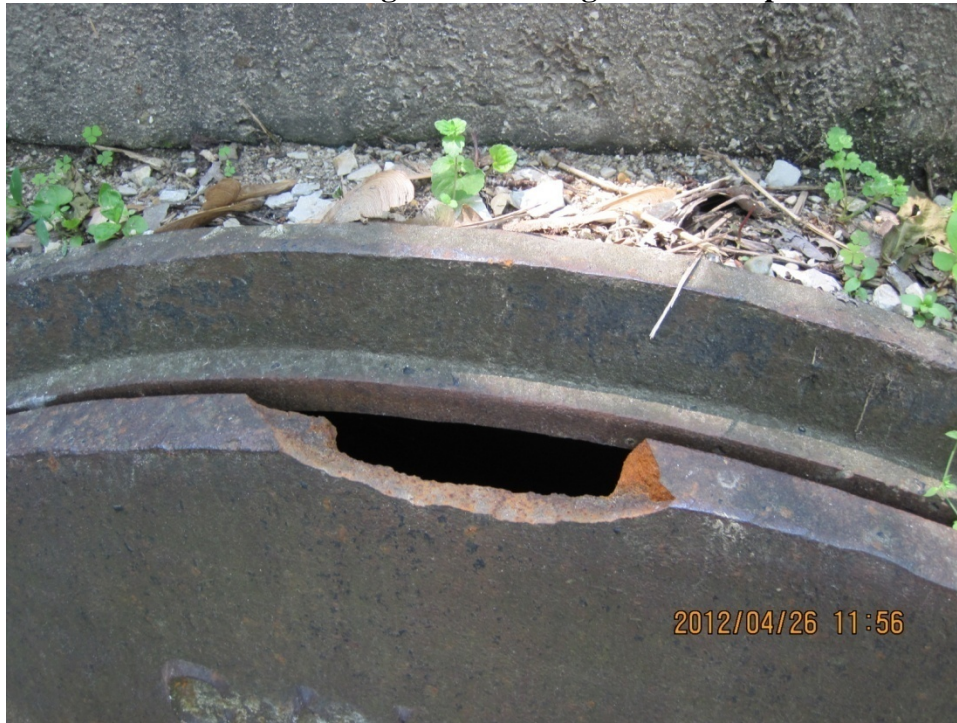
Photo 8.5-16 Missing Section in Highland St Flap Gate

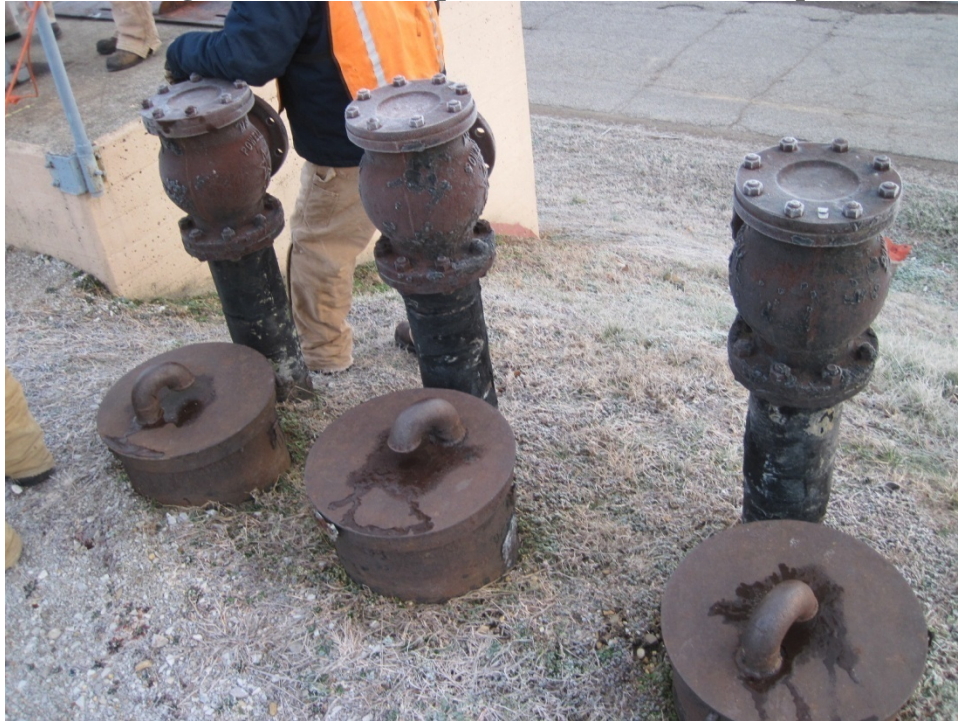
The siphon breakers could not be accessed due to a locked bar (Photo 8.5-17). It is recommended that the siphon breakers be inspected by levee personnel to assess their condition and repair as necessary. Typical air vent condition noted for record (Photo 8.5-18).

Photo 8.5-17 Highland Street Pump Station Air Vents and Siphon Breakers

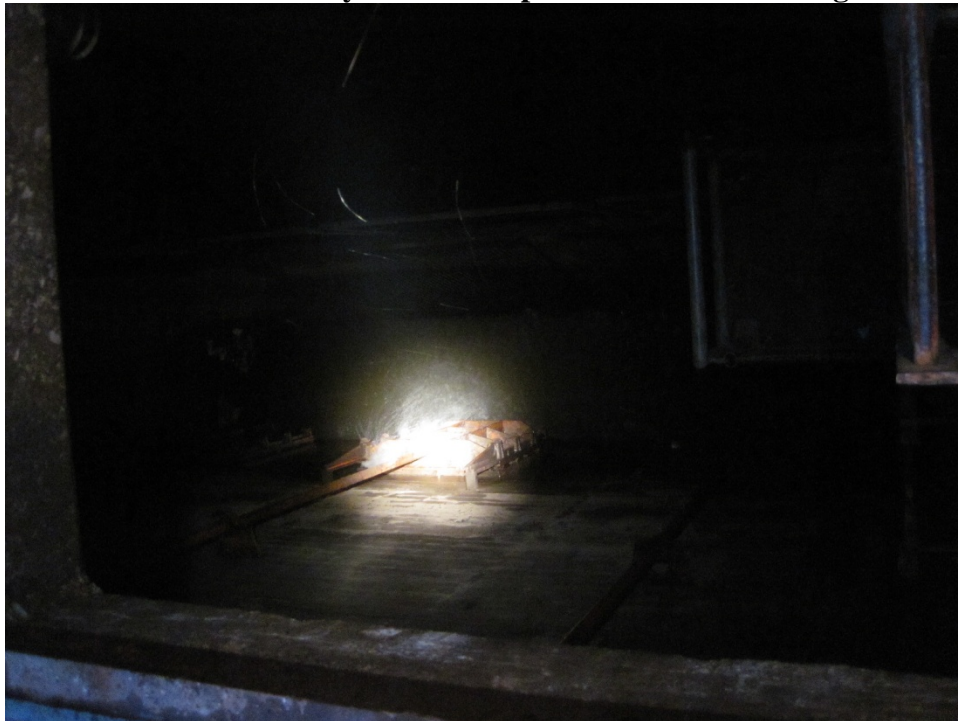
Photo 8.5-20 Perry Street Pump Station Minor Leakage

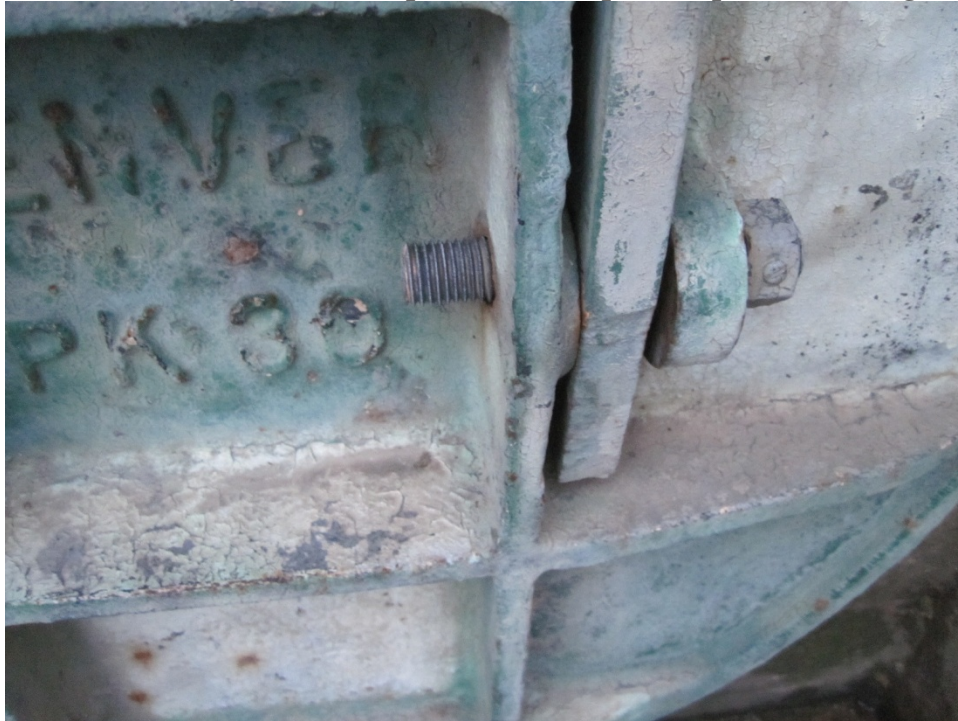
Photo 8.5-22 Perry Street Pump Station Pump #2 Flap Gate Missing Nut

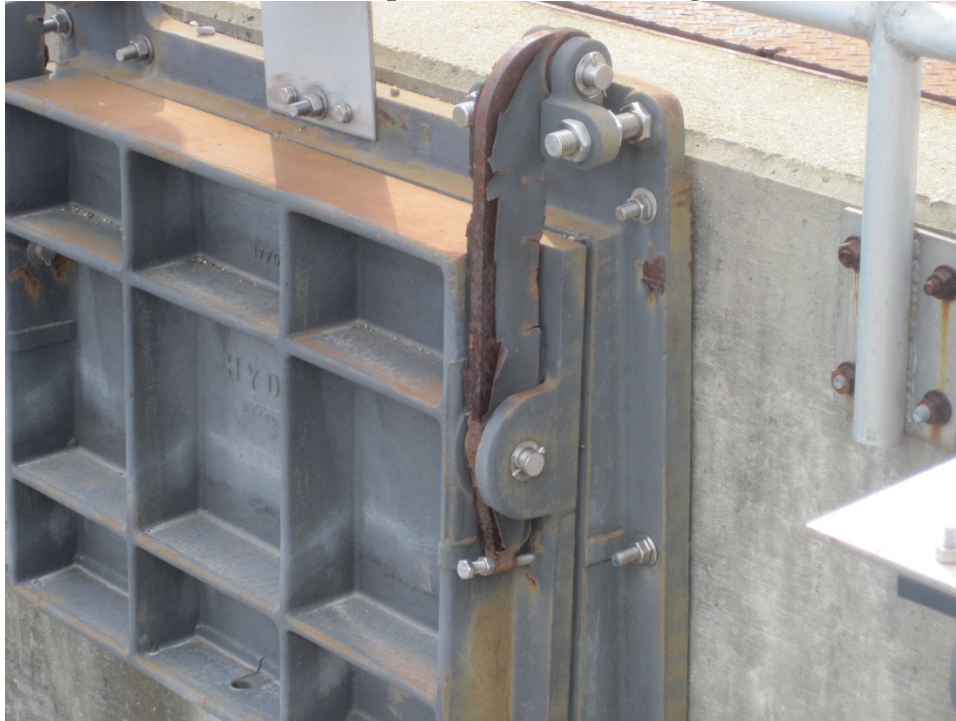
Photo 8.5-34 Sixth Street Pump Station Delaminating Paint and Corrosion

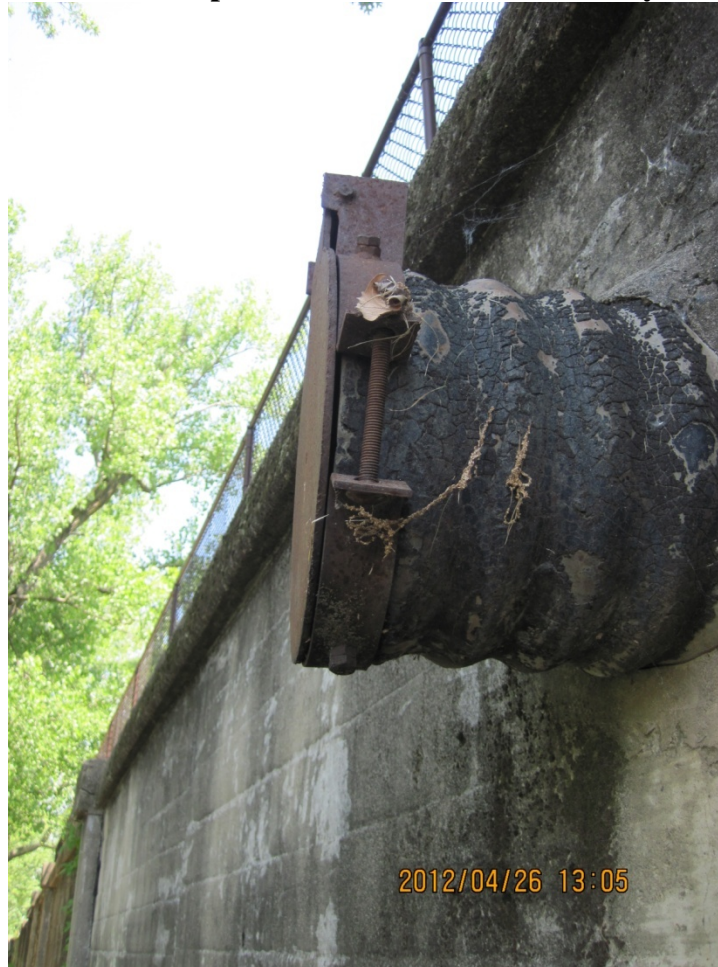
Photo 8.5-53 Flap Gate Located at Patrick Henry Drive

The flap gate located at Patrick Henry Drive (GW #16) is corroded and needs cleaned and painted (Photo 8.5-53).
