LEVEE SYSTEM EVALUATION REPORT

VINCENNES, INDIANA

LOUISVILLE DISTRICT CORPS OF ENGINEERS

May 2014

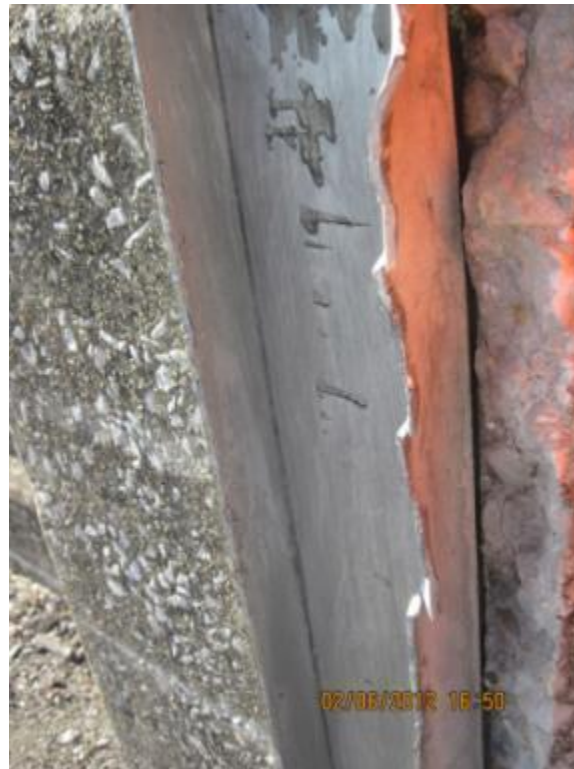
Photo 8.3-1 Traffic damage at Second and Niblack north abutment

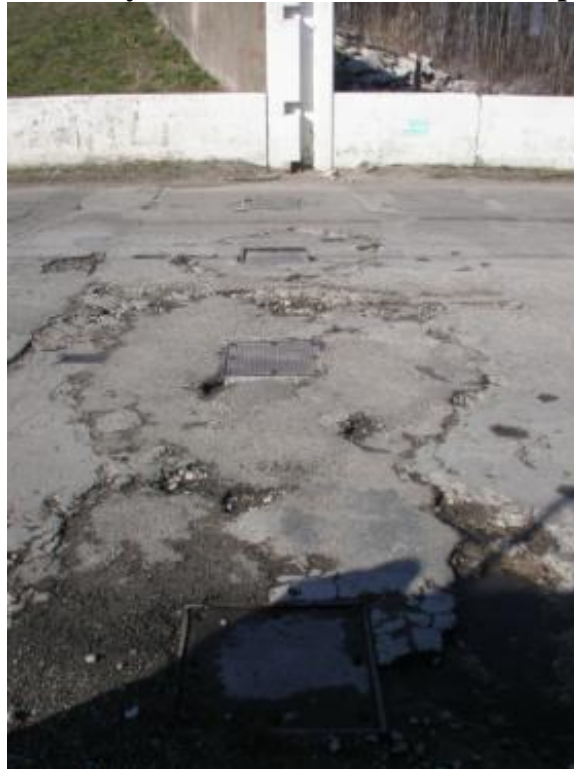
Photo 8.3-2 Severely deteriorated closure sill at Oliphant Drive

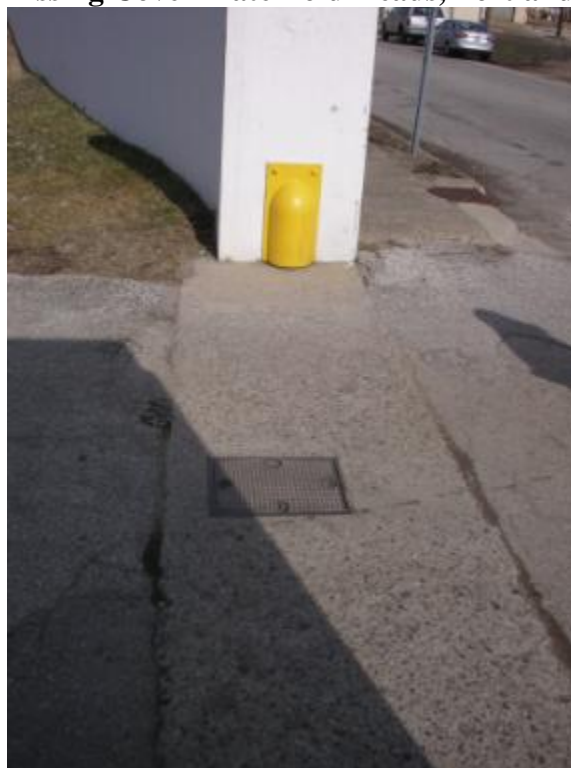
Photo 8.3-5 Missing Cover Plate Bolt Heads, Portland Ave Closure

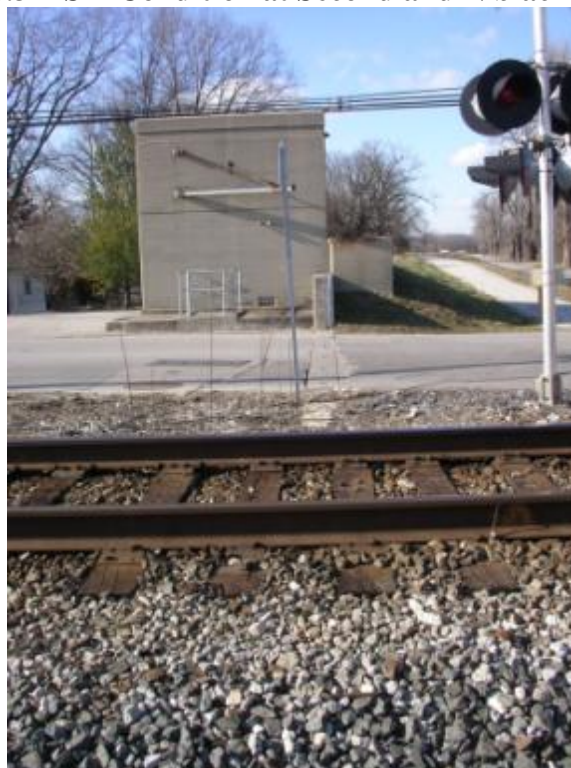
Photo 8.3-7 Sill Condition at Second and Niblack Closure

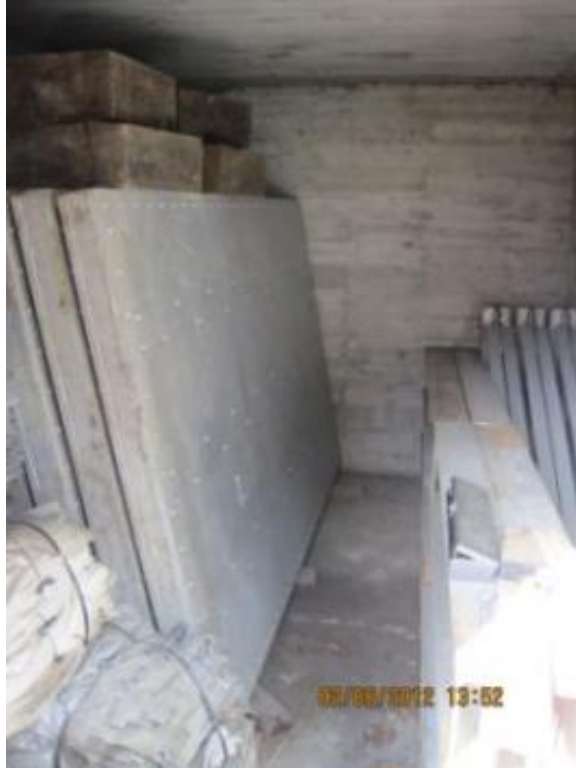
Photo 8.3-9 Typical interior of closure vault

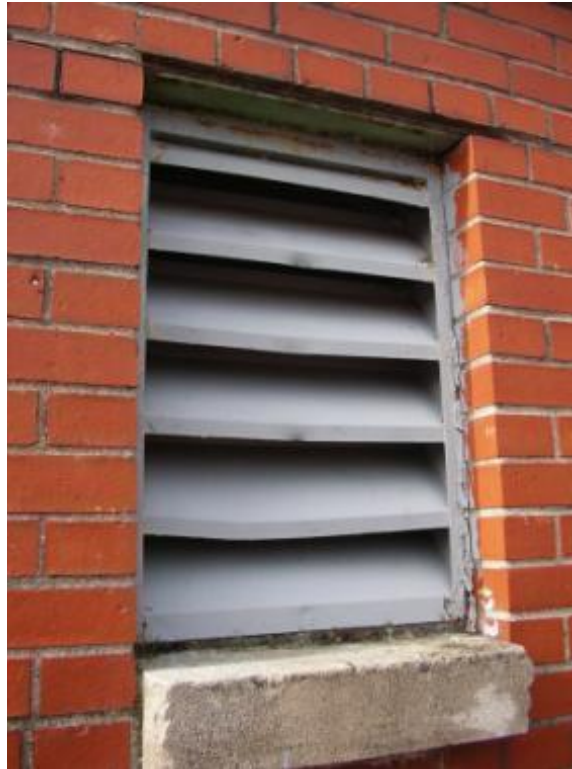
Photo 8.3-13 Cracks in brick façade from lintel corrosion at Kimmell Park Closure vault

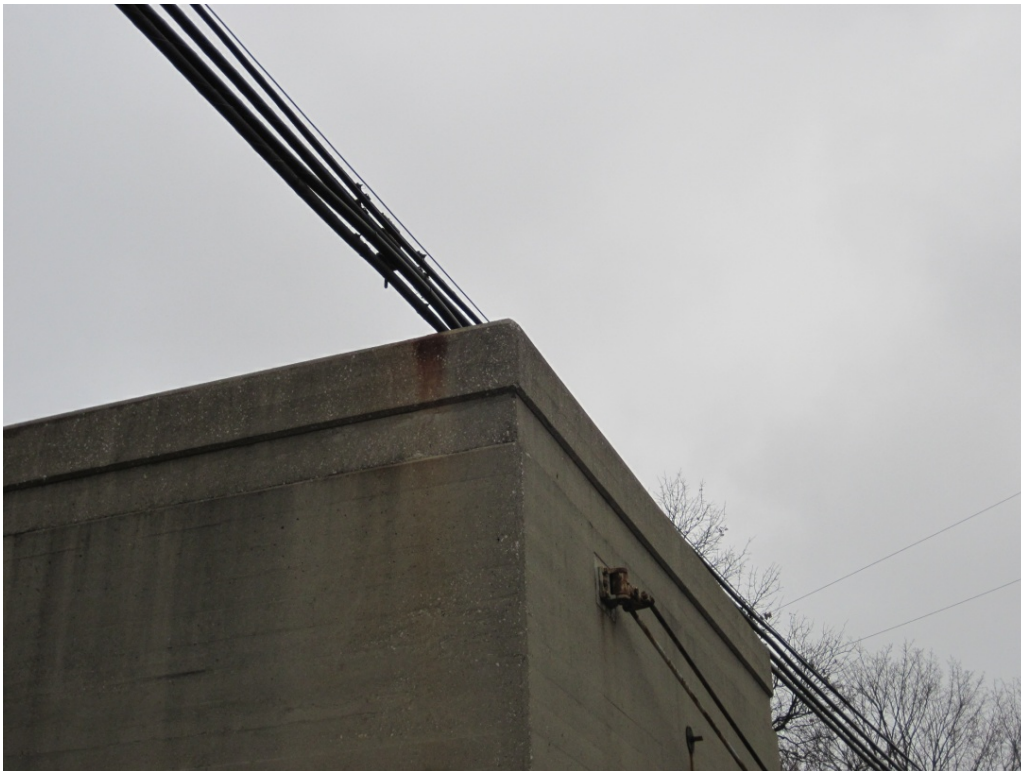
Photo 8.3-14 Overhanging lines near Second Street Pump Station roof

roof parapet. Suggest rerouting lines so they are no longer in contact with the roof as a safety precaution (see Photo 8.3-14).

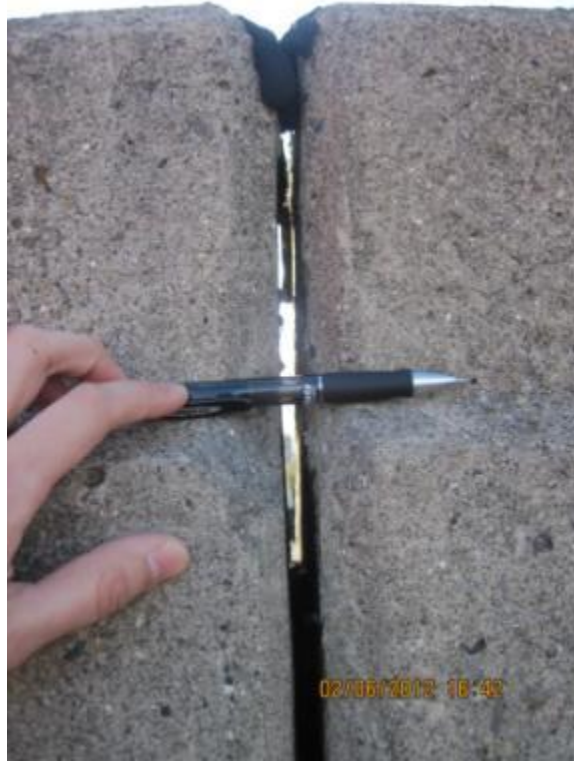
Photo 8.3-18 Missing joint filler in floodwall in Section A, Part 1

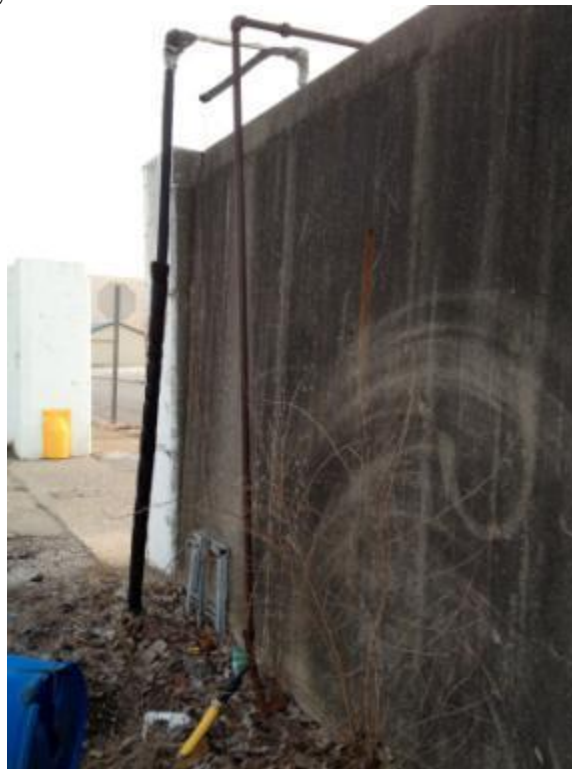
Photo 8.3-21 Utility encroachments on floodwall in Section A, Part 2 (Permitted)

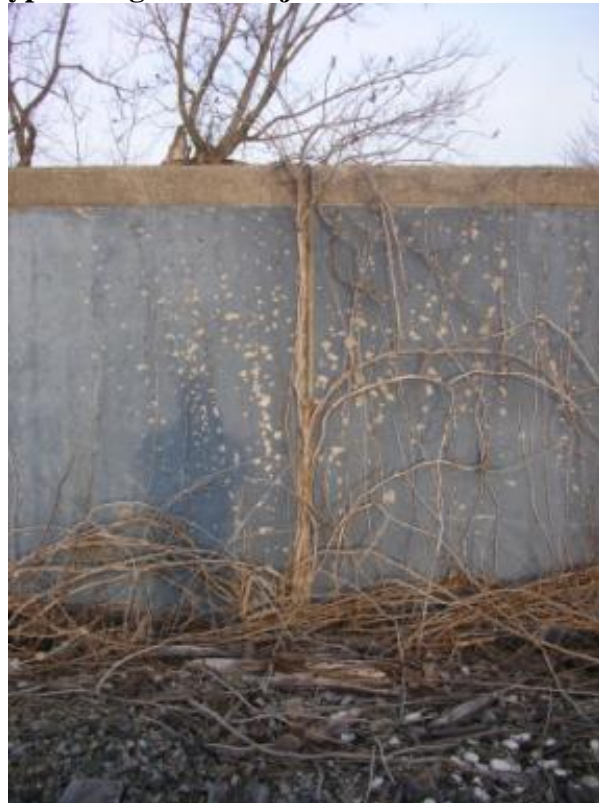
Photo 8.3-22 Typical vegetation in joints of floodwall in Section A, Part 2

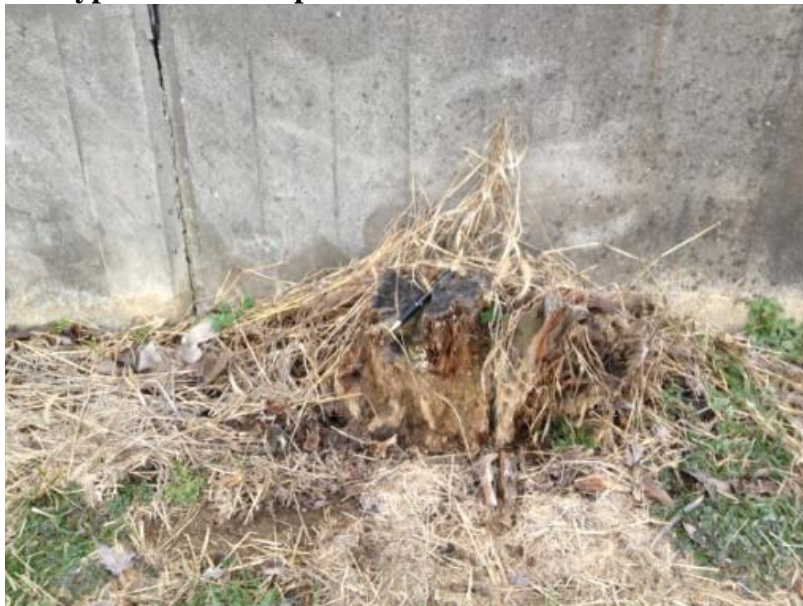
Photo 8.3-23 Typical tree stumps on riverside of floodwall in Section A, Part 2

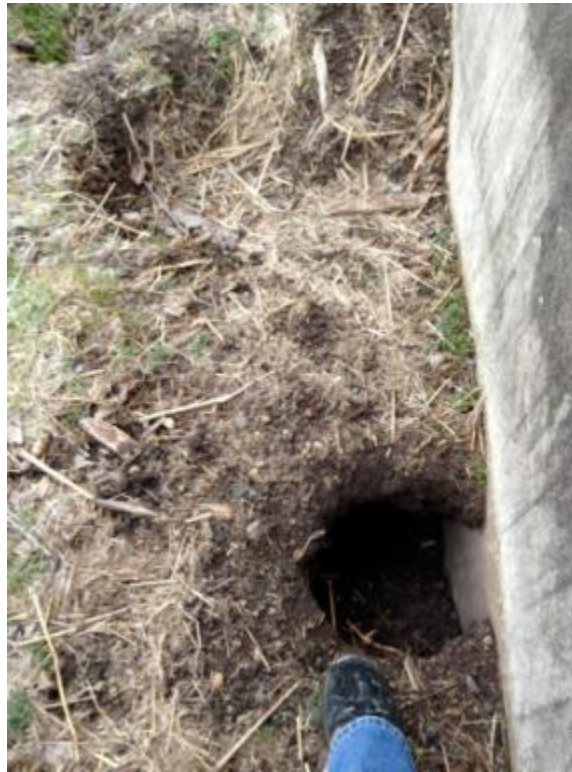
Photo 8.3-24 Numerous animal burrows on riverside of Section A, Part 2 floodwall

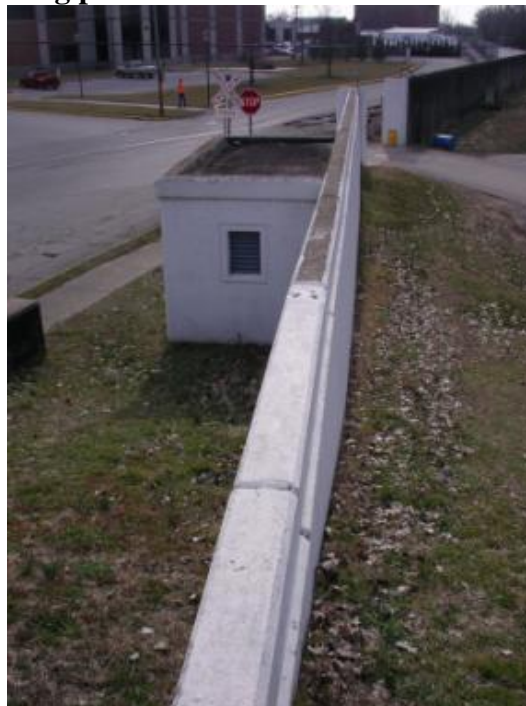
Photo 8.3-25 Missing pedestrian barrier near Portland Avenue Closure

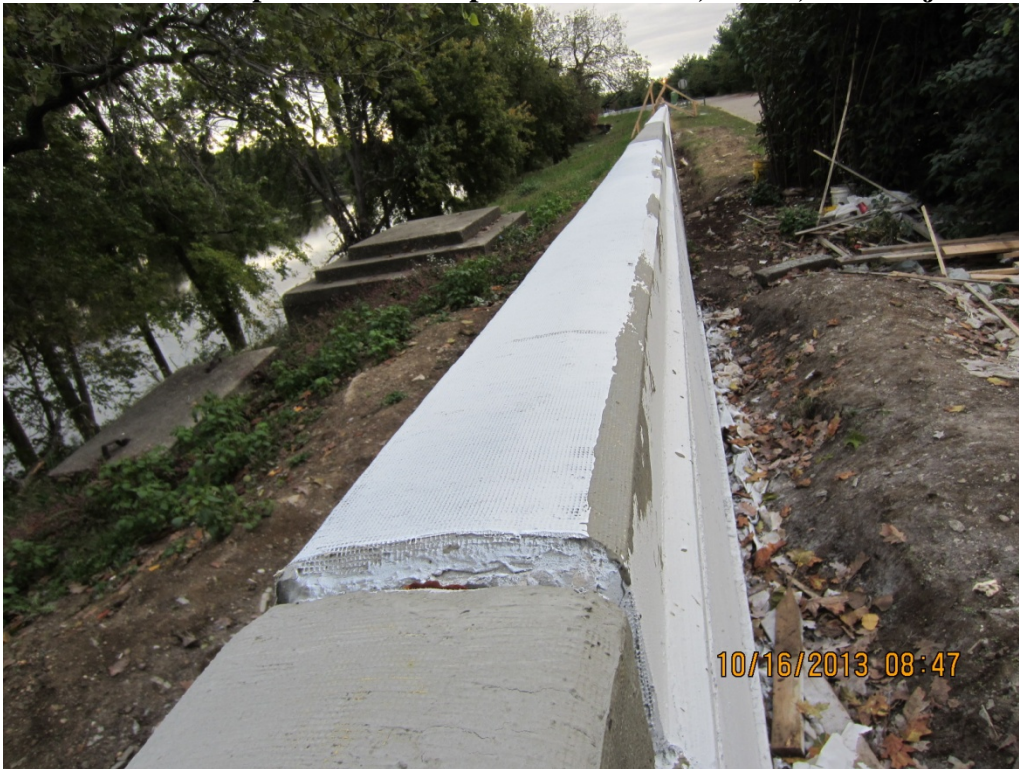
Photo 8.3-31 Completed I-Wall repair in Section B, Part 1, crack injection

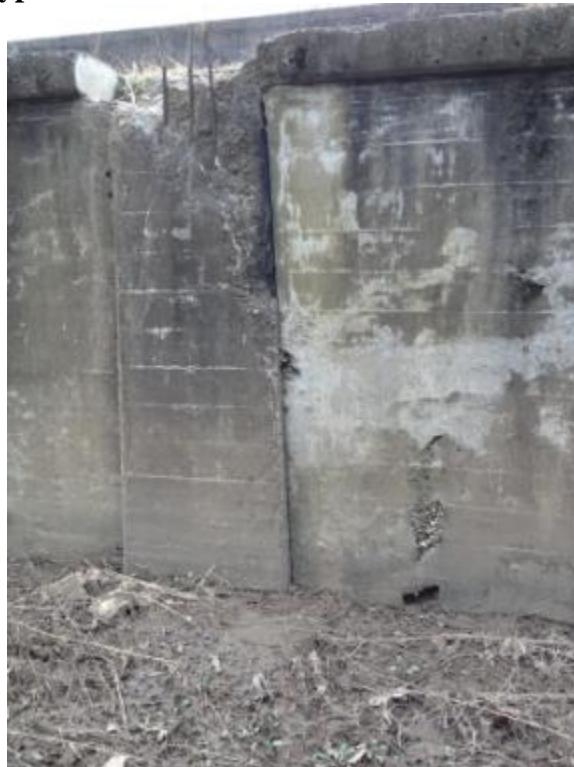
Photo 8.3-33 Typical condition of riverside floodwall in Section B, Part 1

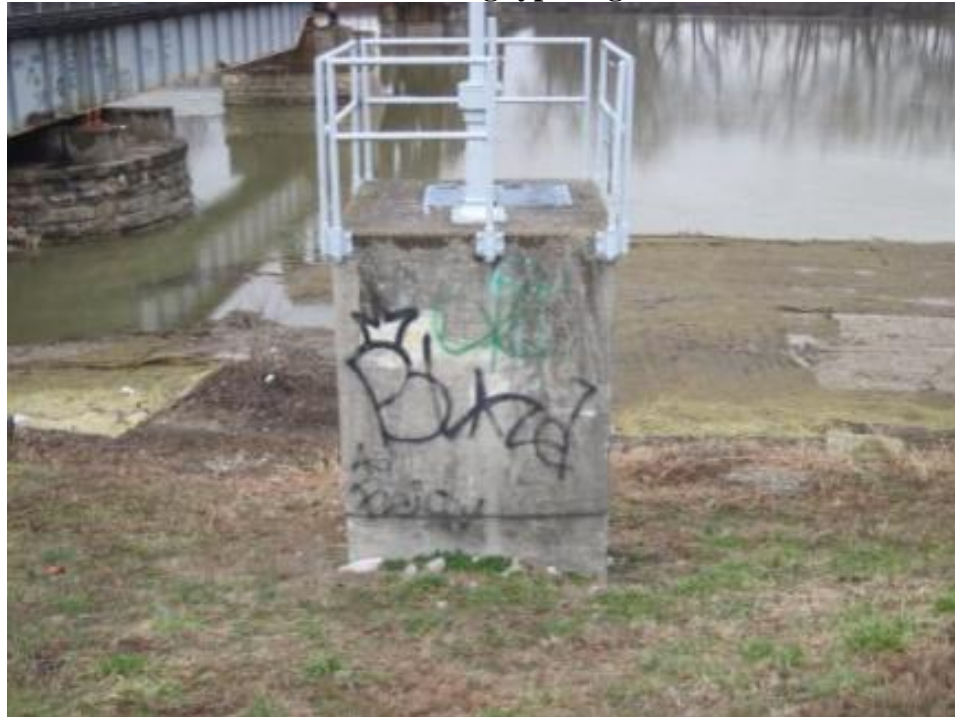
Photo 8.3-34 Gatewell #11 exhibiting typical good condition of concrete

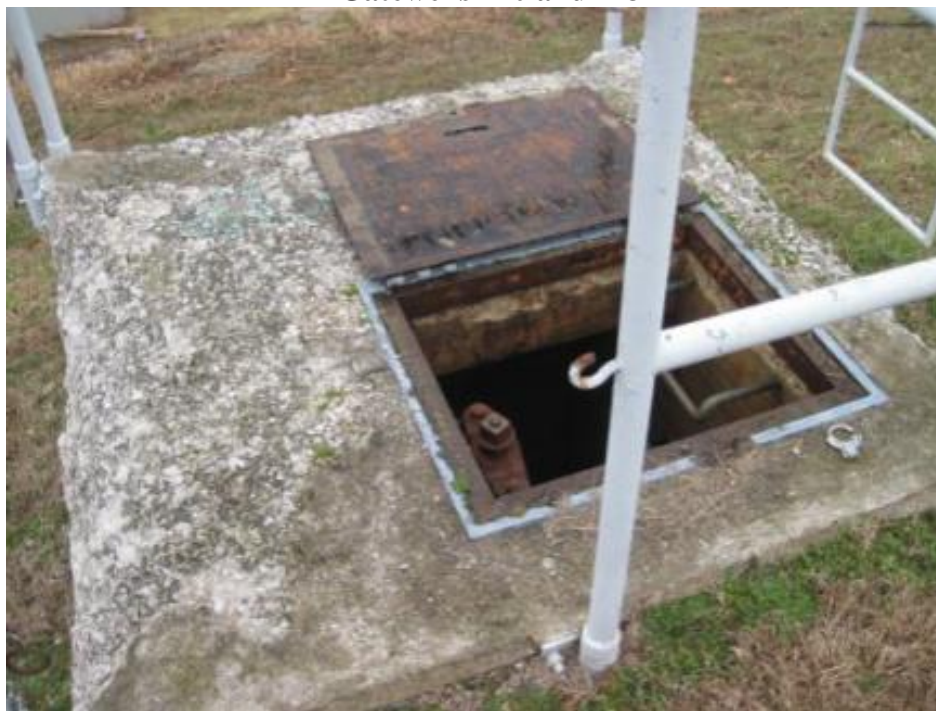
Photo 8.3-35 Gatewell #9 exhibiting poor condition of concrete, condition is similar in Gatewells #10 and #13

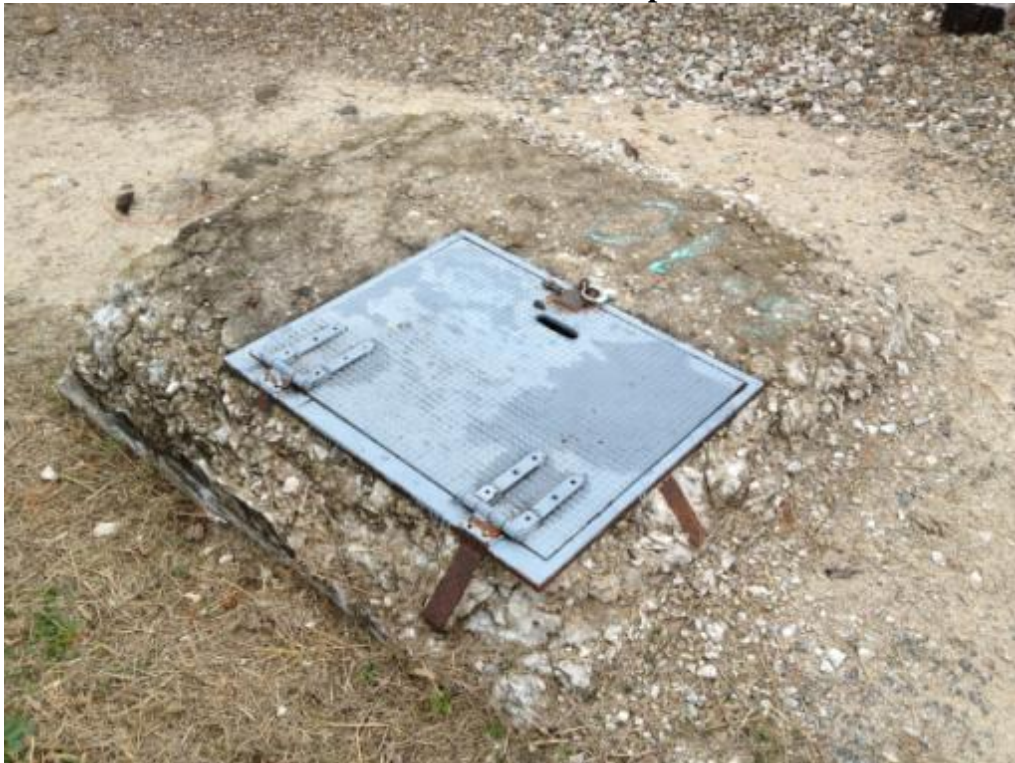
Photo 8.3-37 Deterioration has affected the cover plate recesses in Gatewell #10

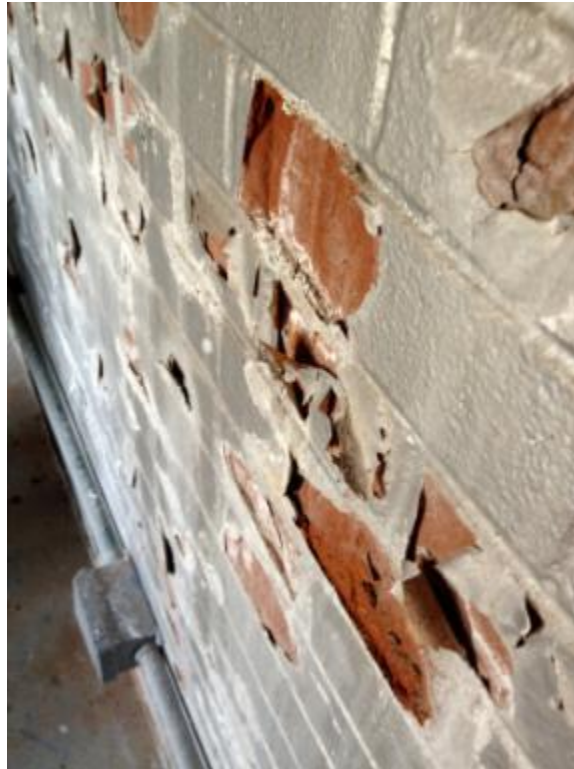
Photo 8.3-45 Typical paint failures on interior brick walls of College Street Pump Plant

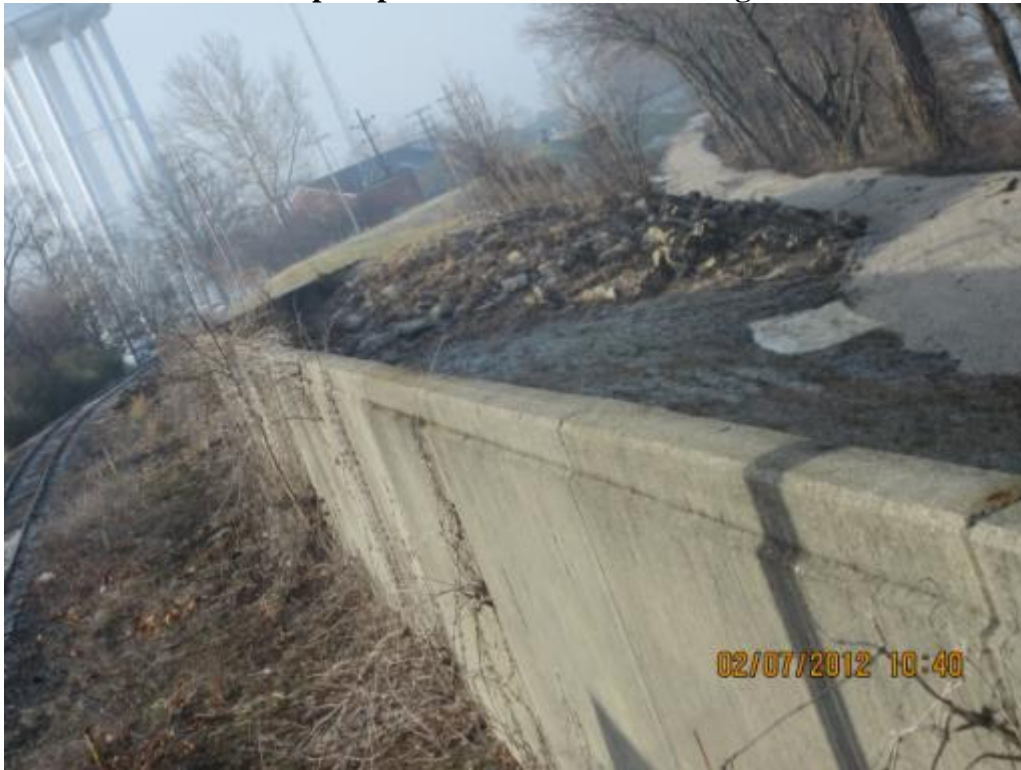
This produces a D_{30} size of 0.16 ft, or 1.92 inches. The median D_{50} size in the field of 8 inches, along with past performance history, indicates that the rip rap size present is sufficient.

Photo 8.4-1. Rip Rap at Station 256+00 looking downstream

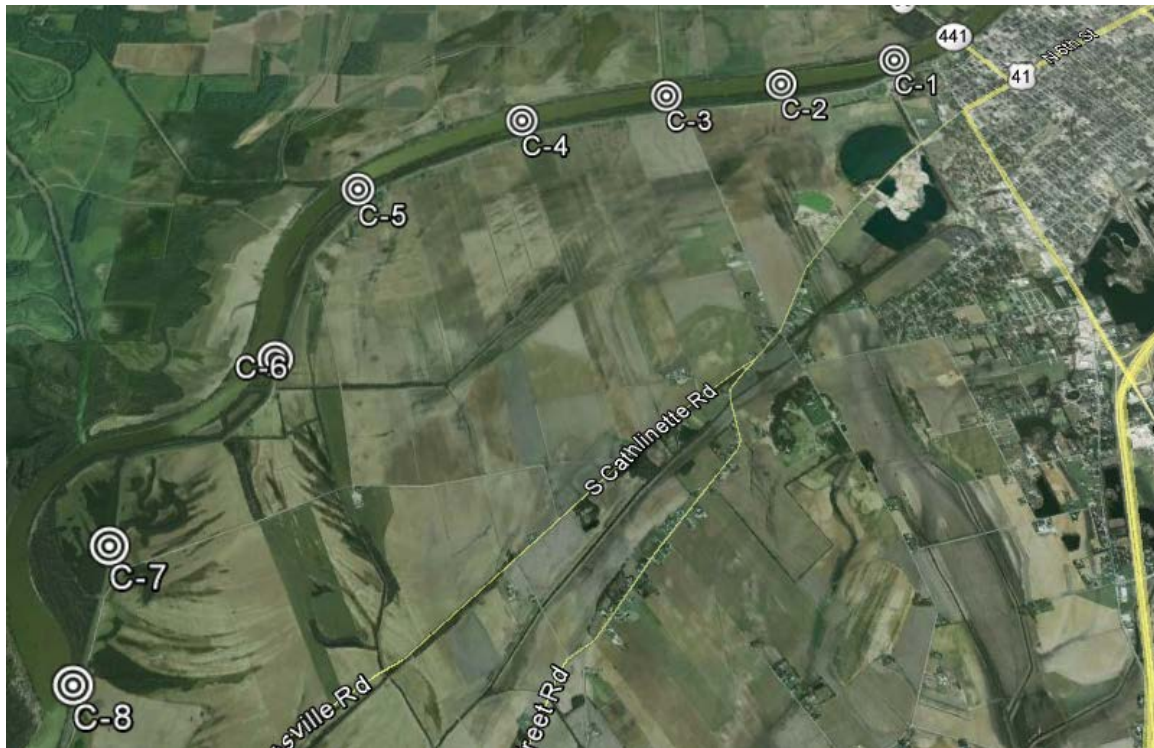
Figure 8.4-8. Location of Brevoort Borings/Piezometers

slope stability modeling. Piezometers were also installed, which could allow for a better quantification of soil parameters if piezometer data is able to be collected during a flood event. Below is Figure 8.4-8 showing the locations of each of the borings/piezometers.

The results of lab testing for the Brevoort Segment embankment were provided in early July 2013. A report of the information gathered is included in Appendix M as Attachment M-3. In late April 2013, a record flood occurred, and data was able to be gathered on all 8 embankment piezometers as the flood progressed. Piezometer data was recorded every 12 hours when the levee was loaded during the 2013 event.

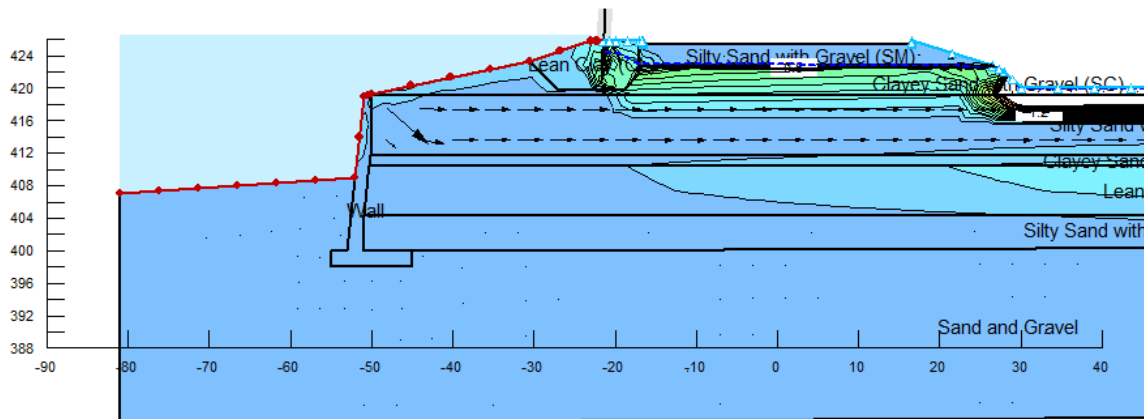
Figure 8.4-9. Typical SeepW Output for I-wall Section

spreadsheet. Therefore, inspection/evaluation of the relief wells in this area is required for the LSE. Details of the seepage analysis are located in Appendix M. Figure 8.4-9 is a typical output plot of a SEEP/W analysis for Station 228+30. Table 8.4-3 shows a summary of the results from the I-wall seepage analyses.

For Station 228+30, a toe drain exists both adjacent to and under Culbertson Blvd for the entire stretch. Seepage analyses of each cross section with the toe drain was performed and yielded favorable results. The results of these analyses are shown in Table 8.4-4. Based on the dependency of the toe drain for this section of I-wall, videotaping of the toe drains to verify their condition is required for the LSE.

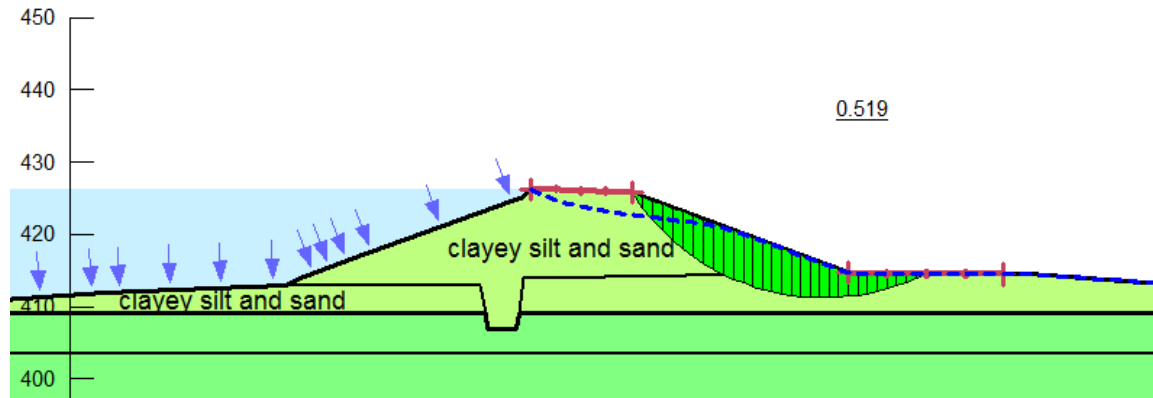
Figure 8.4-10. Brevoort Soil Profile 4 - Steady State Seepage Result

As you can see, profile 1, profile 2, and profile 4 did not meet the required factors of safety. The lower factors of safety for profile 1 and 4 are largely due to the high pore water pressures at the levee landside toe. These high pore pressures reduce the friction between the soil particles causing lower strengths at these areas. The results of Profile 4 are shown in Figure 8.4-10 below.

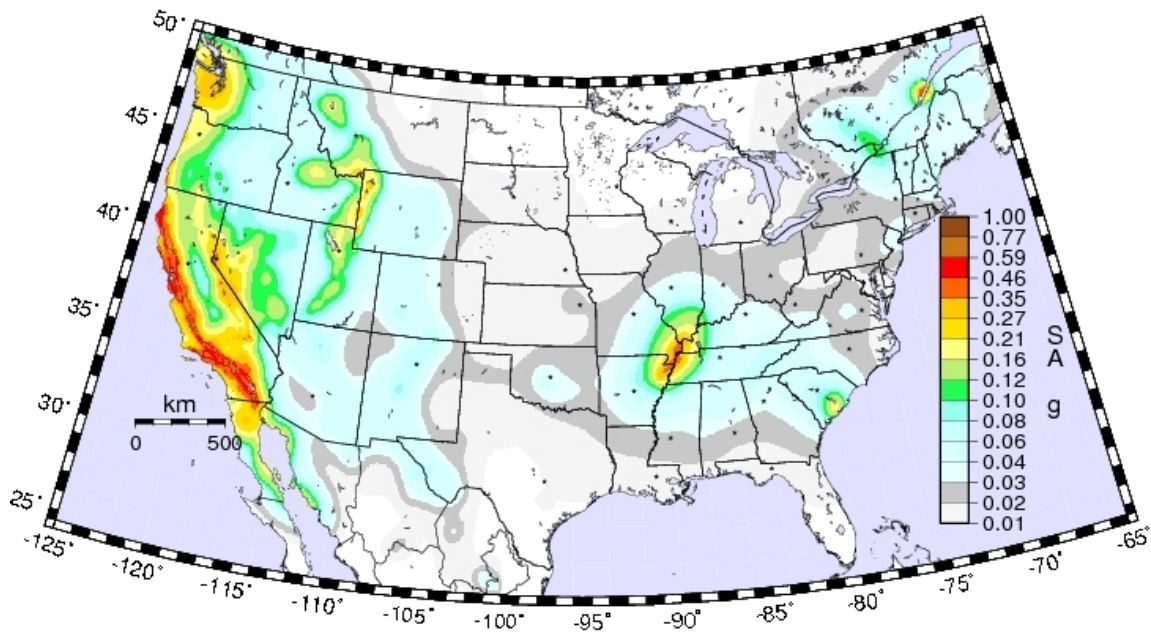
Figure 8.4-11. Seismic Hazard Map

Based on the 2008 USGS Hazard Map *PGA with 10% chance of exceedance in 50 years* shown in Figure 8.4-11 below, the peak ground acceleration (PGA) for the Vincennes area is less than 0.06g. Per EC 1110-2-6067 paragraph 9h(6), if the PGA for the 100 year earthquake is less than 0.10g, no evaluation is required. 10% in 50 years is equivalent to 0.2% annual chance exceedance (500 yr event). Therefore, the 1% annual chance exceedance PGA is also less than the 0.06g and no seismic evaluation is required.

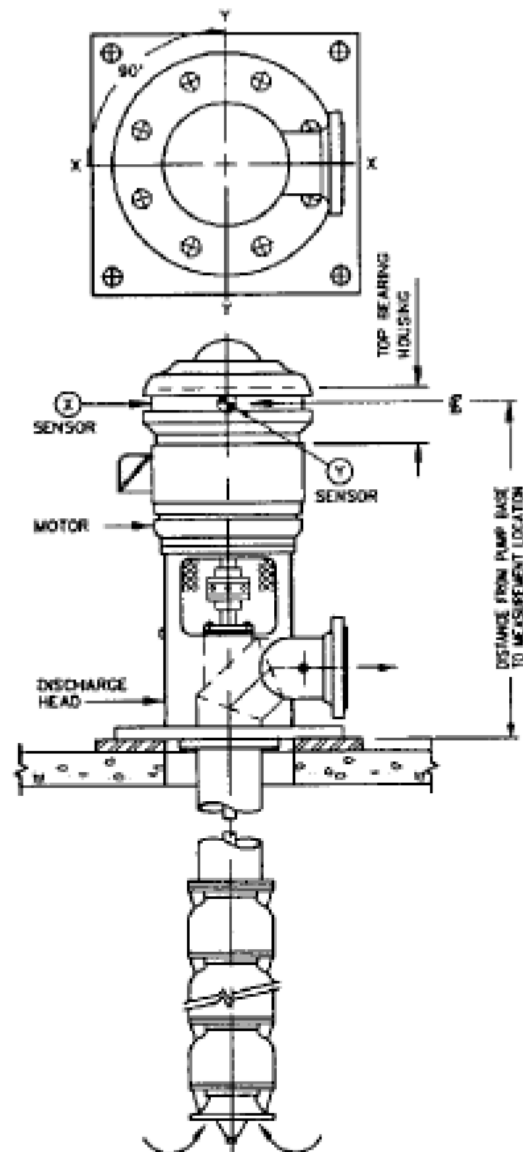
Figure 8.5-1 Vibration Sensor Locations

Velocity measurements were taken during the operation of the pumps for a vibration study. The measurements were taken using a Vibration Sound Level Meter at two locations X and Y. X is located near the thrust bearing at the top of the motor housing on the water discharge side and Y is located 90 degrees counterclockwise at the same elevation. Figure 8.5-1 shows the vibration sensor locations. The velocity measurement data was interpreted using the General Machinery Vibration Severity Chart, Figure 8.5-2. The chart was obtained from IRD Mechanalysis. Results from the vibration study are listed in tables in each pump station's summary report. COE design specifications require that vibration severity shall be in the "good" range or better of the General Machinery Vibration Severity Chart. A "good" or better rating requires that the velocity be 0.0785 in/sec or lower, within the red shaded area on Figure 8.5-2.

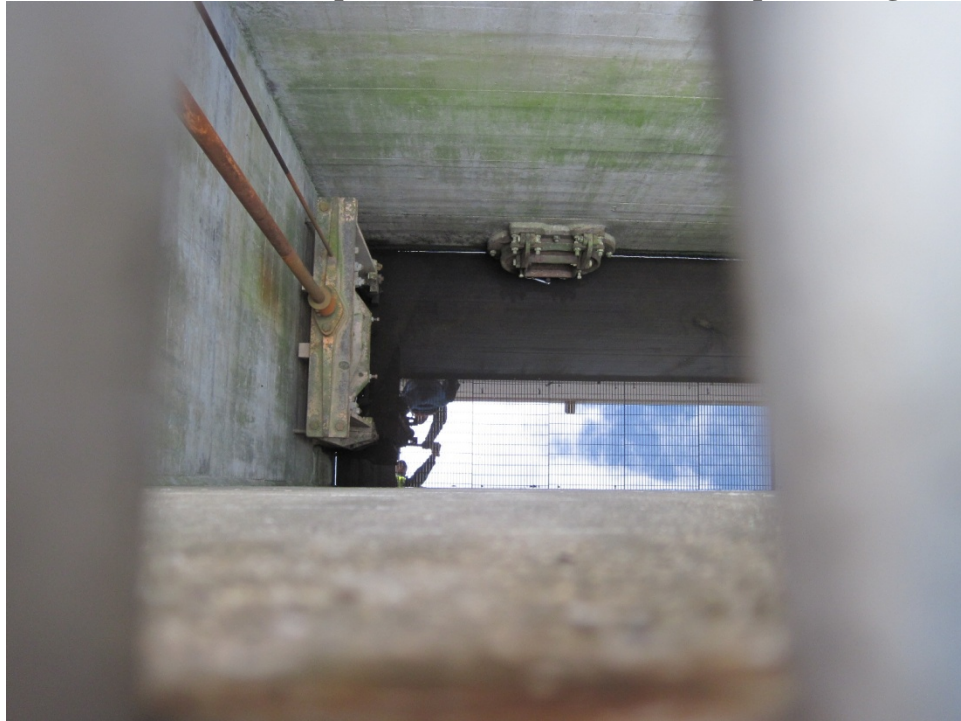
The manually operated sluice gate (Photo 8.5-1) in the discharge well was stuck in place and not able to be operated. Additionally, the sluice gate in gate well #2 is inoperable. These are LSE items and shall be repaired. Both flap gates (Photos 8.5-1 & 8.5-2) were visually inspected from above and appeared to be in acceptable condition. The discharge flap gate near the train trussel has a previous repair (Photo 8.5-3) and damaged pipe (Photo 8.5-4). See Structural section of this report for pipe repair recommendation.

Photo 8.5-2 Second Street Pump Station Pump Discharge Flap Gate

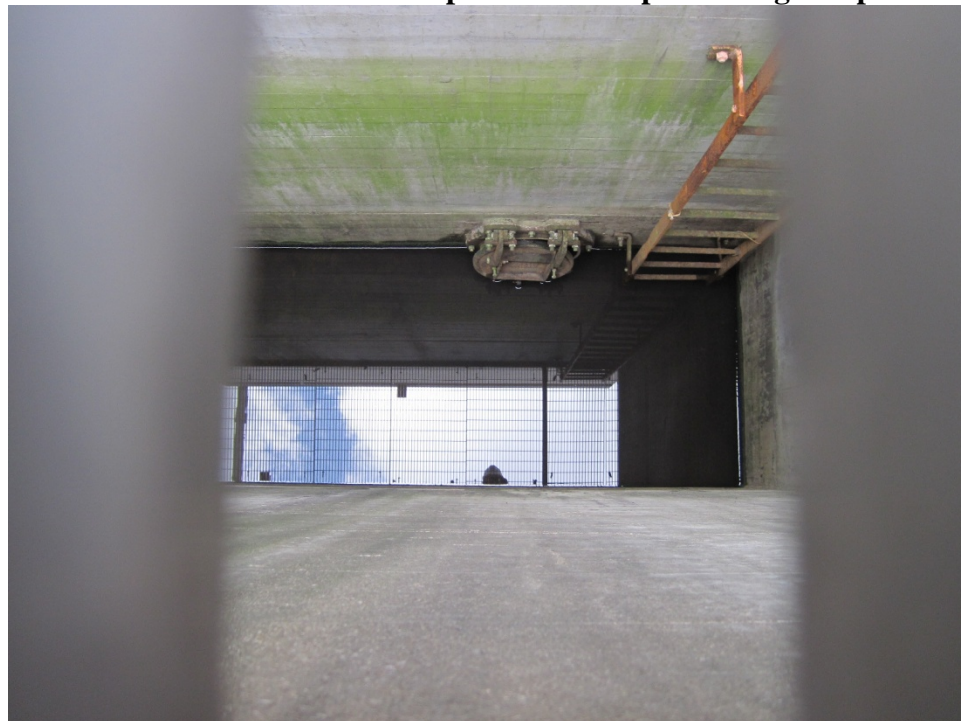
Photo 8.5-3 Second Street Pump Station Previous Flap Gate Repair

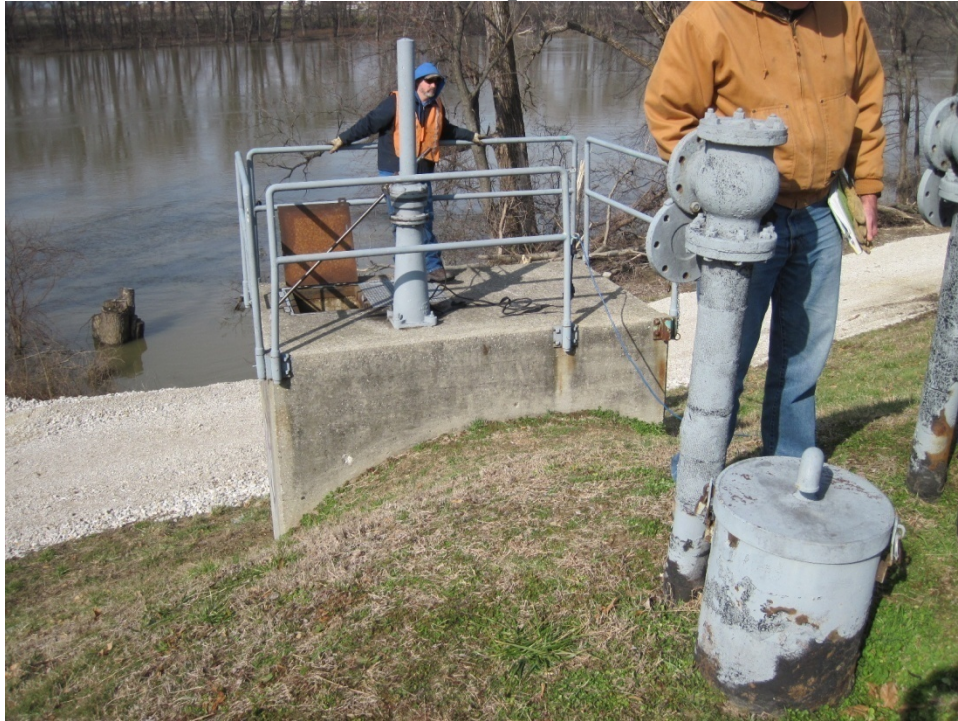
All three inlet sluice gates were operated a full open and close cycle. The gates operated acceptably, but leakage was noted when the gates were closed (Photo 8.5-5). This may be corrected with wedge adjustment. The sluice gate in discharge gate well #7 (Photo 8.5-6) was also operated a full open and close cycle acceptably. The gate stem is bent (Photo 8.5-7) and is recommended to be straightened or replaced. The discharge flap gate is misaligned (Photo 8.5-8).

Photo 8.5-7 College Avenue Discharge Gatewell #7 Has Bent Stem

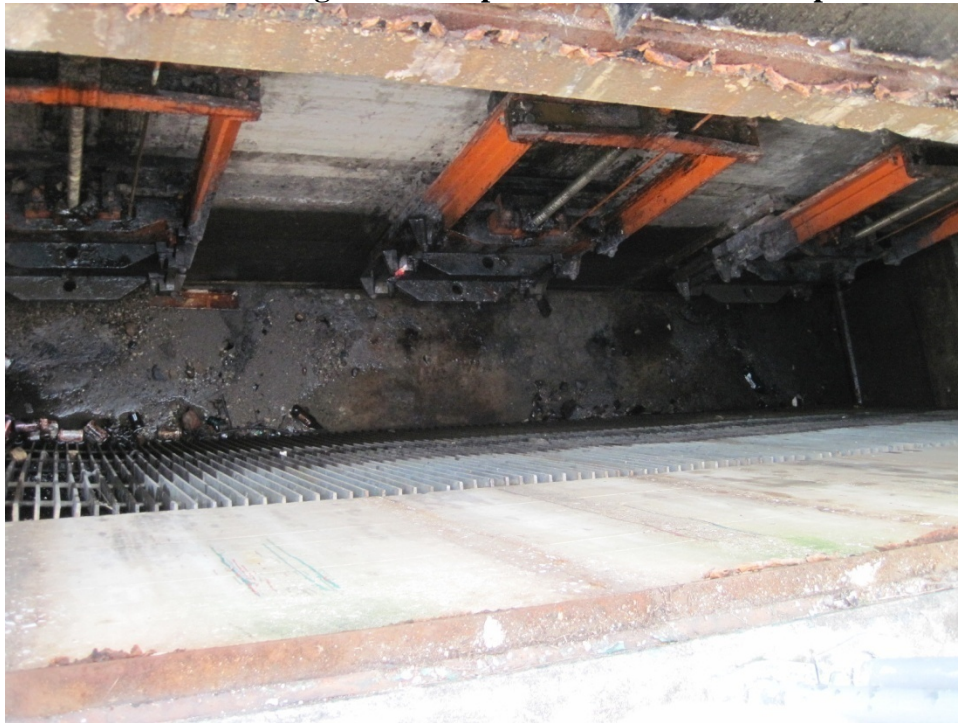
All three sluice gates were operated a full open and close cycle (Photo 8.5-10 & 8.5-11). The gates operated acceptably and showed no leakage when the gates were closed. The sluice gate in the discharge gatewell (Photos 8.5-12) was also operated a full open and close cycle acceptably. The smaller flap gate functioned acceptably, but cleaning and painting is recommended (Photo 8.5-13). During the initial visit the larger flap gate was submerged and unable to be completely inspected (Photo 8.5-14). While inspecting the flap gate during the follow-up inspection it was noted that a piece of the top of the flap gate has broken off (Photo 8.5-15 & 8.5-16) and the brace weld is cracked. This is an LSE item and shall be repaired..

Photo 8.5-11 Highland Street Pump Station Sluice Gates Closed

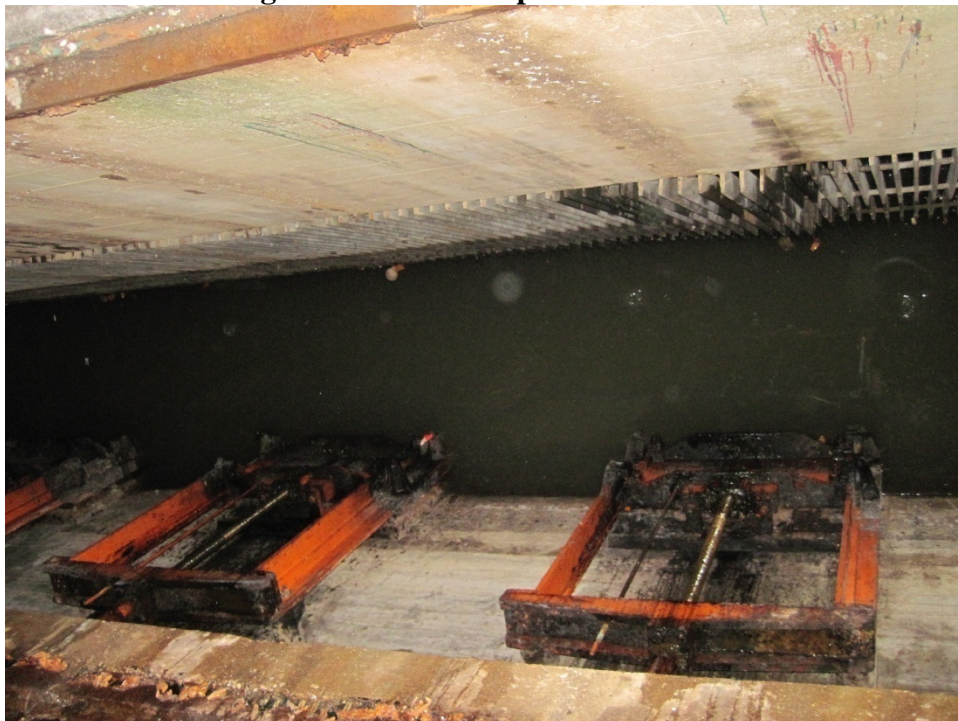
Photo 8.5-12 Highland Street Discharge Gatewell

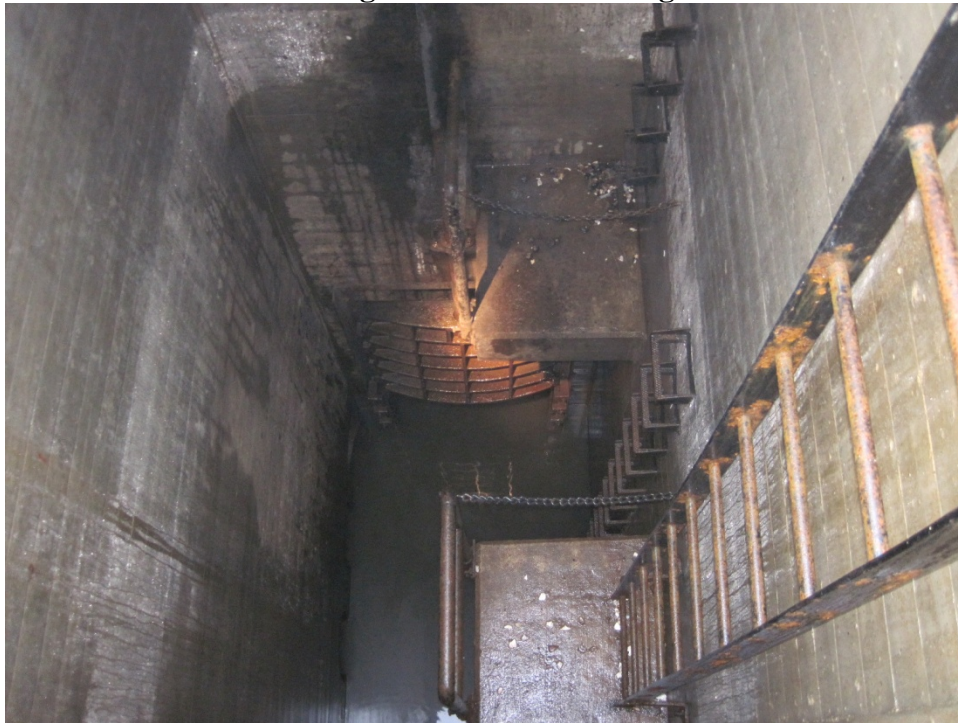
Photo 8.5-13 Highland Street Pump Station Smaller Flap Gate

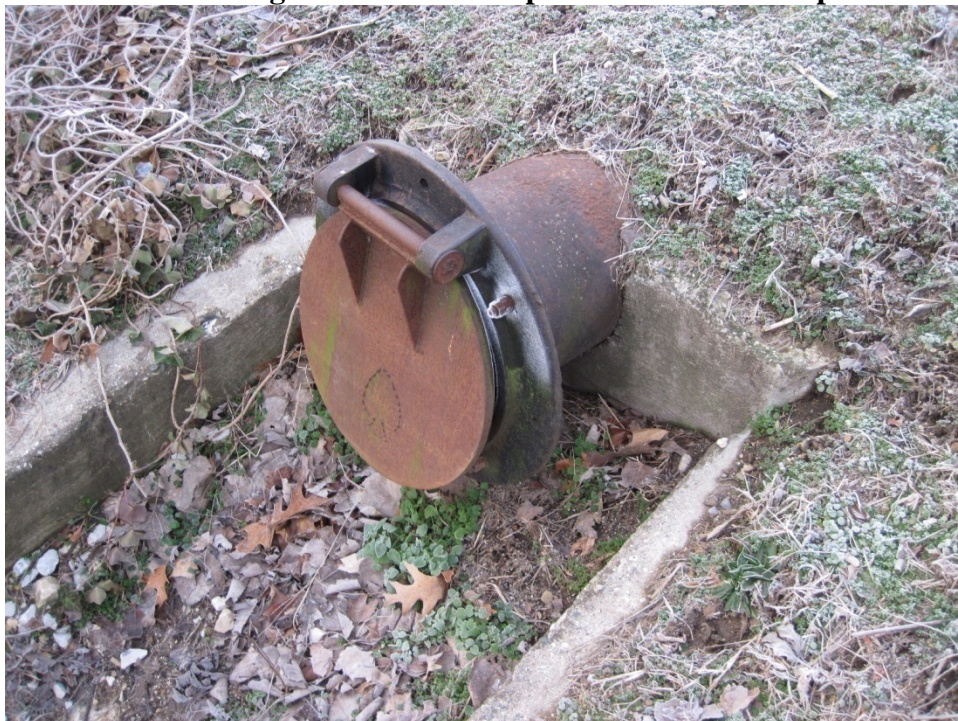
Photo 8.5-14 Highland Street Larger Flap Gate Initial Condition

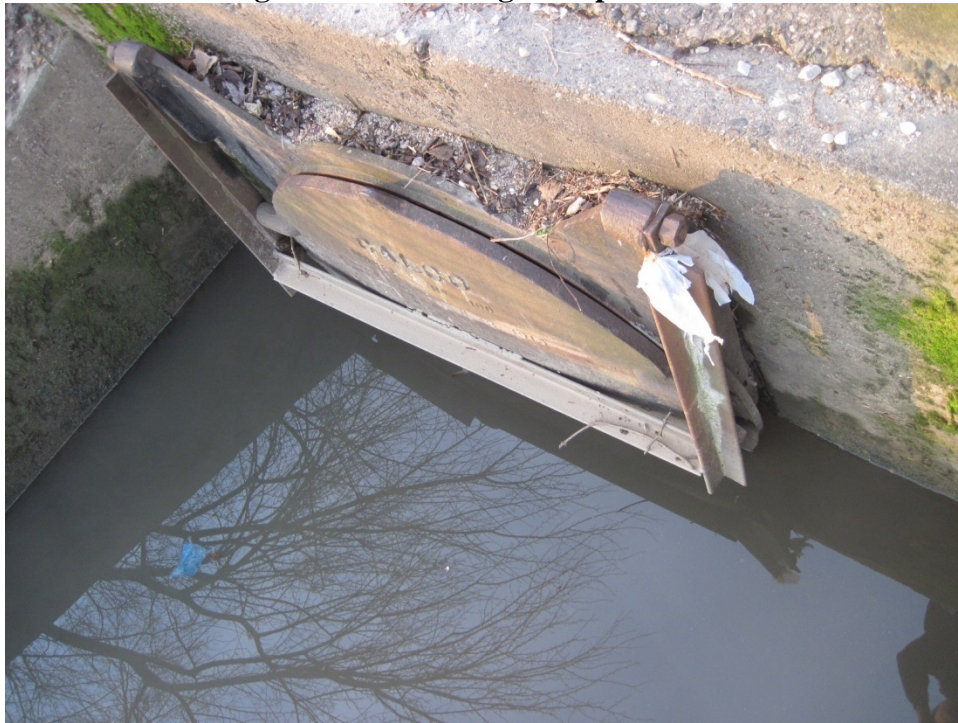
Photo 8.5-15 Highland Street Larger Flap Gate Follow-Up Condition

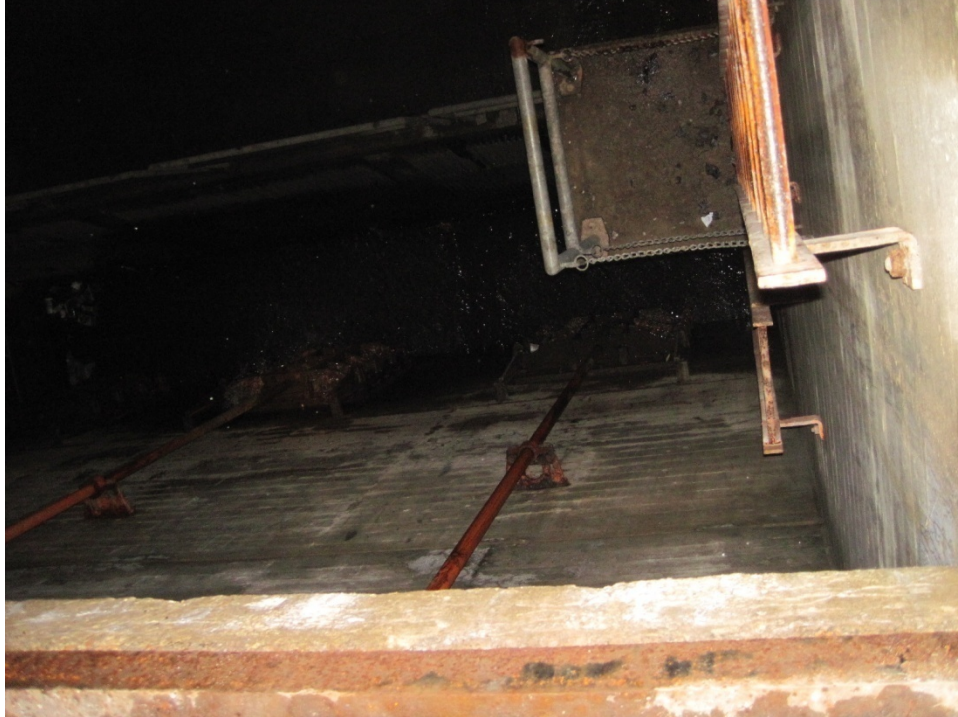
All three sluice gates were operated a full open and close cycle (Photo 8.5-19). The gates operated acceptably, but minor leakage was noted when the gates were closed (Photo 8.5-20). This may be corrected with wedge adjustment. The pump discharge flap gates are shown in (Photo 8.5-8.5-21). The flap gate for pump #2 is missing a nut (Photo 8.5-22). This is an LSE issue. The sluice gate in the gravity discharge gatewell (Photo 8.5-23) was operated a full open and close cycle acceptably. The flap gate for the gravity discharge had some debris around the seal face (Photo 8.5-24).

Photo 8.5-20 Perry Street Pump Station Minor Leakage

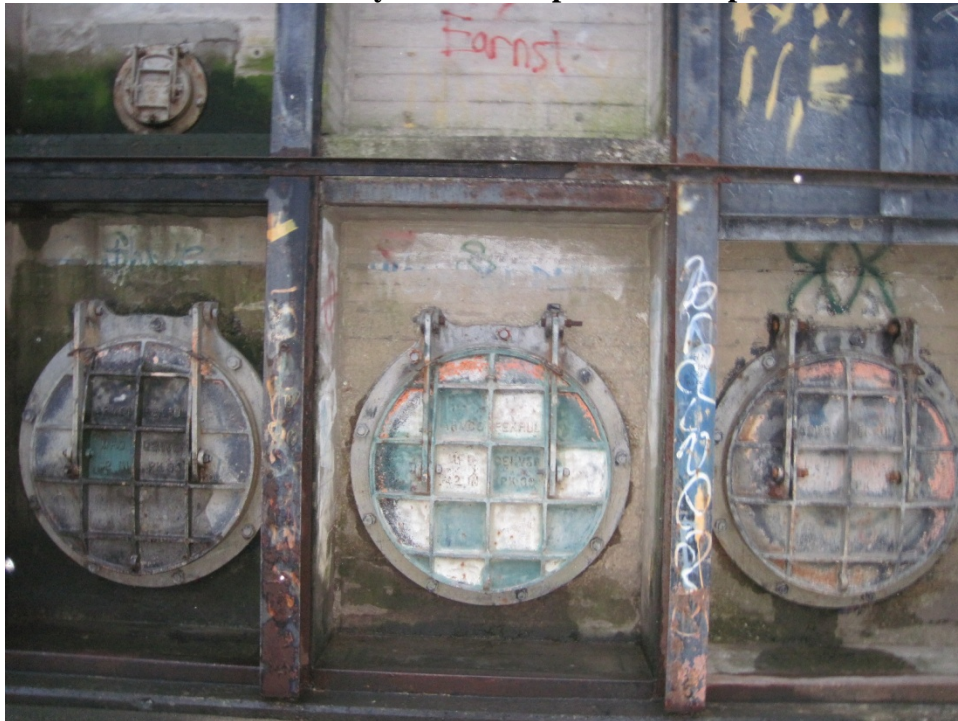
Photo 8.5-22 Perry Street Pump Station Pump #2 Flap Gate Missing Nut
