LEVEE SYSTEM EVALUATION REPORT

VINCENNES, INDIANA

LOUISVILLE DISTRICT CORPS OF ENGINEERS

May 2014

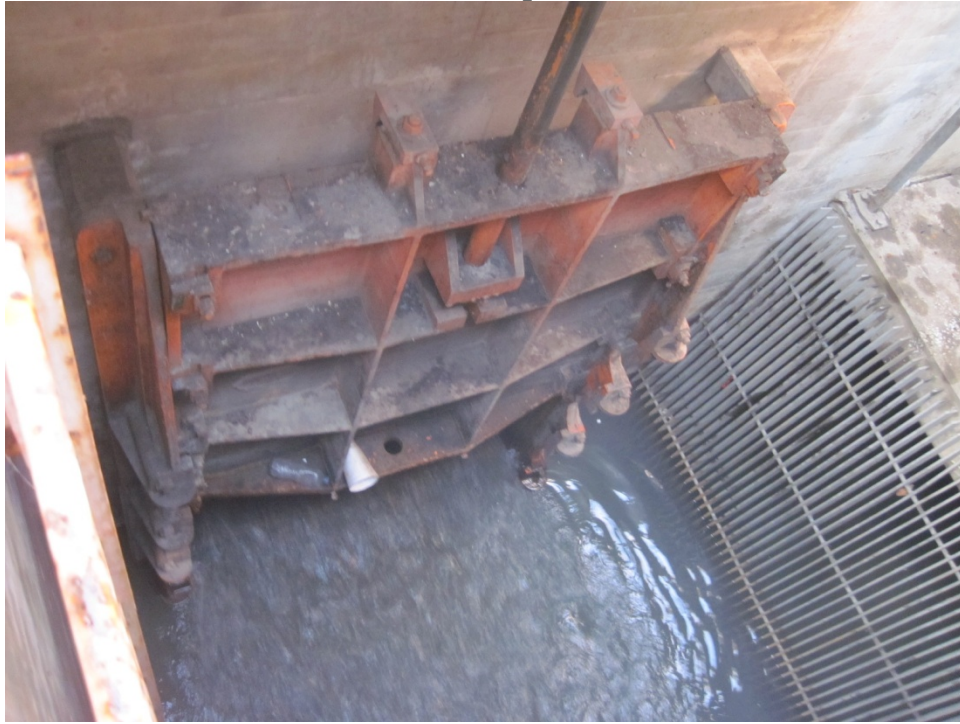
The sluice gate was operated a full open close cycle acceptably (Photo 8.5-25). The four pump discharge flap gates: pump #1 (Photo 8.5-26), pump #4 & #2 (Photo 8.5-27), and pump #3 & #4 (Photo 8.5-28) were visually inspected during operation and determined to be acceptable. The sluice gate in the discharge gatewell (Photo 8.5-29) was operated a full open and close cycle acceptably. The flap gate at the river needs realigned and painting is recommended (Photo 8.5-30).

Photo 8.5-26 St. Clair Pump Station Pump #1 Discharge

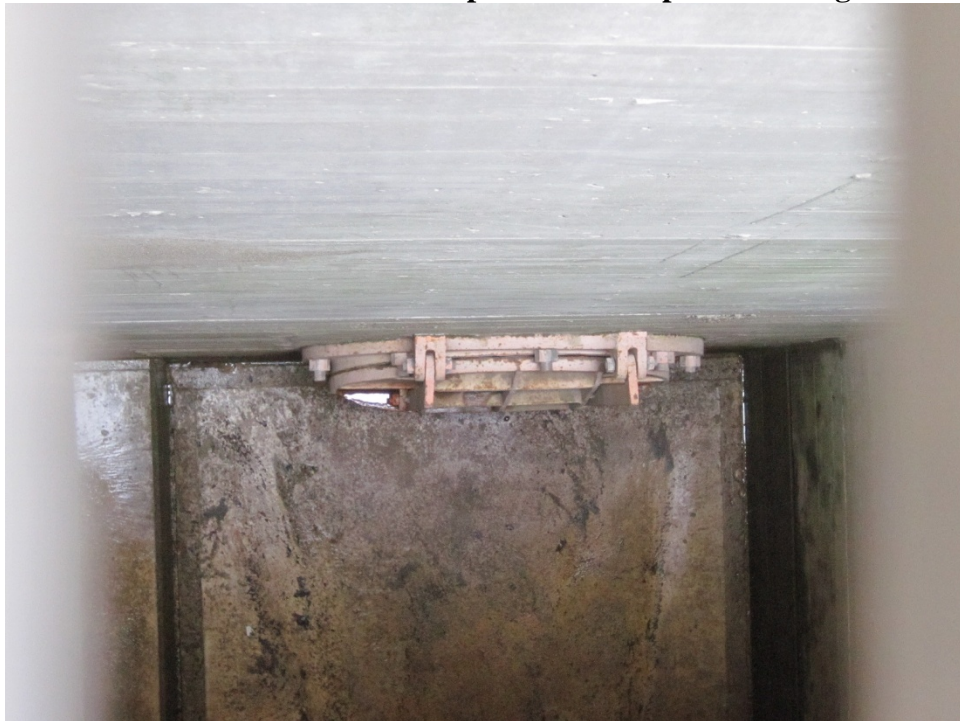
Photo 8.5-27 St. Clair Pump Station Pump #4 & #2 Discharge Flap Gate

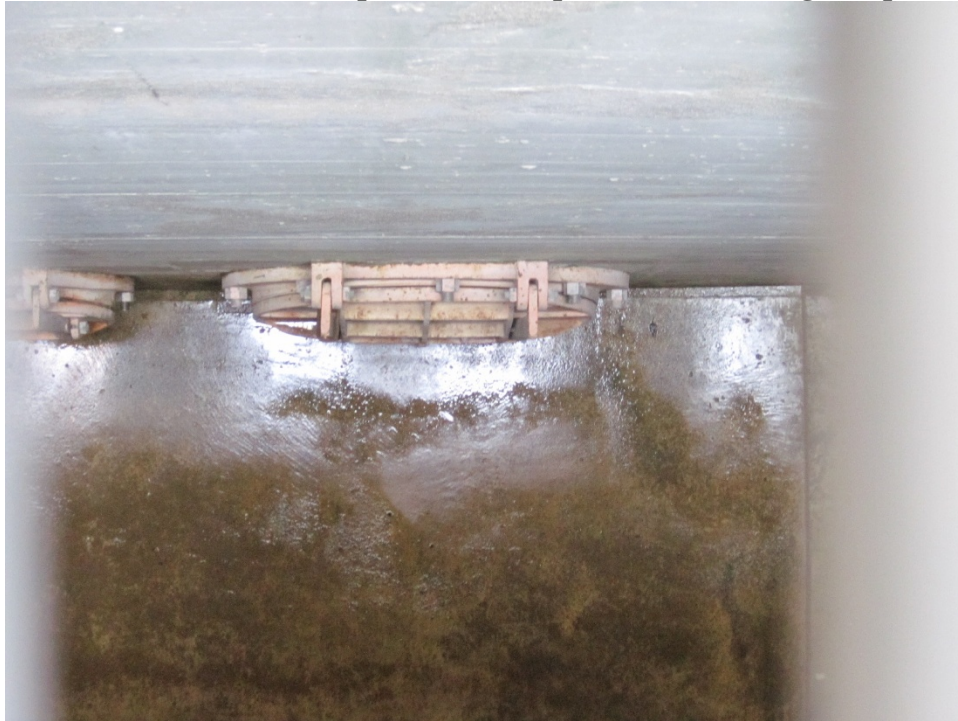
Photo 8.5-28 St. Clair Pump Station #3 & #4 Discharge Flap Gate

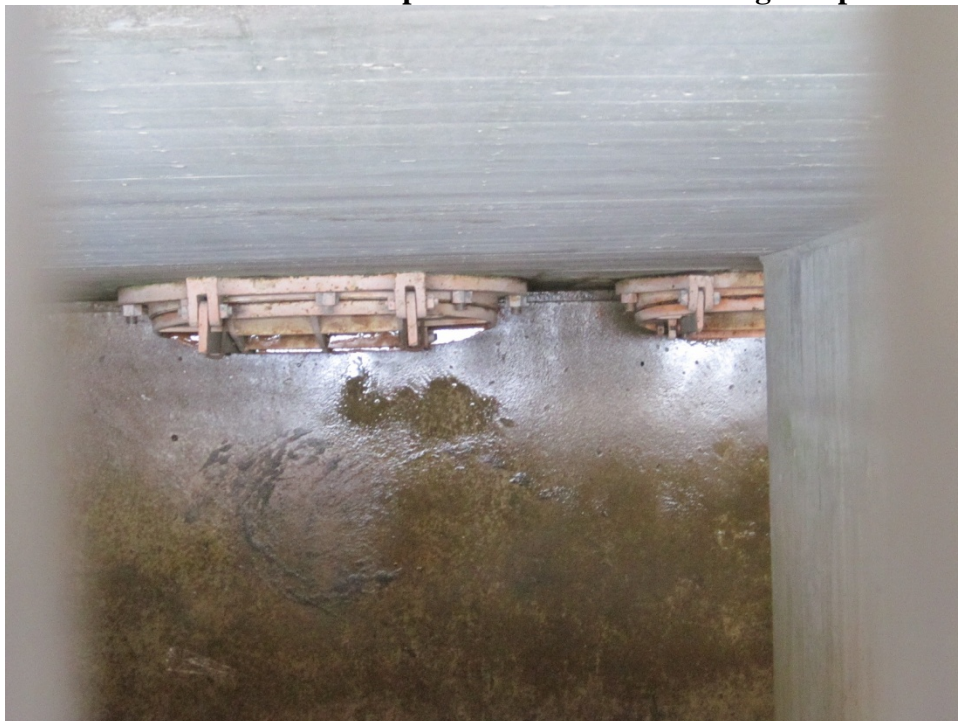
Photo 8.5-29 St. Clair Pump Station Gatewell Sluice Gates

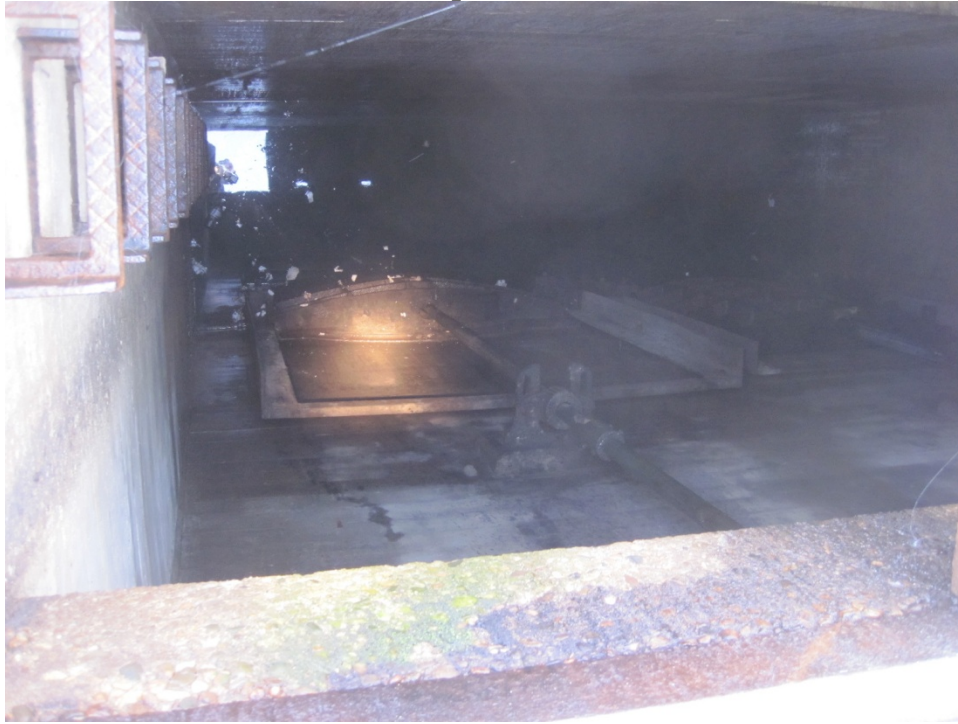
Photo 8.5-30 St. Clair Pump Station Discharge Flap Gate

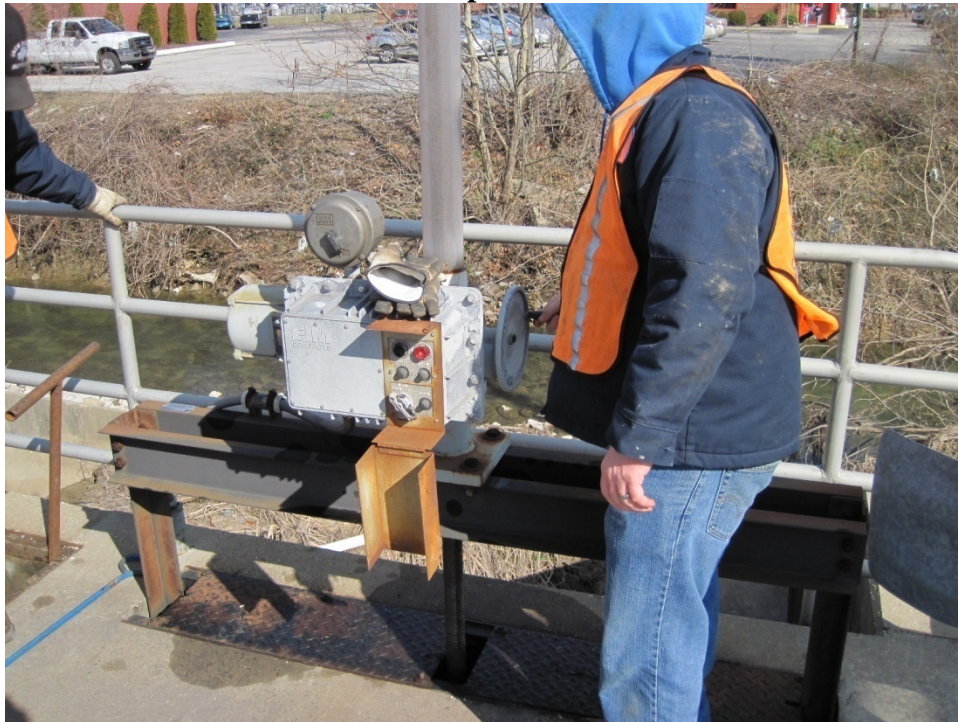
The electrically actuated sluice gate (Photo 8.5-31) initially would not operate due to faulty underground wiring. This wiring was replaced and the gate was operated a full open full close cycle. The three pump discharge gates (Photo 8.5-32) and the single gravity flap gate (Photo 8.5-33) were inspected and found to be acceptable other than delaminating paint and corrosion (Photo 8.5-34).

Photo 8.5-32 Sixth Street Pump Station Pump Discharge Flap Gates

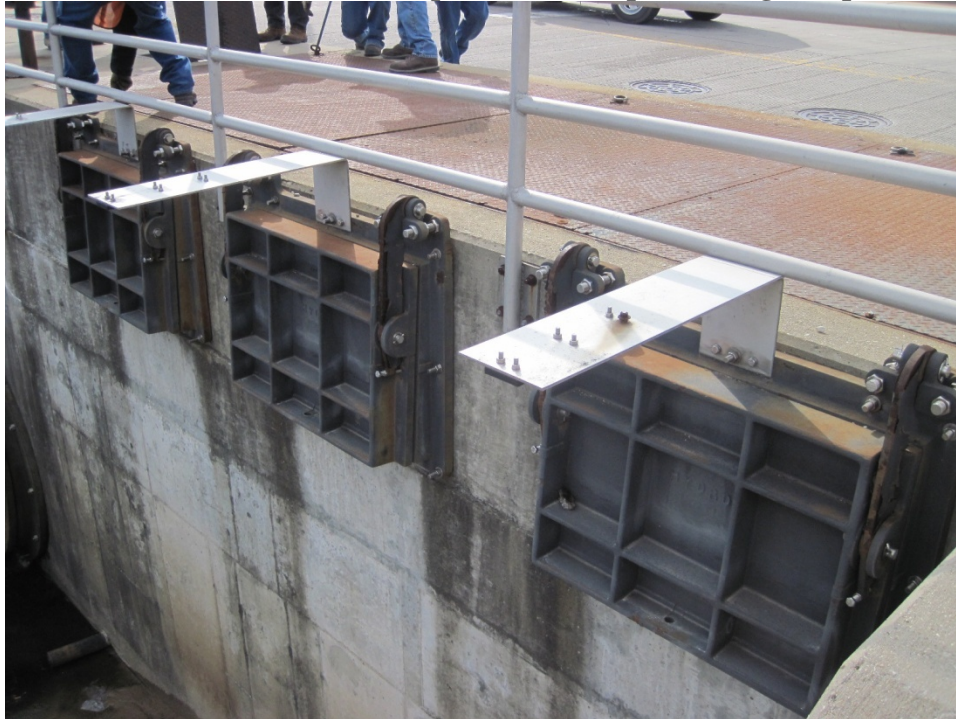
Photo 8.5-33 Sixth Street Pump Station Gravity Discharge Flap Gate

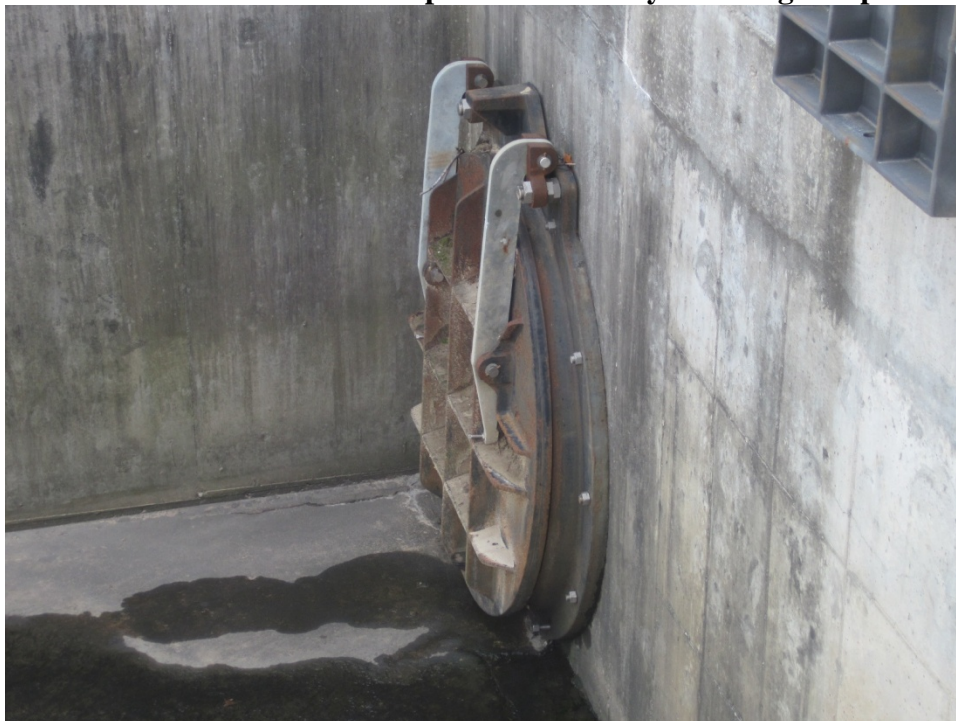
Photo 8.5-34 Sixth Street Pump Station Delaminating Paint and Corrosion

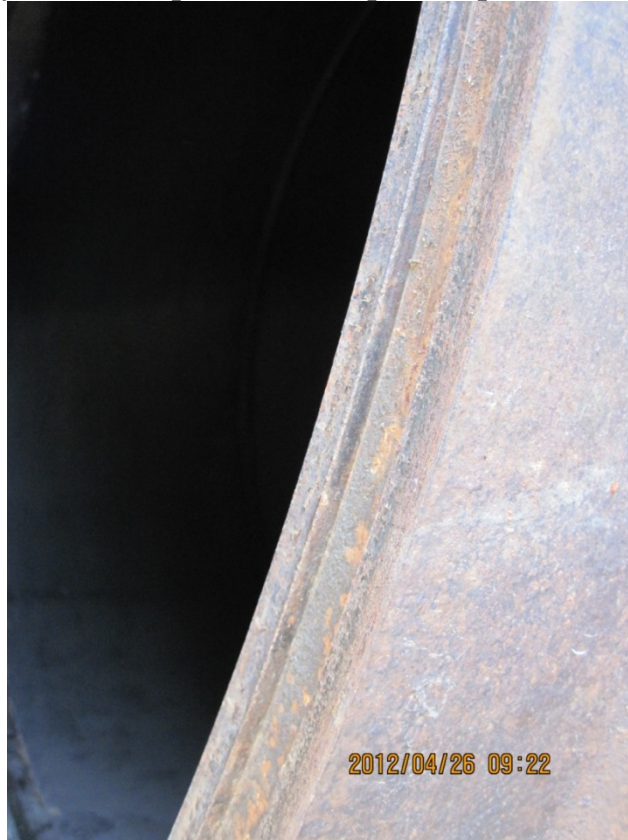
Both sluice gates was operated a full open close cycle acceptably. Both flap gates were visually inspected. The flap gate for pump #1 was missing the rubber seal (Photo 8.5-35). It is recommended that a new seal be installed.. The flap gate for Pump #2 had slight movement at the ear attaching the hinge arm to the headwall (Photo 8.5-36). It is recommended that these bolts be investigated and the gate aligned if necessary. All three gravity sluice were operated a full open and close cycle acceptably (Photo 8.5-37).

Photo 8.5-36 City Ditch Pump Station Pump #2 Flap Gate

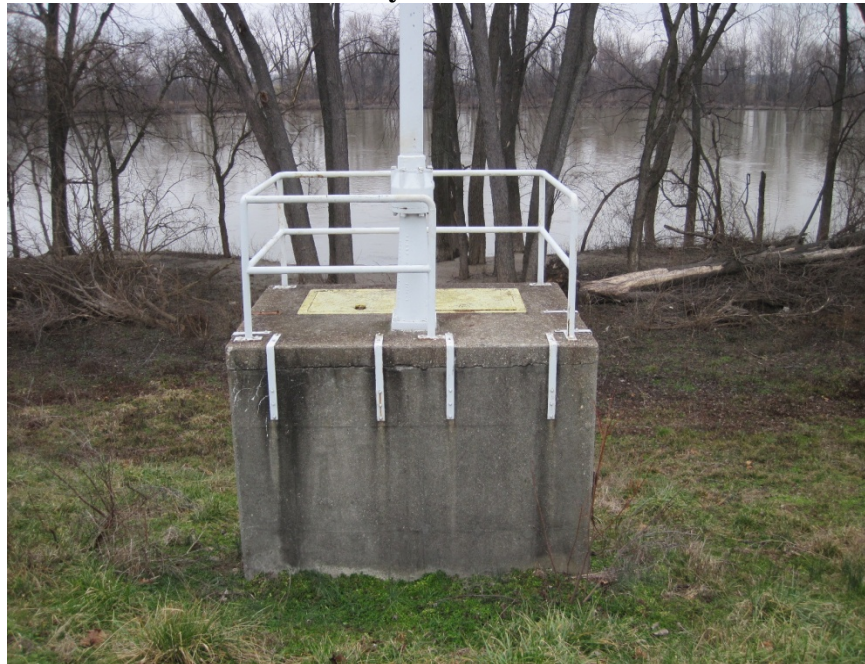
Photo 8.5-38 Sanitary Treatment Plant Gatewell

The sanitary treatment plant sluice gate (Brevoort Levee Station 659+26) is inoperable. This is an LSE item and shall be repaired/replaced (Photo 8.5-38).

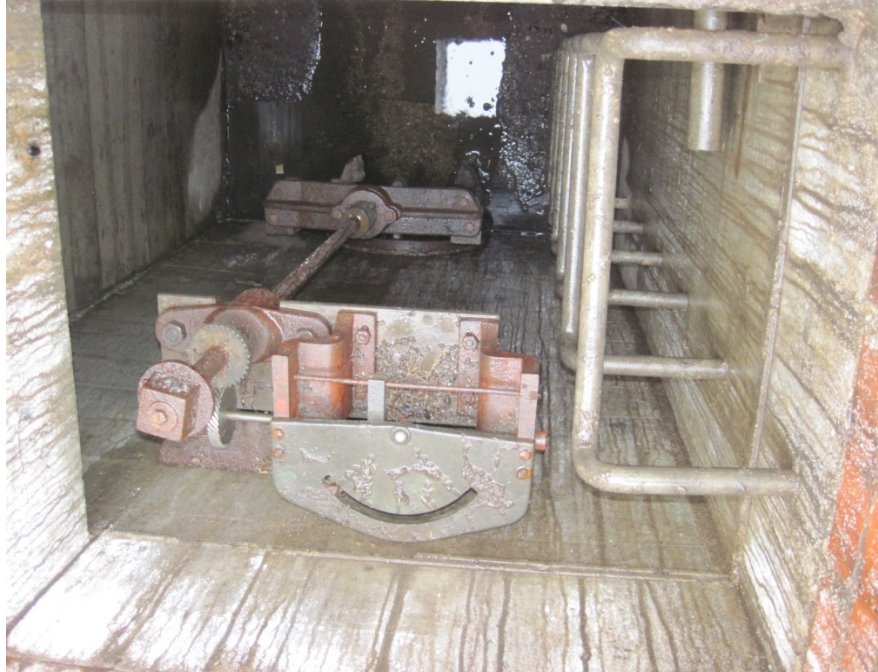
Photo 8.5-39 Patrick Henry Drive Sluice Gate

The sluice gate located at Patrick Henry Drive (GW-16) operated acceptably (Photo 8.5-39).

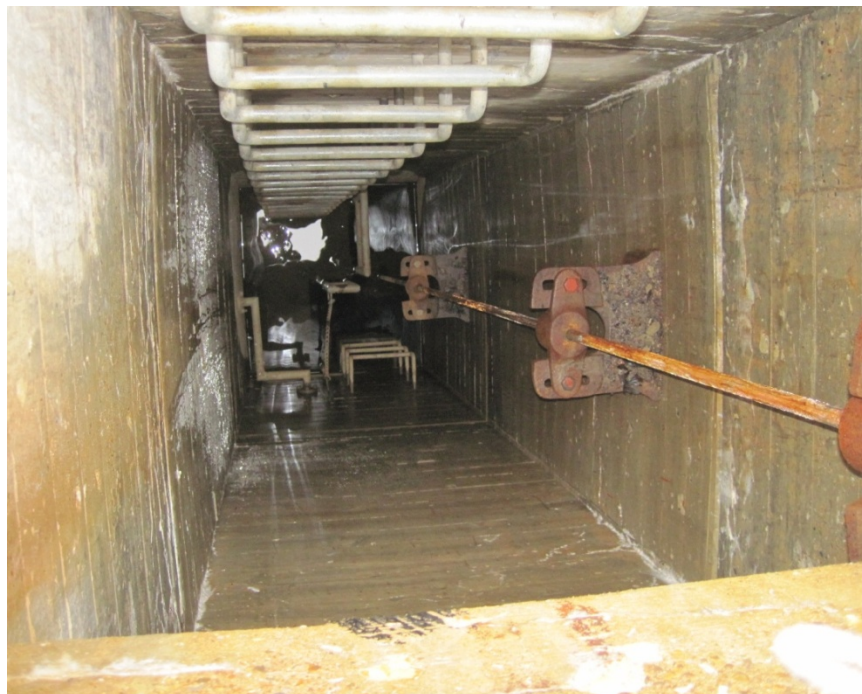
Photo 8.5-40 Gatewell #14 Sluice Gate

The sluice gate located at gatewell #14 is planned to be abandoned (Photo 8.5-40).

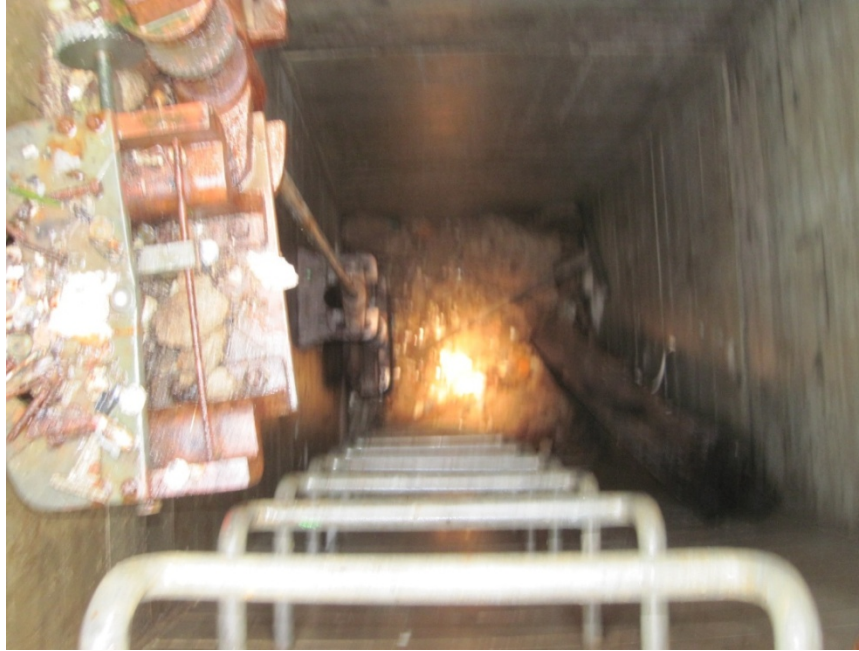
Photo 8.5-41 Gatewell #13 Sluice Gate

The sluice gate located at gatewell #13 is planned to be abandoned (Photo 8.5-41).

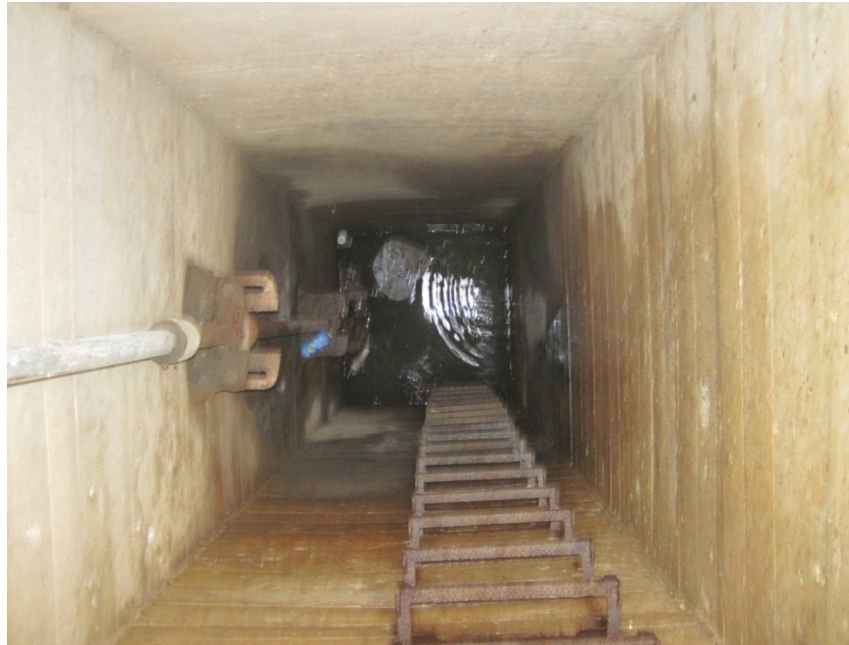
Photo 8.5-42 Gatewell #11 Sluice Gate

The sluice gate located at gatewell #11 is planned to be abandoned (Photo 8.5-42).

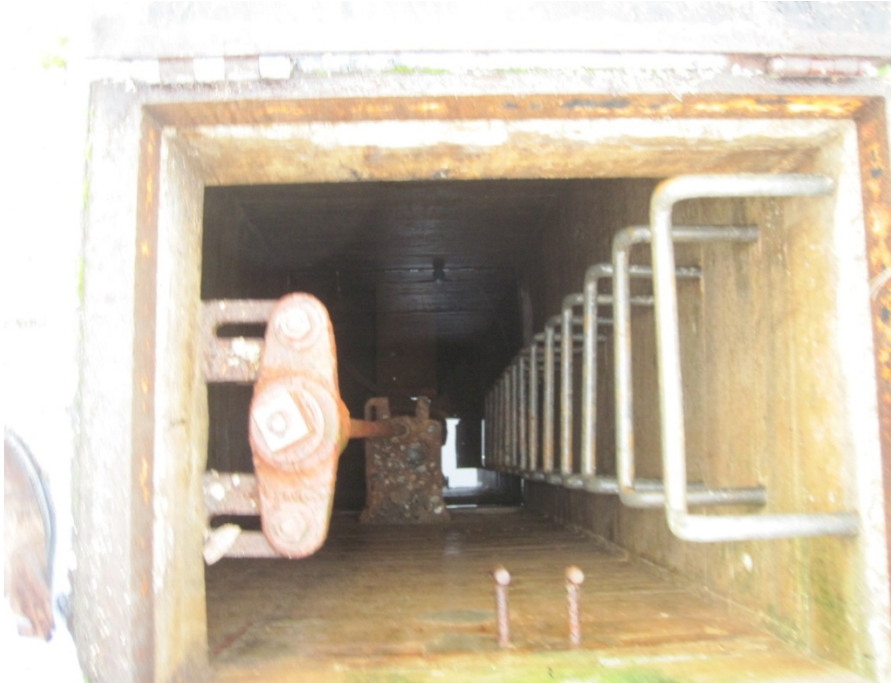
Photo 8.5-43 Gatewell #9 Sluice Gate

The sluice gate located at gatewell #9 is planned to be abandoned (Photo 8.5-43).

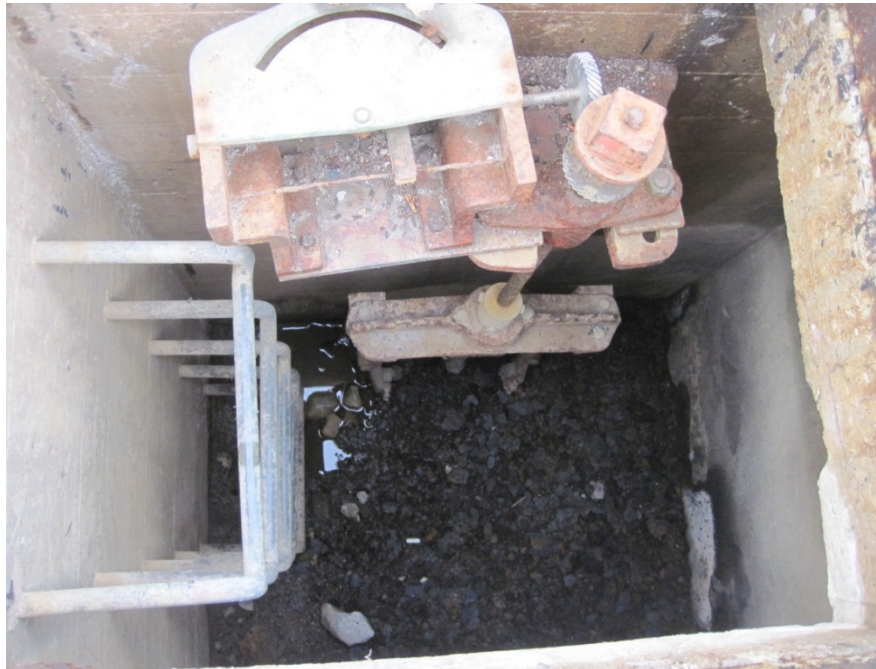
Photo 8.5-44 Gatewell #10 Sluice Gate

The sluice gate located at gatewell #10 is planned to be abandoned (Photo 8.5-44).

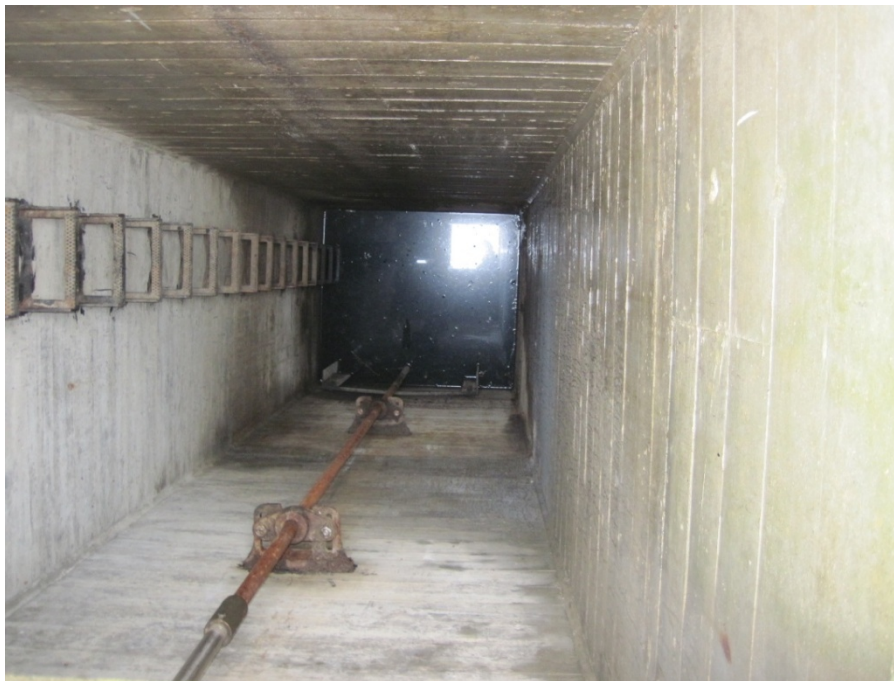
Photo 8.5-45 Gatewell #8 Sluice Gate

The sluice gate located at gatewell #8 operated acceptably (Photo 8.5-45).

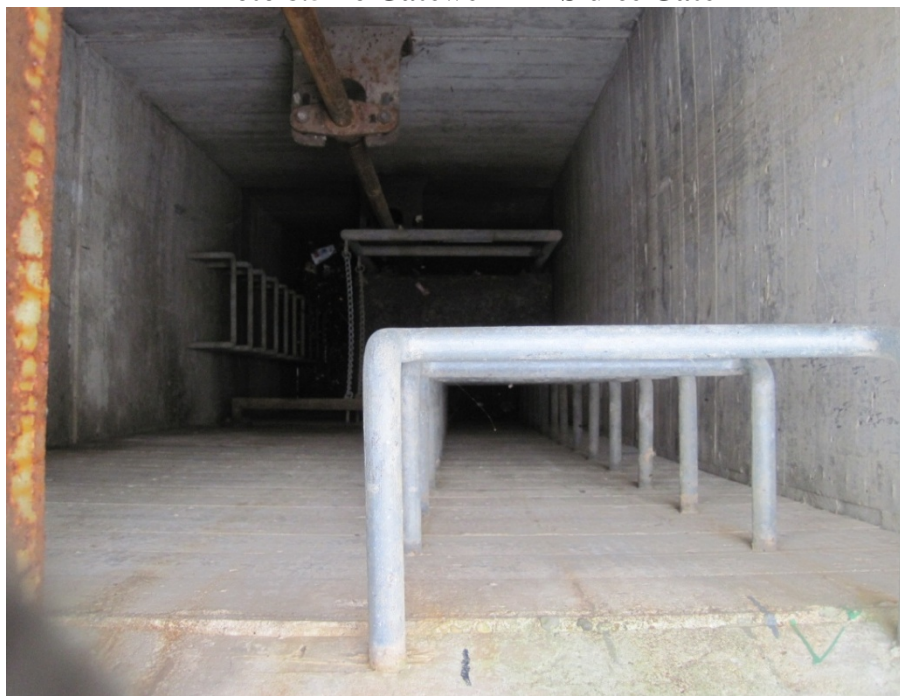
Photo 8.5-46 Gatewell #12 Sluice Gate

The sluice gate located at gatewell #12 operated acceptably (Photo 8.5-46).

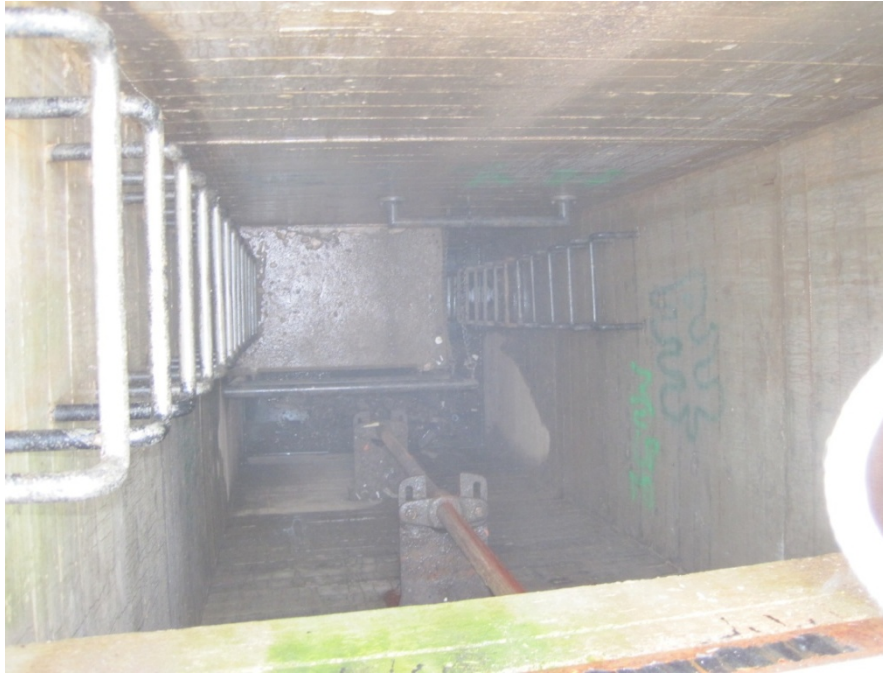
Photo 8.5-47 Gatewell #15 Sluice Gate

The sluice gate located at gatewell #15 operated acceptably (Photo 8.5-47).

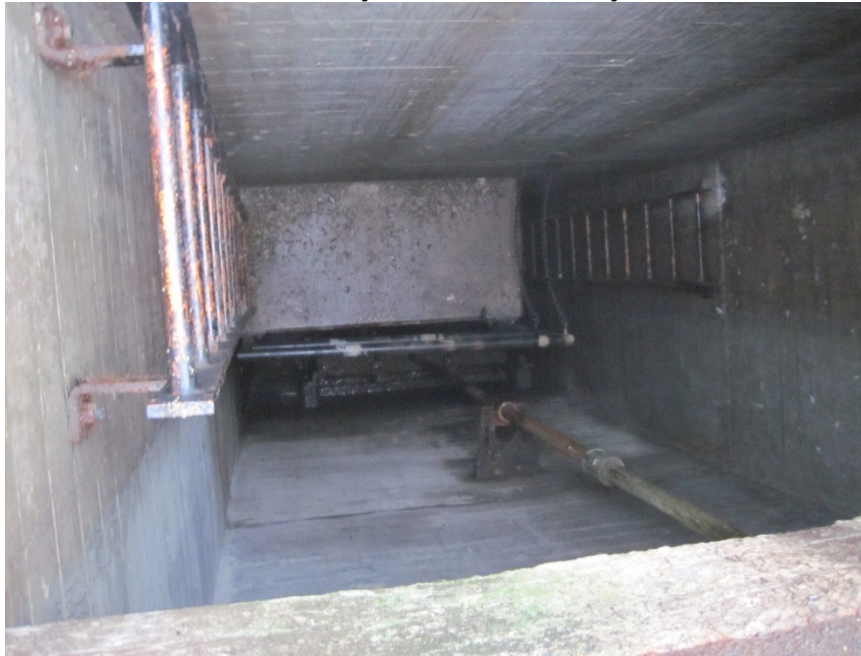
Photo 8.5-48 Gravity Gatewell at Perry Street P.S.

The gravity sluice gate located at Perry Street P.S. operated acceptably (Photo 8.5-48).

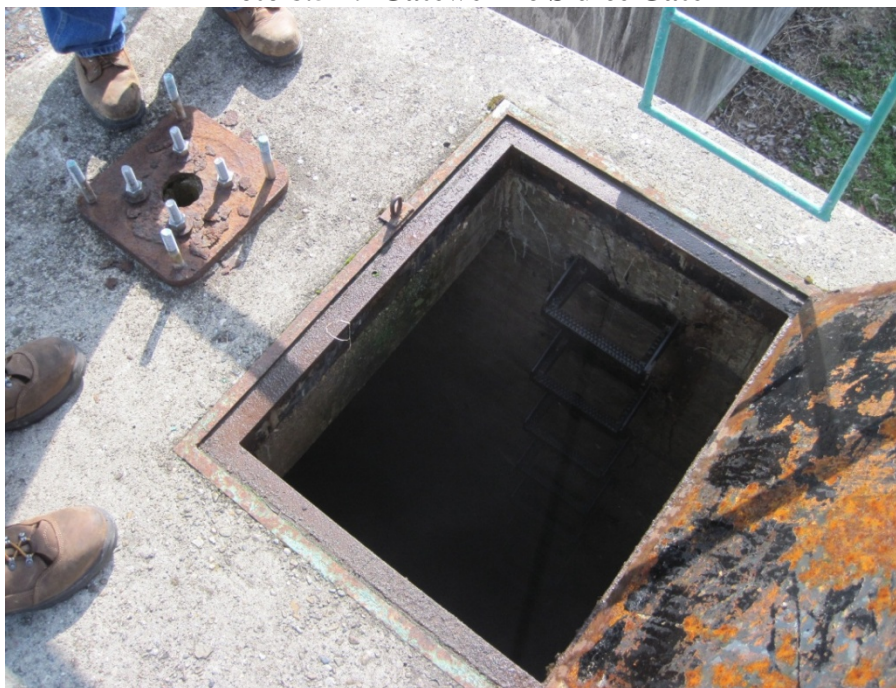
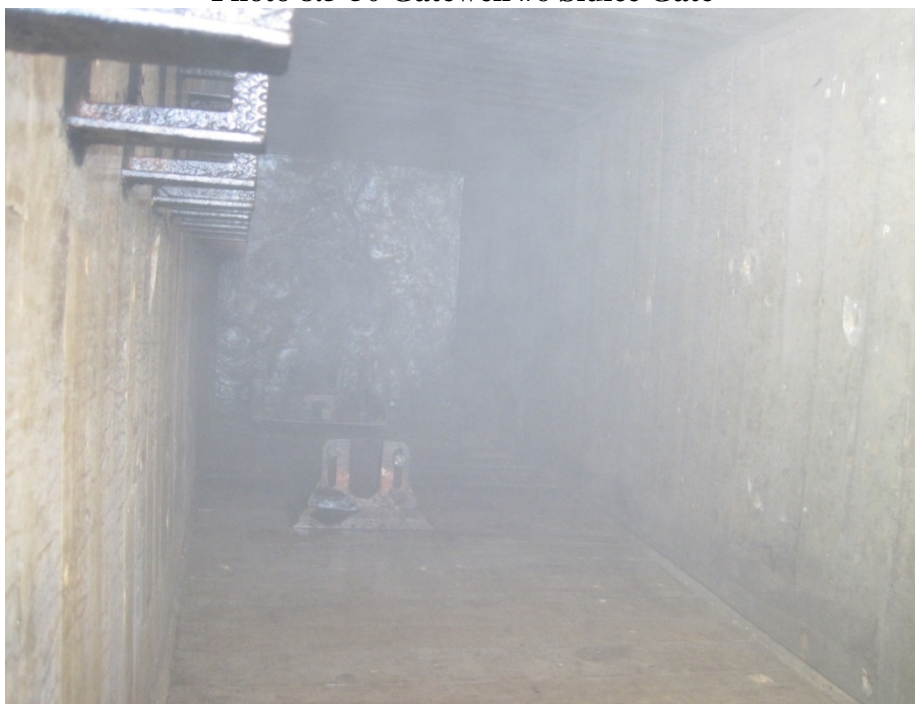
The sluice gate located at gatewell #6 is inoperable and shall be properly abandoned as permitted. This is an LSE item (Photos 8.5-49 and 8.5-50).

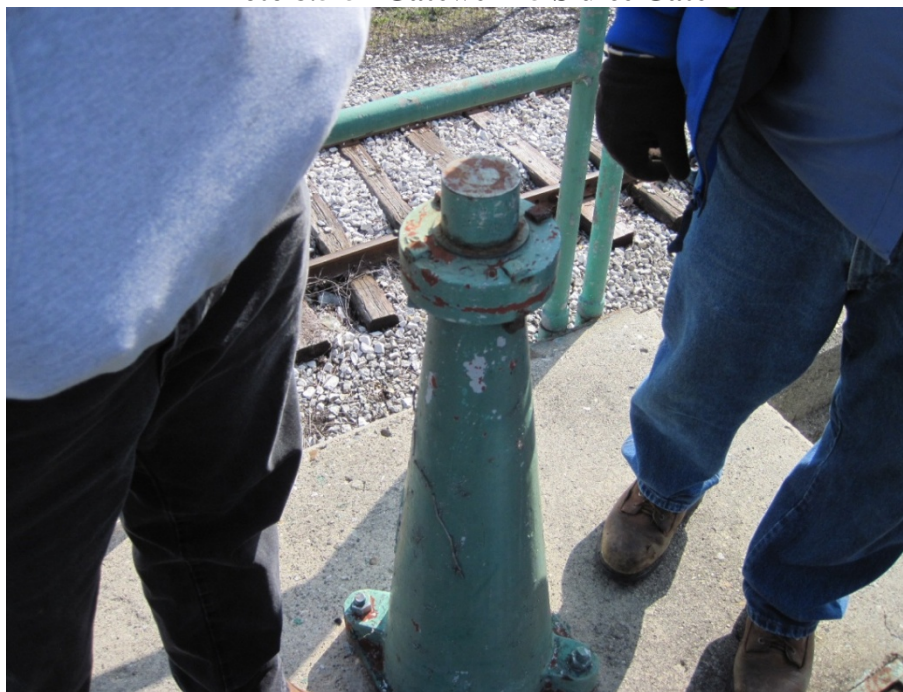
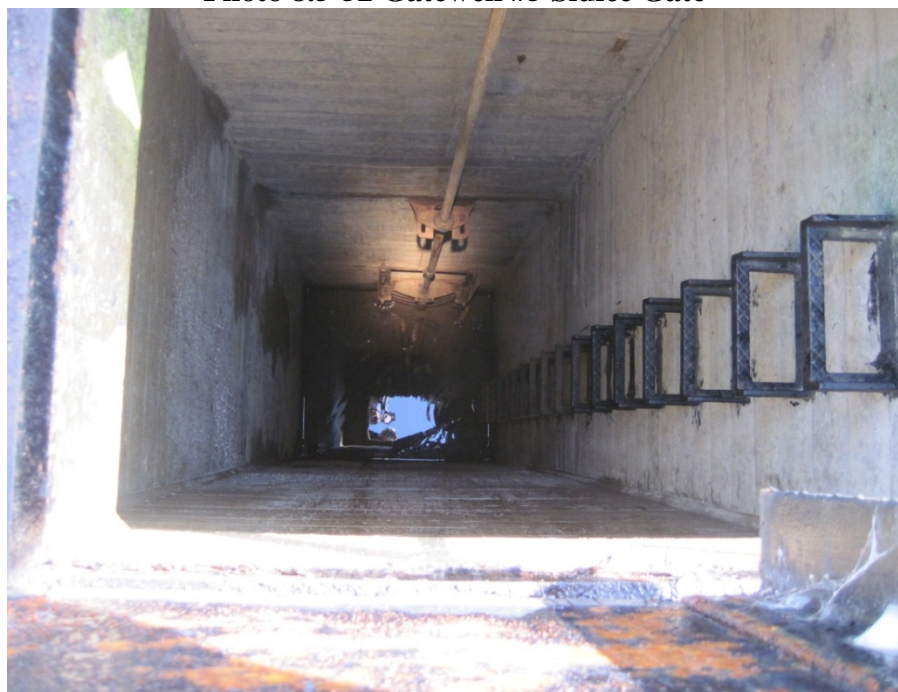
The sluice gate located at gatewell #5 is inoperable and shall be properly abandoned as permitted (Photos 8.5-51 and 8.5-52). This is an LSE item.

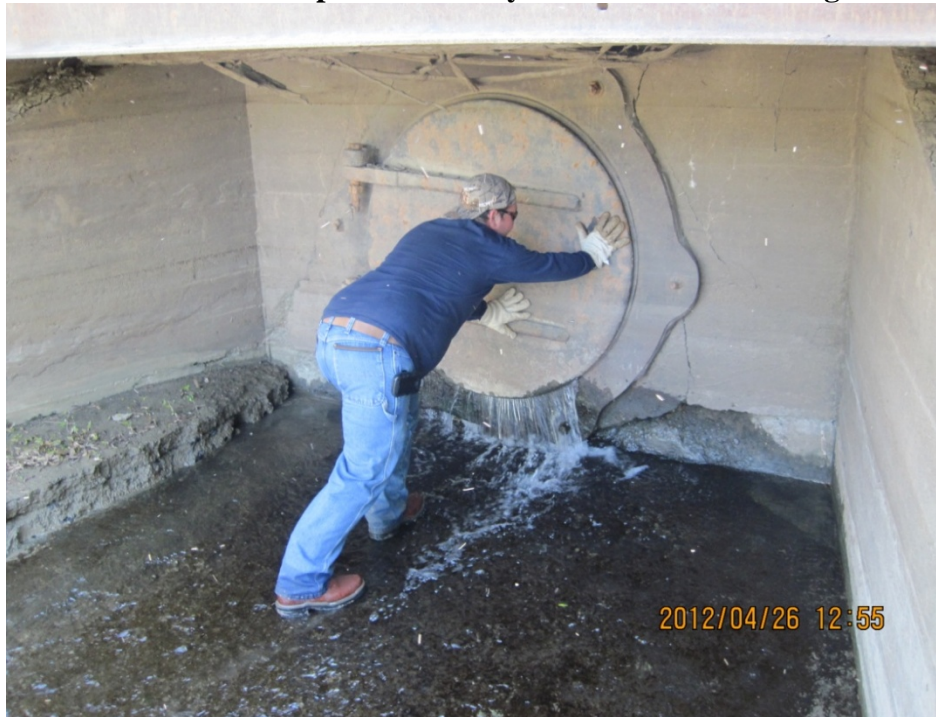
Photo 8.5-54 Flap Gate for City Condensation Drainage

The flap gate for the City condensation drainage at GW #15 is slightly misaligned and needs adjusted (Photo 8.5-54).

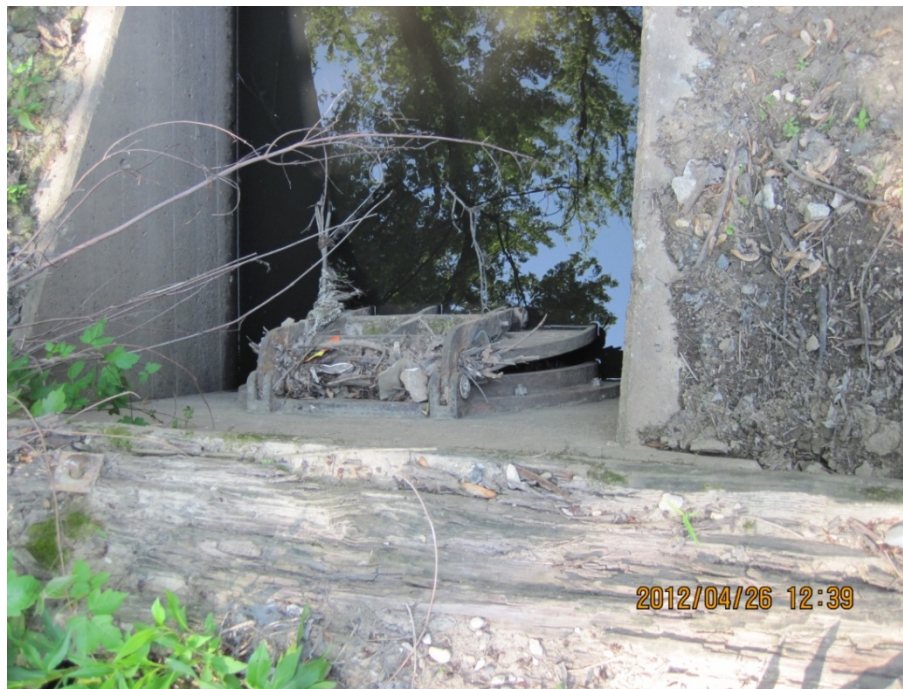
Photo 8.5-55 Flap Gate for Gatewell #12

The flap gate for gatewell #12 contains debris and is unable to close. Remove debris so gate can operate freely (Photo 8.5-55).

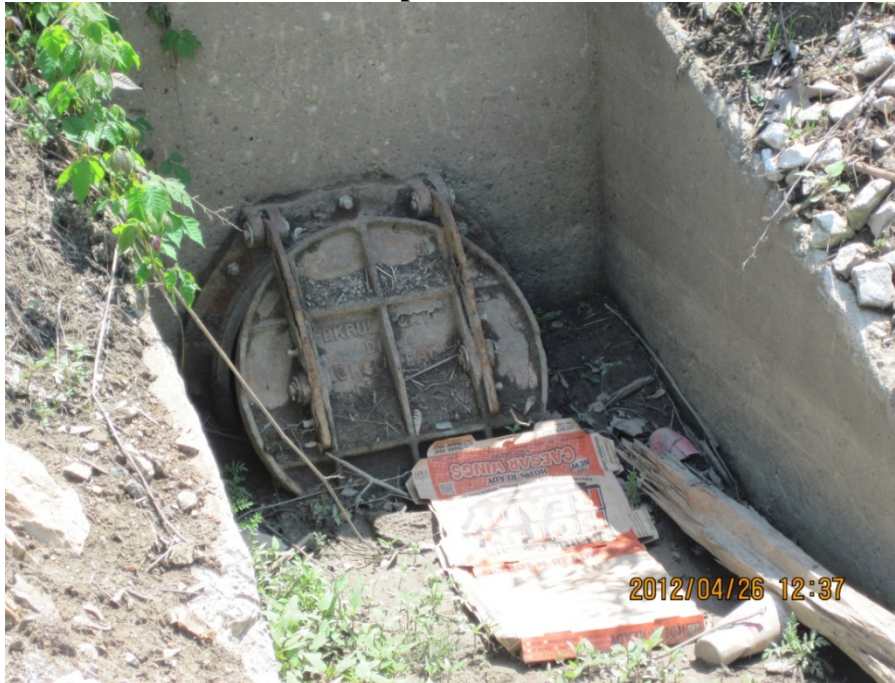
Photo 8.5-56 Flap Gate for Gatewell #11

The flap gate for gatewell #11 is silted in and is unable to close. Remove debris so gate can operate freely (Photo 8.5-56).

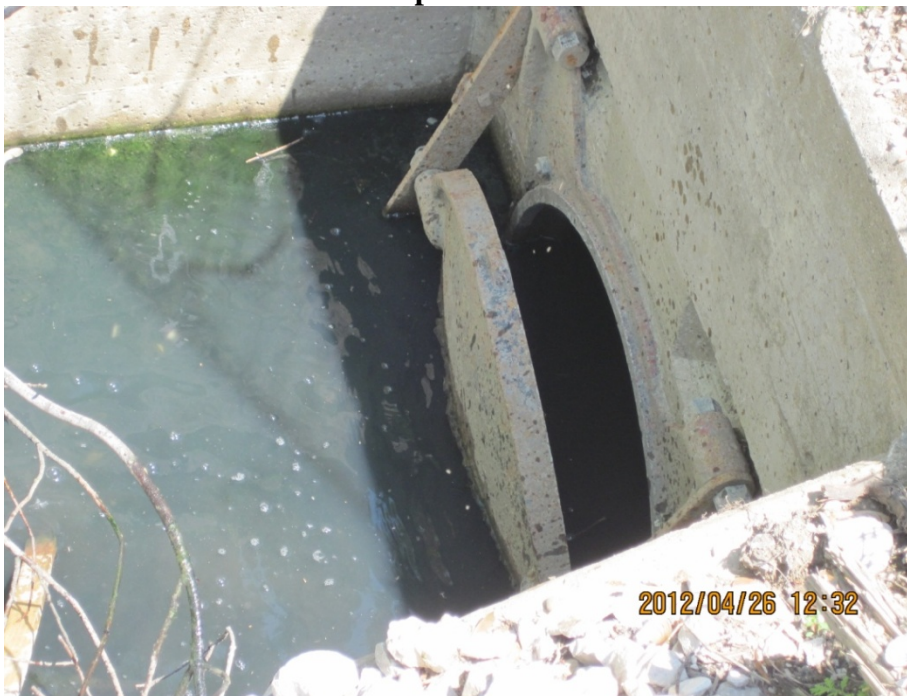
Photo 8.5-57 Flap Gate for Gatewell #8

The flap gate for gatewell #8 is misaligned and needs adjusted (Photo 8.5-57).

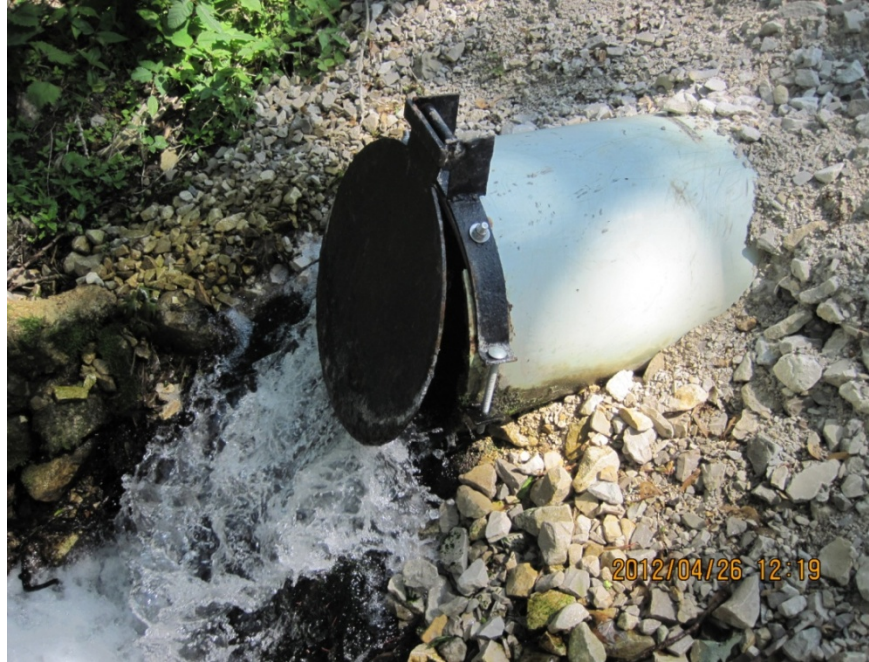
Photo 8.5-58 Flap Gate for Gatewell #6

The flap gate for gatewell #6 is corroded and needs painted. This line is to be abandoned.

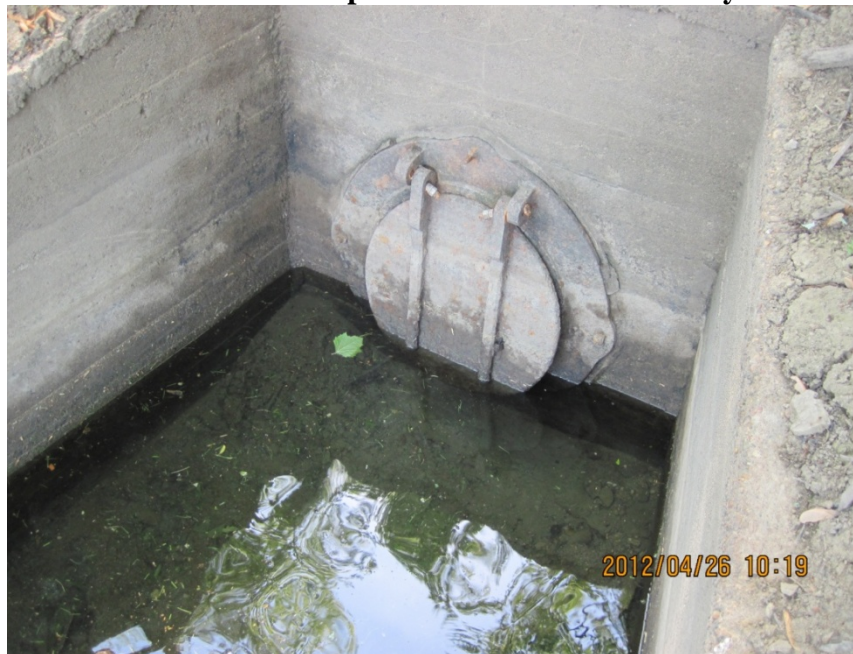
Photo 8.5-59 Flap Gate Located at Pearl City

The flap gate located at Pearl City (Station 200+75) has corroded bolts and needs painted. This gate has been replaced under Permit No. 2011035.VIN (Photo 8.5-59).

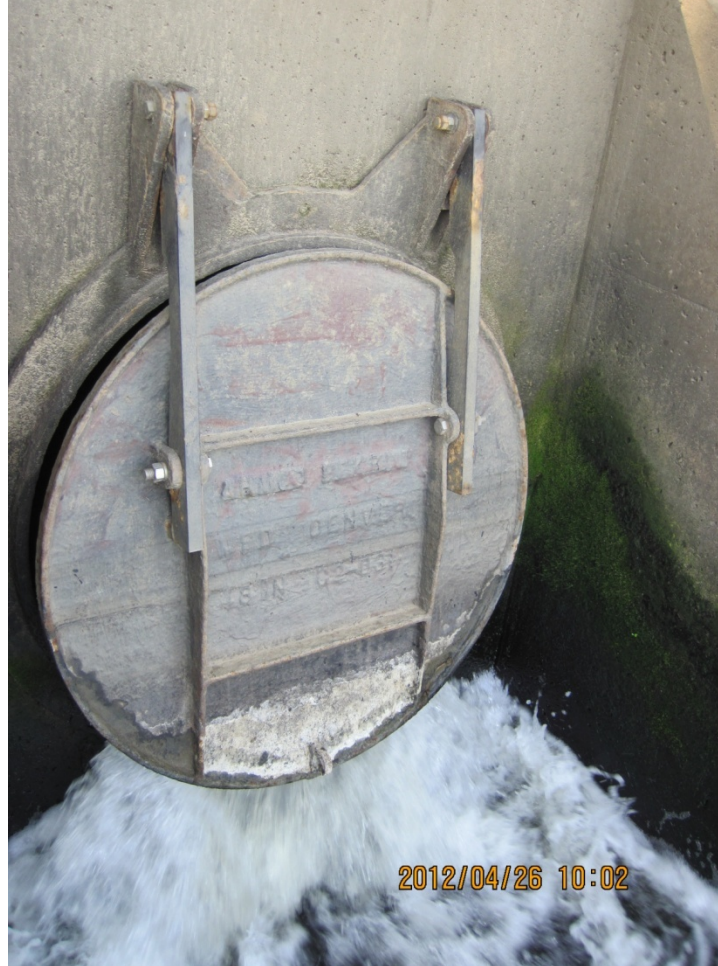
Photo 8.5-60 Flap Gate for Waste Water Treatment Plant

The flap gate for the waste water treatment plant is recommended to be cleaned and painted (Photo 8.5-60).

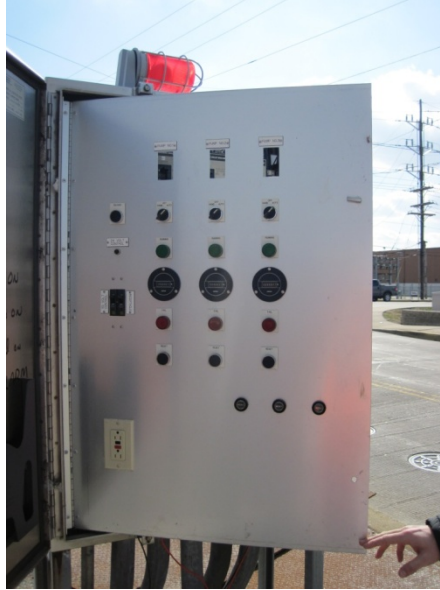
Photo 8.6-1 Sixth St Control Panel

The Sixth Street Pump Station differs from all the other pump stations in that it is a submersible station. The pumps are submersible type and located within a sump adjacent to Niblack Blvd. Power distribution equipment and control hardware is located in a control panel (photo 8.6-1) next to the sump area. The control panel equipment is in good physical and operating condition. Pump Station system voltage readings (Table 8.6-1) were taken via the MCC mounted voltmeter:

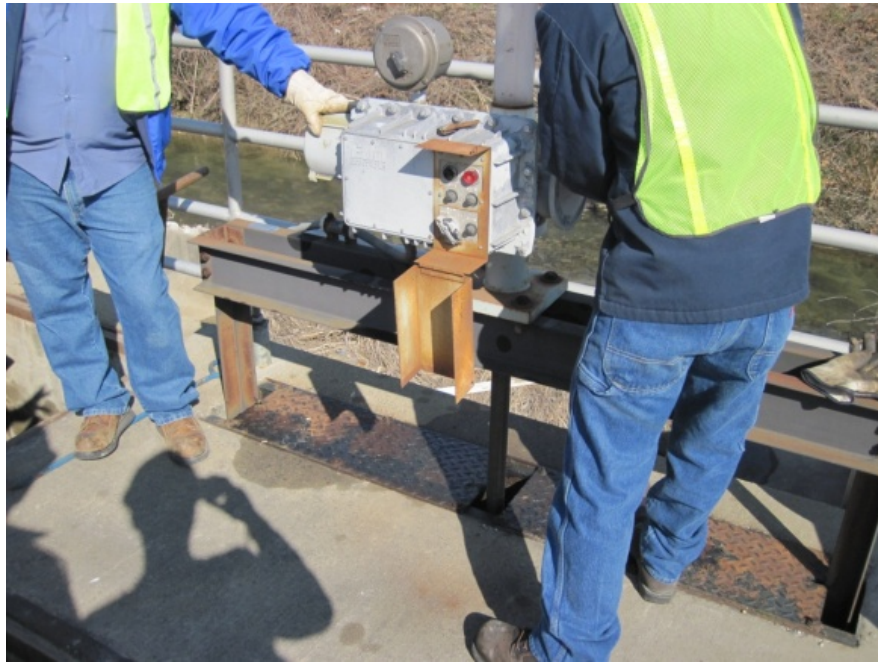
Photo 8.6-2 Sixth St Electrical Actuator

An electrical actuator is present at the station and allows water to drain into a creek during low water rain events. (Photo 8.6-2)

The actuator is fed from the pump station and was not tested. The actuator ran partially then stopped working. Insulation testing was performed on the three phase conductors of the actuator controller (photo 18) and results showed 0Ω on the A phase of the circuit. This indicated a short on the branch circuit which caused the actuator to malfunction. This short was also causing the fuses (photo 3018) on the controller to blow. All three phase conductors were replaced and the actuator functioned properly. Maintenance personnel also noted lightning damage to motor contacts (photo 3008), which have since been replaced.

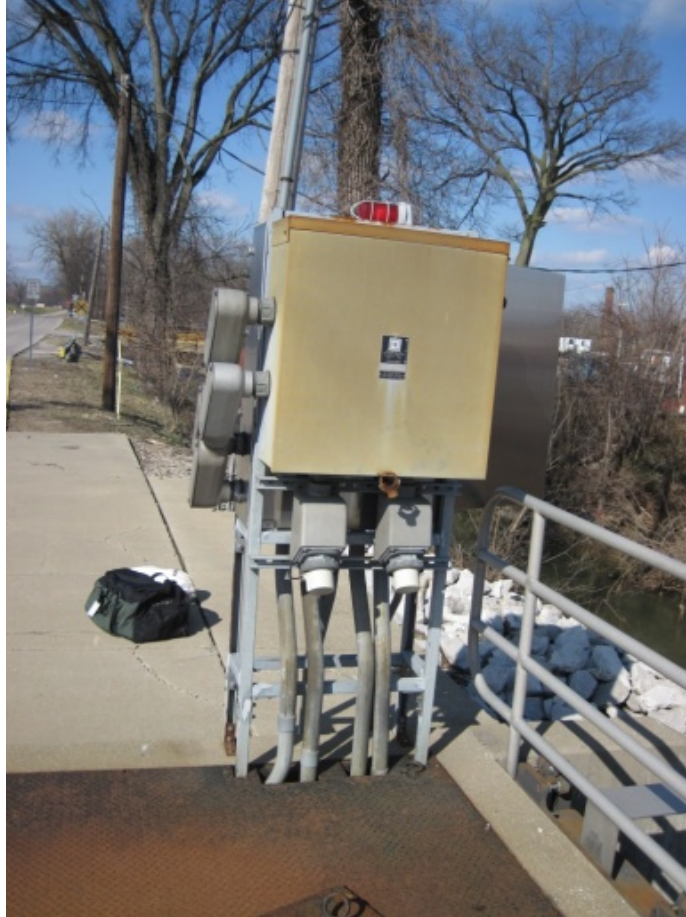
Backup power to the pump station is provided through a portable generator connected via pin and sleeve connectors. A 400 amp, double-throw, non fused manual safety switch transfers power from utility (normal) to portable generator (emergency) (Photo 8.6-3).

Photo 8.6-3 Sixth Street Generator Receptacles and Safety Switch

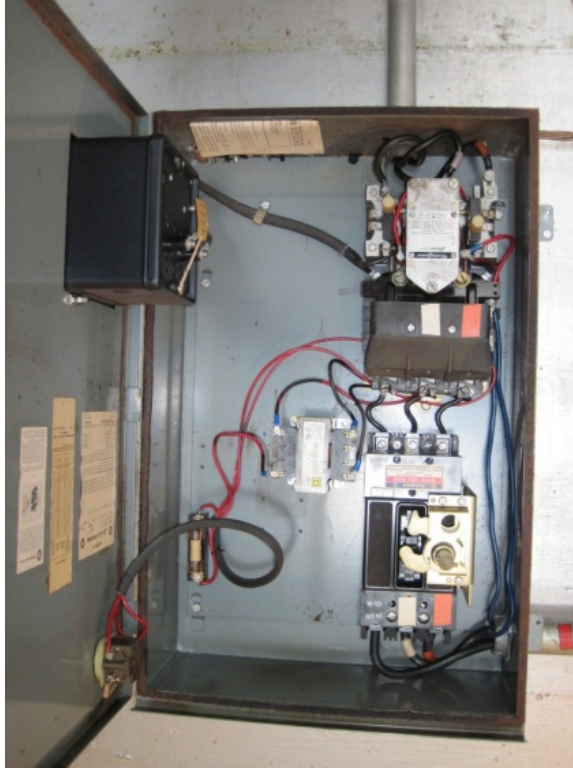
The existing motor starting equipment consists of two wall mounted Westinghouse control panels. The equipment is outdated but it is in good operating condition (photo 8.6-4).

Photo 8.6-4 Second Street Pump Station Motor Control Equipment
