LEVEE SYSTEM EVALUATION REPORT

VINCENNES, INDIANA

LOUISVILLE DISTRICT CORPS OF ENGINEERS

May 2014

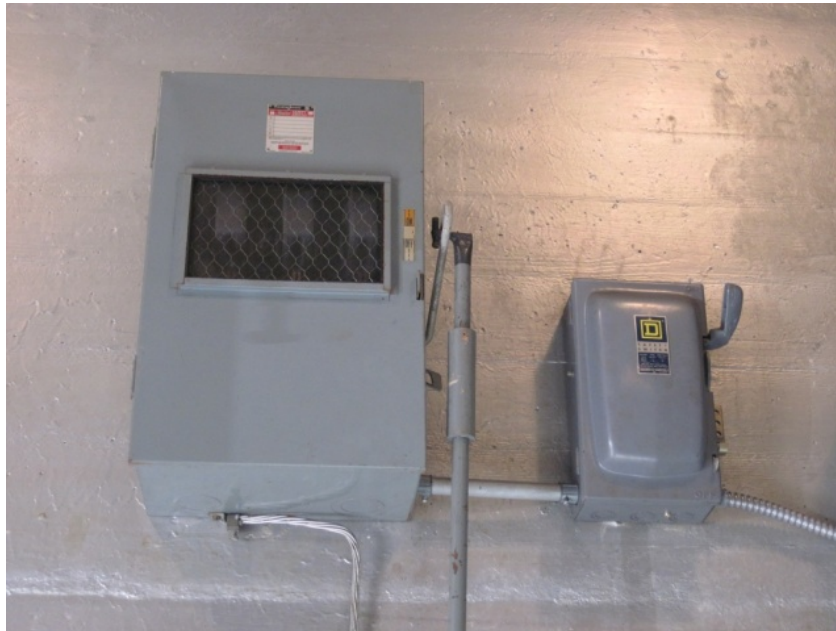
Pump Station system voltage readings were not taken due to the fact that the incoming power was fed through a tapped 200A non-fused disconnect (Photo 8.6-5), which presents an arc flash hazard.

Photo 8.6-5 Second Street Pump Station non-fused disconnect

1. Investigate conducting an Arc Flash study for each pump station.
2. Set up transformer servicing contract for Perry Street PS and St. Claire Street PS.
3. Replace non-fused disconnects with fused disconnects at Second Street PS and Highland Street PS.

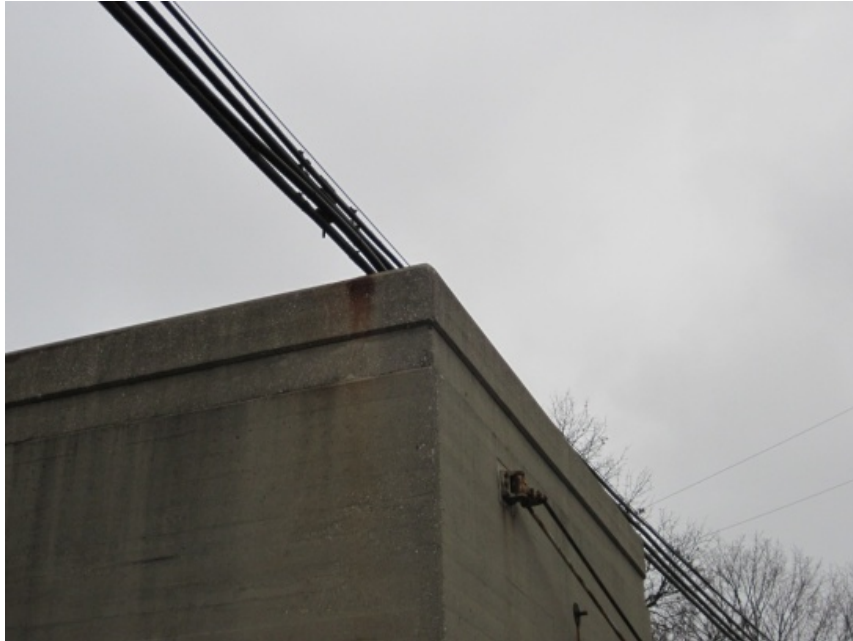
Low hanging communication cables are currently resting on the station roof parapet wall (Photo 8.6-7).

Photo 8.6-7 AT&T Communications Lines resting on Second St. PS Parapet Wall

The cables in question belong to AT&T. The local sponsor has been given USACE's standard operating procedure for the routing of electrical lines over, under, and around floodwalls, levees, and pump stations. They are coordinating with AT&T to obtain the required clearances for the lines above the pump station.

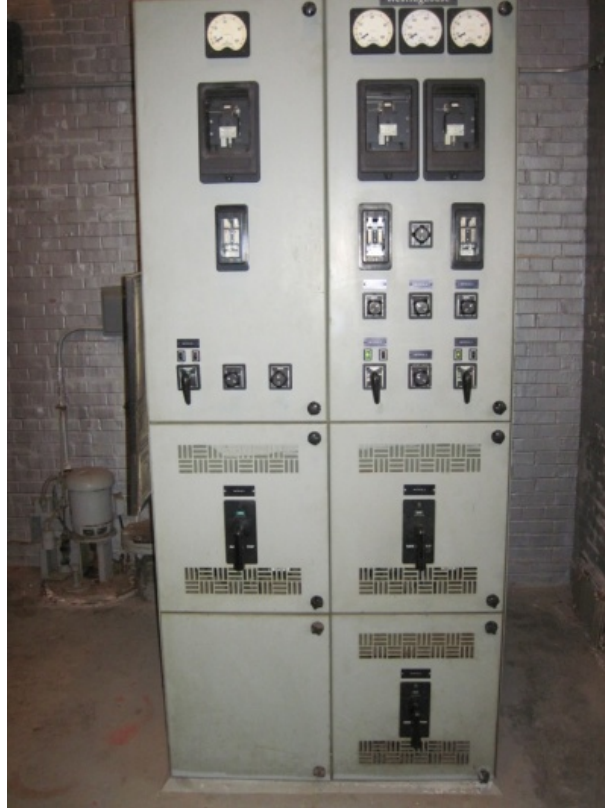
Photo 8.6-8 Highland Street Pump Station Motor Control Center

The existing motor control center (Photo 8.6-8) is Westinghouse switchgear. The controls for Motor 1 work intermittently, while Motor 3 is out of rotation due to its lack of reliability and breaker malfunctions.

Pump Station system voltage readings were not taken due to the fact that the incoming power was fed through a tapped 400A non-fused disconnect, which presents an arc flash hazard. The MCC is in need of replacement and the City of Vincennes is in the process of upgrading to a Square D Model 6 MCC in the future.

1. Replace existing unreliable MCC equipment (motors #1 and #3 power distribution equipment) with new MCC equipment at Highland Street PS.
